# **Pond Interconnection and Estuary Culvert Inspection Report**

## Storm Water Management Pond Interconnections

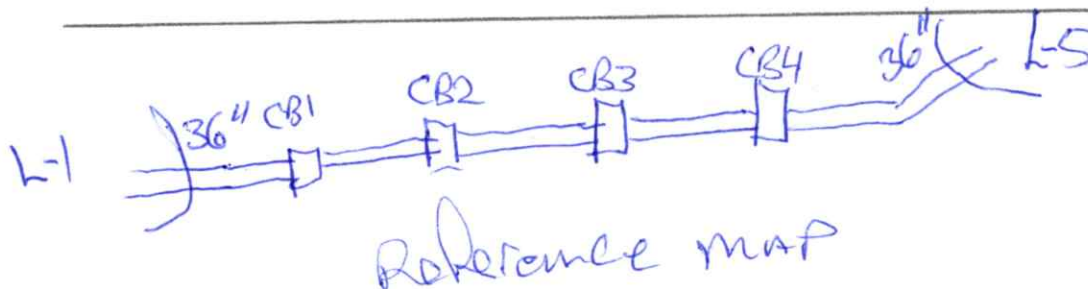
Lake 1 to Lake 5  
River Club

General Condition of Pipe: Dive team noted 10" of sediment at the entrance of the pipe. Slight sediment increases at catch basin 2. Catch basin 2 is in overall good condition. Sediment decreased to 2" to 8" after catch basin 2. At 100' into the pipe the sediment rose to 24". Dive is unable to further inspect the pipe due to clog at 100'.

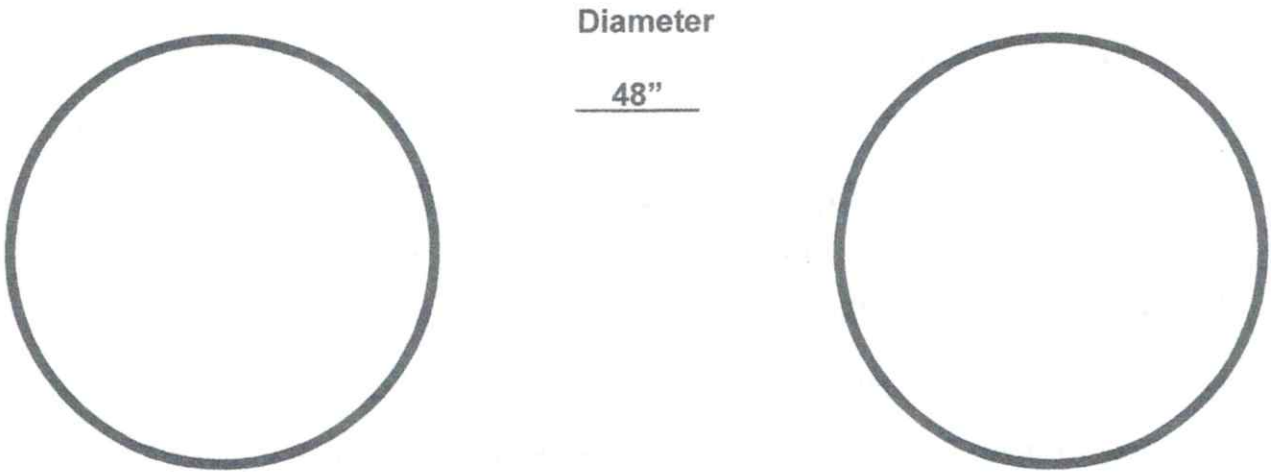
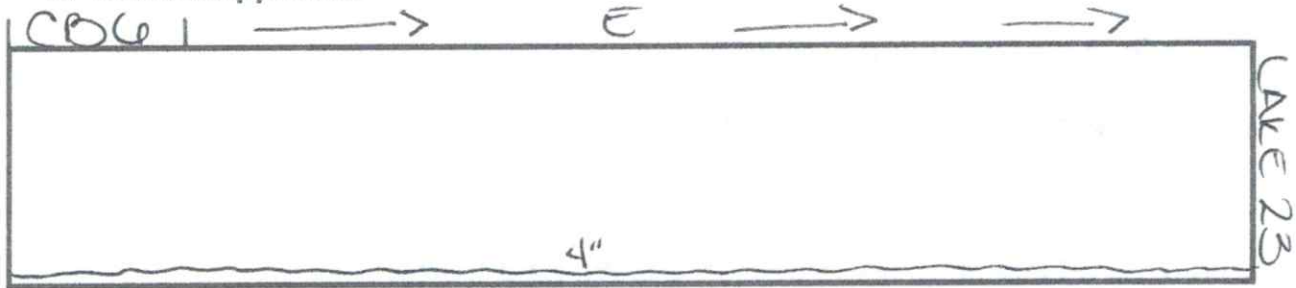
Lake 22 to Lake 23  
Basin 3

Comments: Diver noted that Lake 22 connects to Lake 23 through a series of 6 catch basins. The outfall in Lake 22 is a 24" pipe that runs through the first 5 catch basins. Dive was unable to inspect due to size.

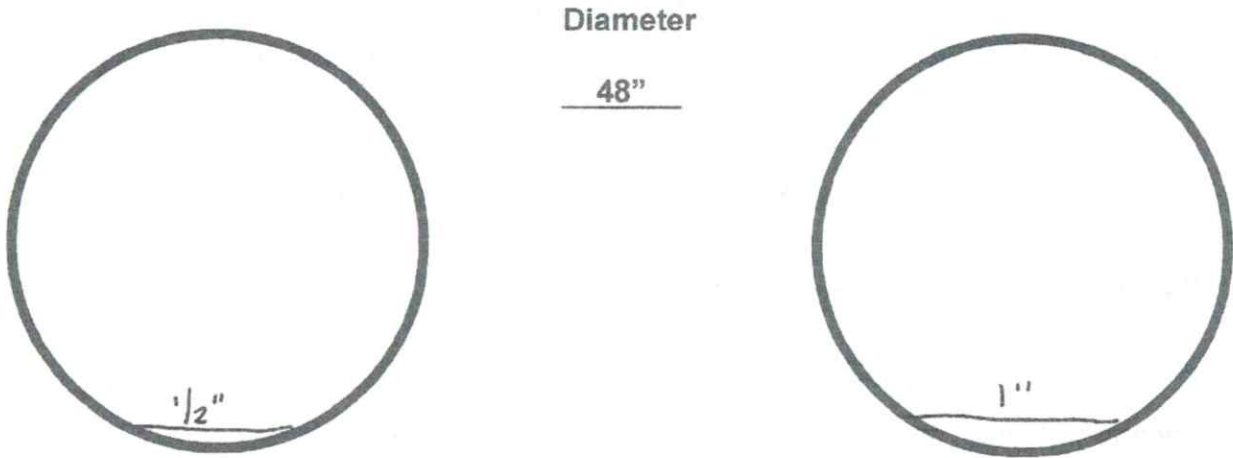
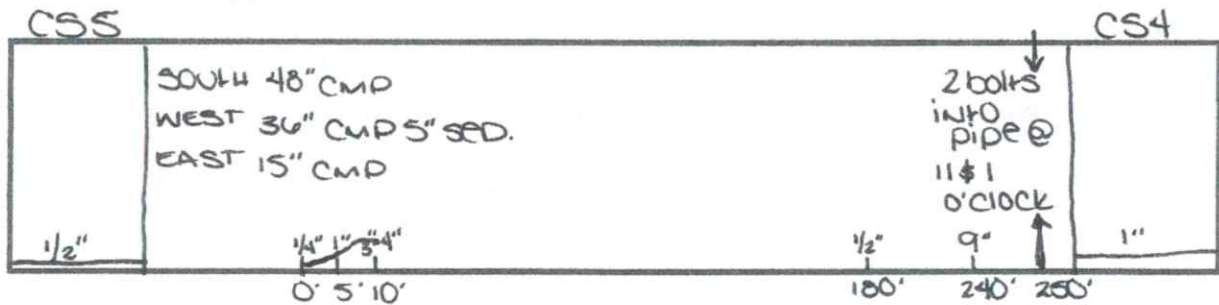
General Condition of Pipe: Diver noted ½" to 9" pf sediment throughout the  
length of the pipe. Also noted marine growth along the sides and minor  
corrosion.

Comments: Diver noted two bolts protruding into the pipe 10" in from control structure 4 in the 11 and 1 O'clock position.

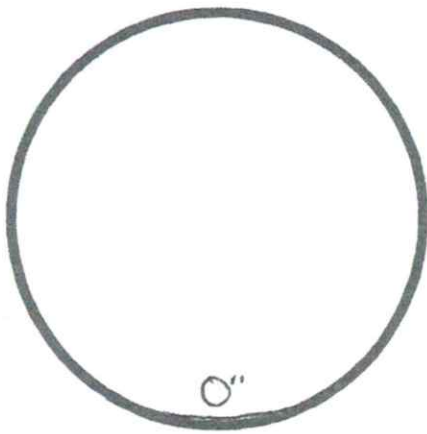
| Page | Basin | Connection | | | | |
|---|---|---|---|---|---|---|
| 64 | 2 TO 3 | Lake | 9 | - | Lake | 14 Cleaned CB1 to Lake 14 Note collapsed pipe 19ft from entrance in pond 9. Needed to create a channel at 14 outfall due to pile of silt. Unpermitted weir modification noted. |

General Condition of Pipe: Diver noted moderate growth on the sides of the pipe.  
Pipe collapsed 19' into pipe from the 11 to 2 O' clock position.

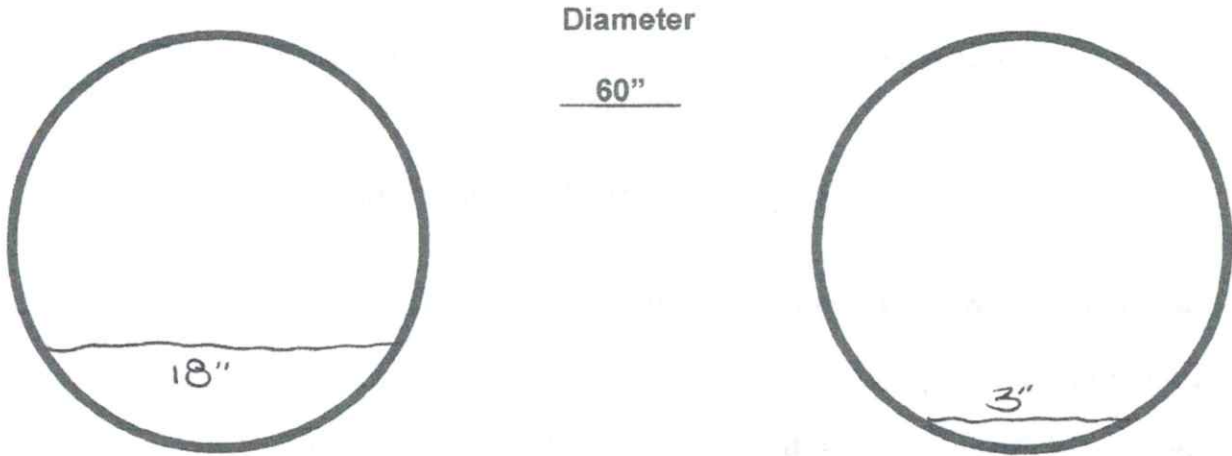
General Condition of Pipe: Diver noted a rebar trash rack at Lake 10 outfall, heavy corrosion on the trash rack along with heavy marine growth and mild corrosion. Control structure 1 has some rebar exposed. Diver also noted the sediment levels decreased throughout the pipe.

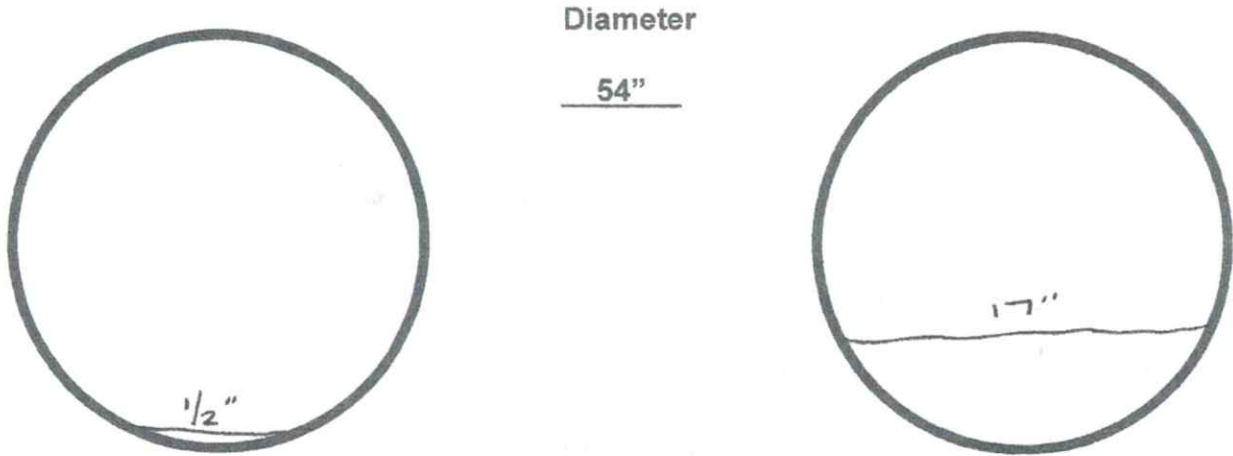
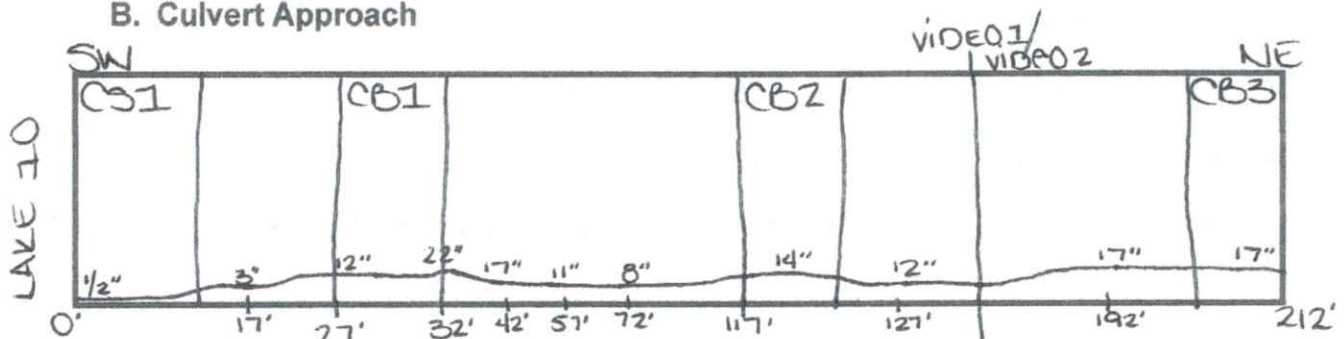
General Condition of Pipe: Control structure 1 has cracking around the pipe on  
the structure wall. Diver noted ½" to 22" of sediment and moderate growth  
throughout the pipe. Also noted mild cracking on the walls of catch basin 1.

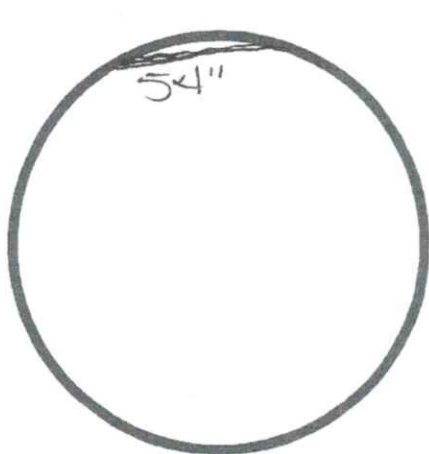
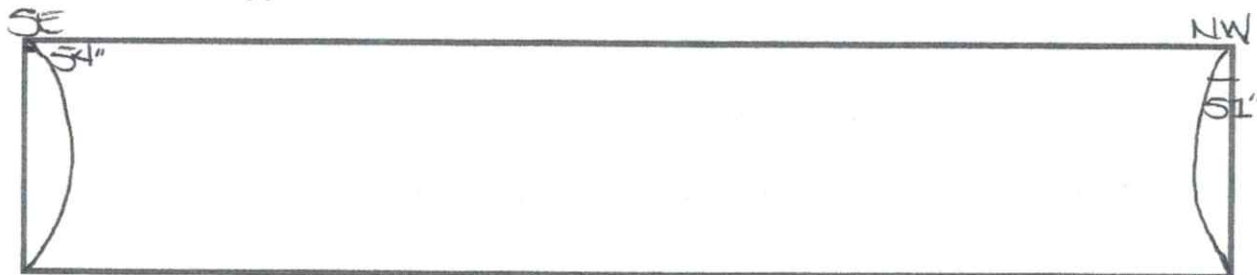
General Condition of Pipe: Dive team noted that the pipe is completely full of mud at the entrance.

**Comments:** Diver located outfall and noted 51" of sediment. Diver was unable to enter the pipe at either end.

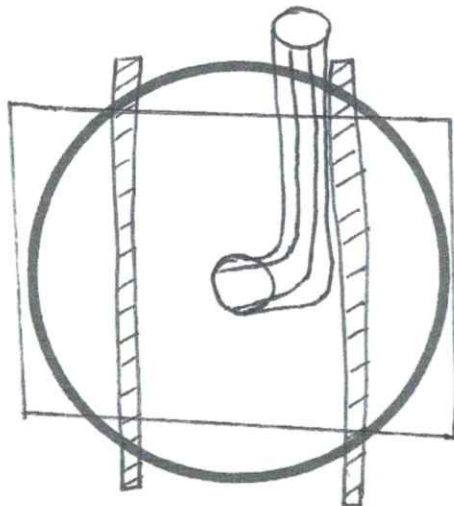
General Condition of Pipe: Dive team noted that the outfall has a homemade control structure. The control structure is not flush against the mouth of the pipe, and is not secured to the pipe. Diver also noted a 4" gap at the 6 O'clock position.

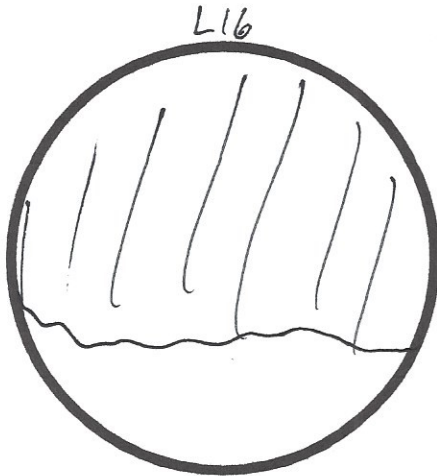
General Condition of Pipe: South side of pipe in Lake 16 is crushed and diver is unable to enter. Crushed area of pipe is 4ft with the top crushed downward. The pipe feels loose and is able to be moved by hand.

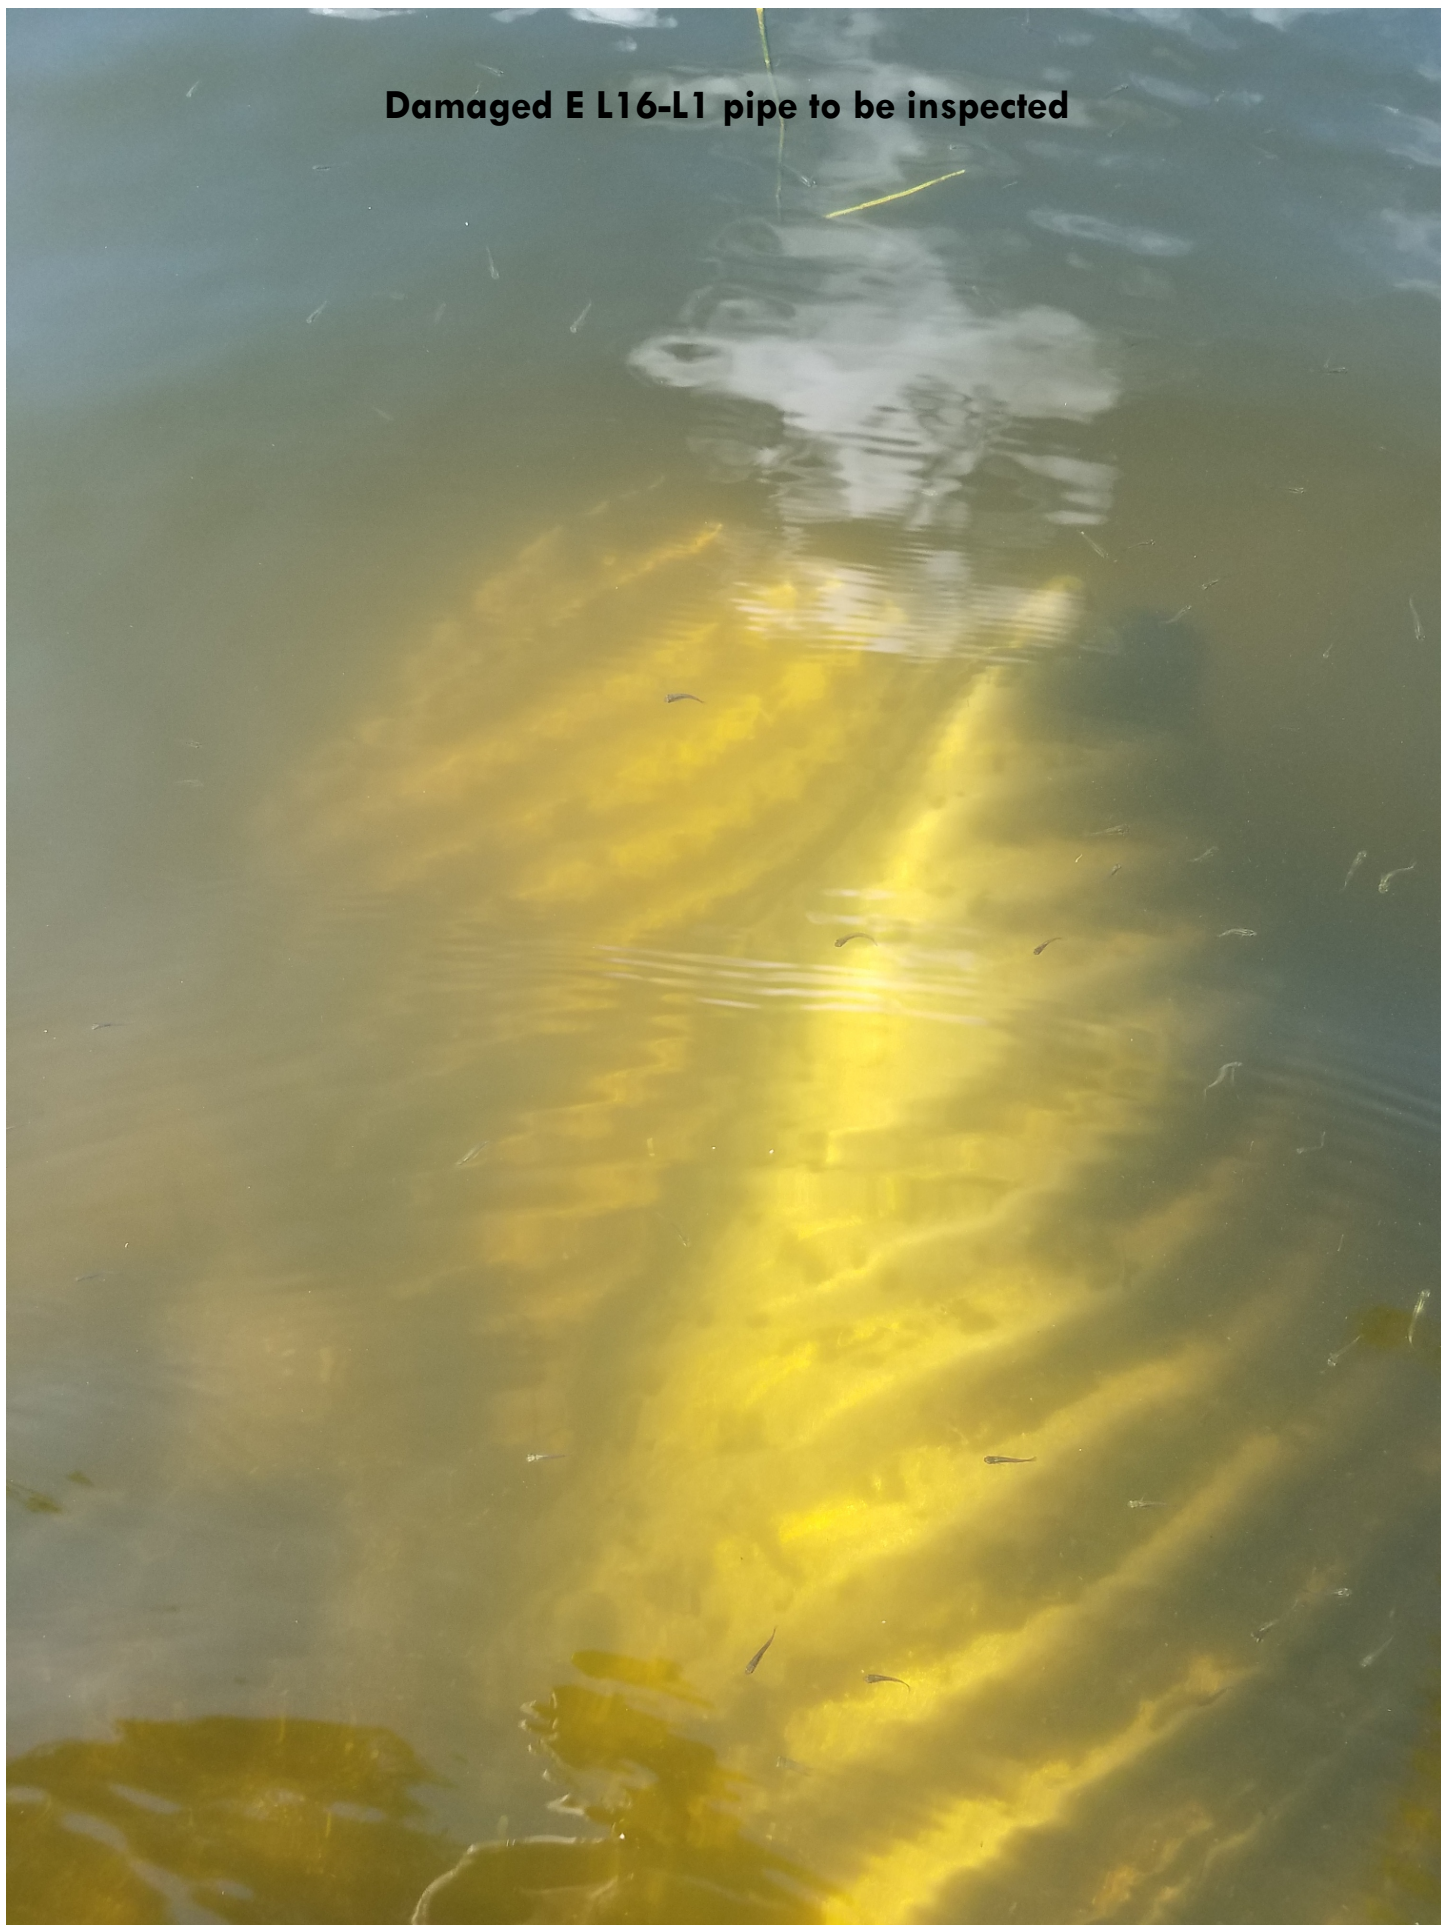
**Damaged E L16-L1 pipe to be inspected**
