## APPENDIX E

### SHENANDOAH PIPING REPORT

## **Pond Interconnection and Estuary Culvert Inspection Report**

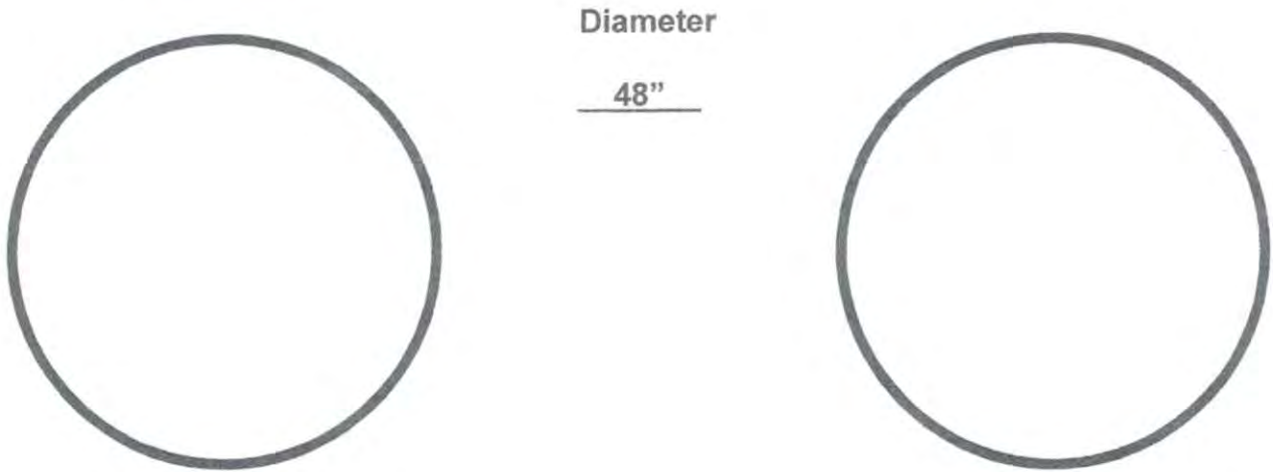
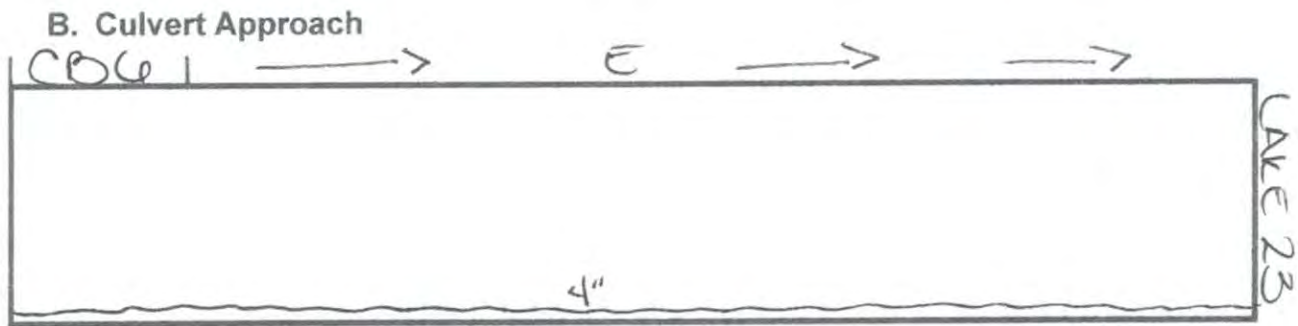
General Condition of Pipe: Diver noted 4" of sediment throughout the length of the pipe. Overall condition of the pipe is good with no damage or obstructions.

Comments: Diver noted that Lake 22 connects to Lake 23 through a series of  
6 catch basins. The outfall in Lake 22 is a 24" pipe that runs through the first 5  
catch basins. Dive was unable to inspect due to size.

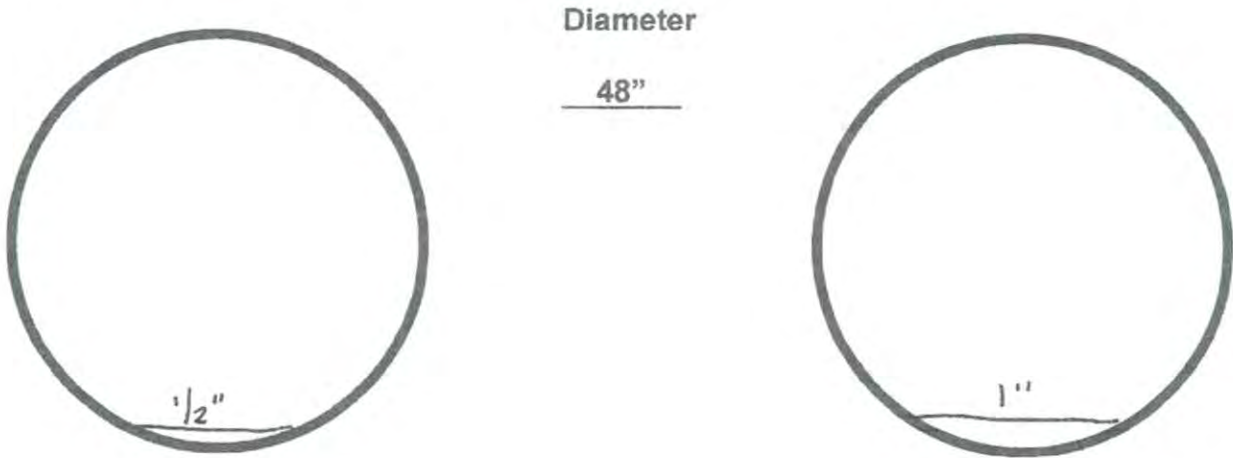
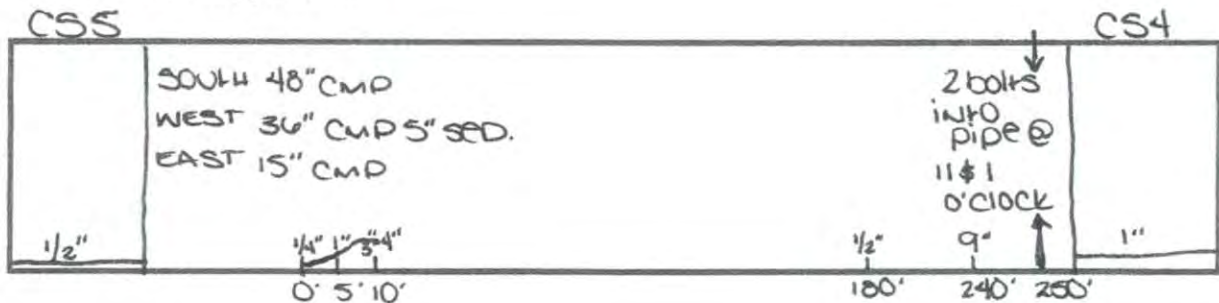
General Condition of Pipe: Diver noted ½" to 9" pf sediment throughout the  
length of the pipe. Also noted marine growth along the sides and minor  
corrosion.

Comments: Diver noted two bolts protruding into the pipe 10" in from control structure 4 in the 11 and 1 O'clock position.

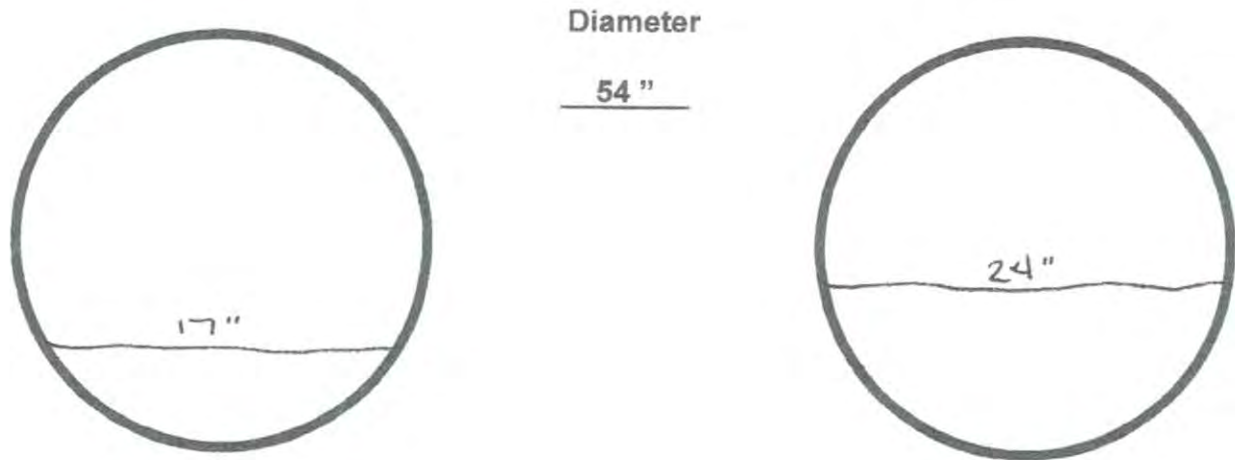
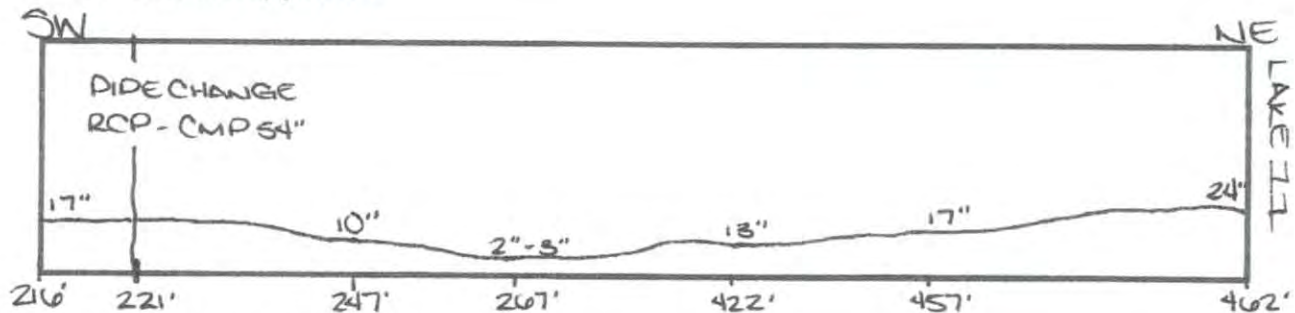
General Condition of Pipe: Diver noted 2" – 2' of sediment throughout the length of the pipe along with moderate growth and minor corrosion. Overall condition of the pipe appears to be good. Diver also noted that the sediment build up at outfall in Lake 11 is natural bottom and is half up the sides of the pipe covering 50%.

Comments: Diver noted that the pipe changes from RCP to 54" CMP at 221'.

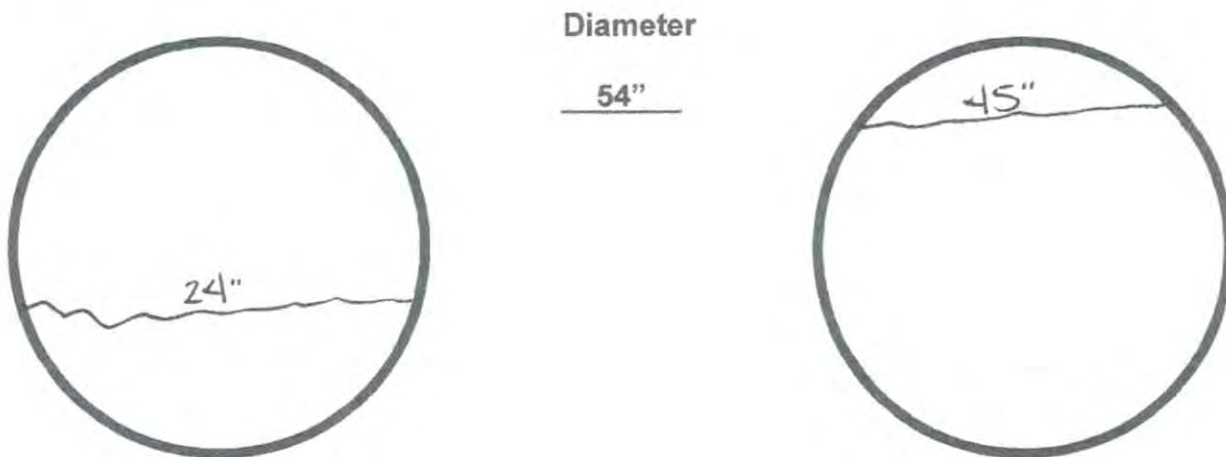
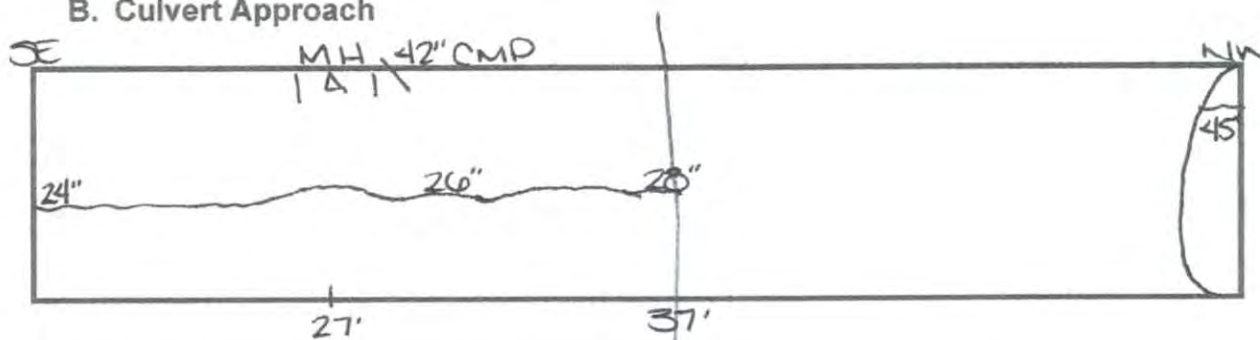
General Condition of Pipe: Diver noted 24" of sediment at the South East outfall  
along with minor growth. Also noted the pipe changed to 42" CMP after Manhole  
A. Sediment level rose to 26" after manhole A and continued to rise to 28" at 37'  
into the pipe. Diver was unable to inspect past 37' due to sediment levels.

Comments: Diver located outfall and noted 45\" of sediment. Diver was unable to enter the pipe at the outfall.

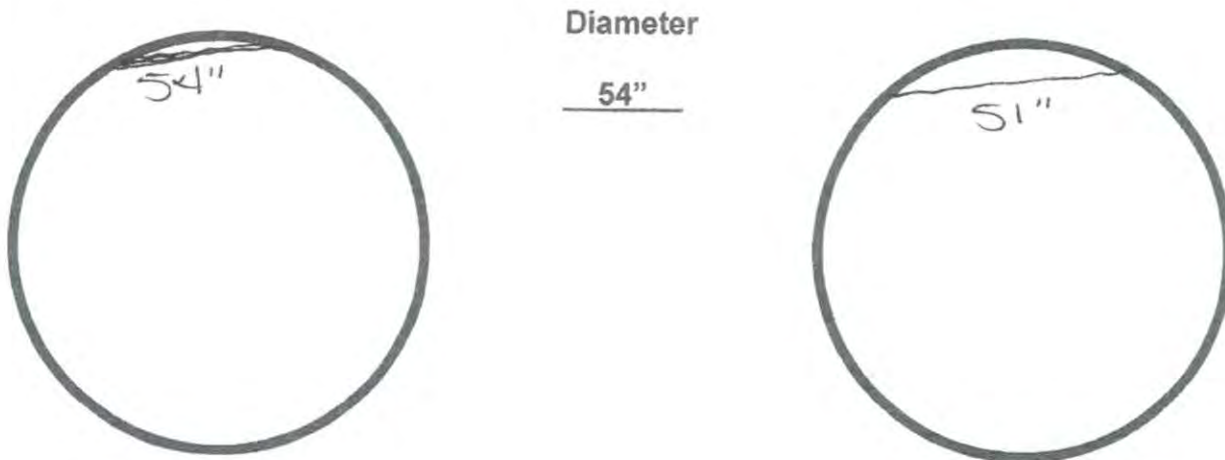
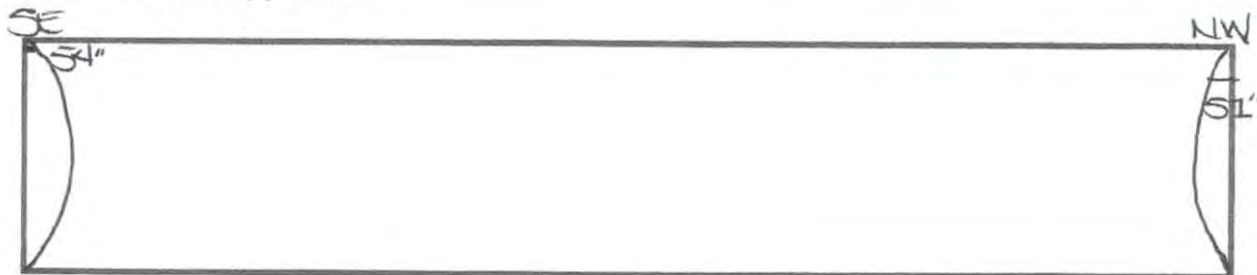
General Condition of Pipe: Dive team noted that the pipe is completely full of mud at the entrance.

Comments: Diver located outfall and noted 51\" of sediment. Diver was unable to enter the pipe at either end.

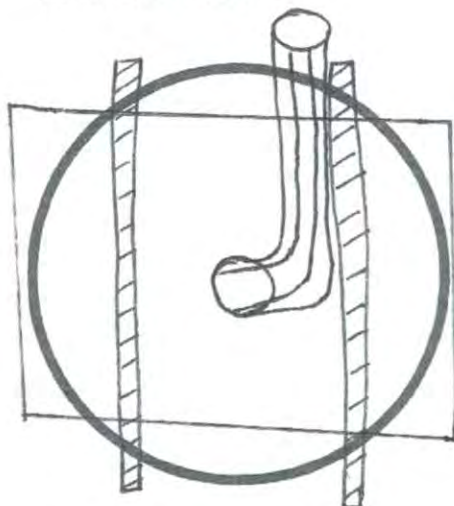
General Condition of Pipe: Dive team noted that the outfall has a homemade control structure. The control structure is not flush against the mouth of the pipe, and is not secured to the pipe. Diver also noted a 4" gap at the 6 O'clock position.

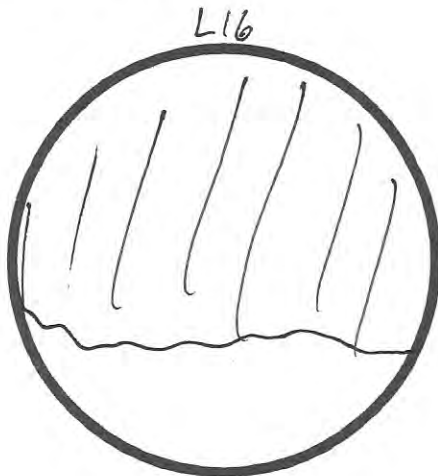
General Condition of Pipe: South side of pipe in Lake 16 is crushed and diver is unable to enter. Crushed area of pipe is 4ft with the top crushed downward. The pipe feels loose and is able to be moved by hand.
