# GRAND HARBOR COMMUNITY ASSOCIATION

## Property Condition Assessment Report of Findings

KHA No: 147699000

JANUARY 27, 2020

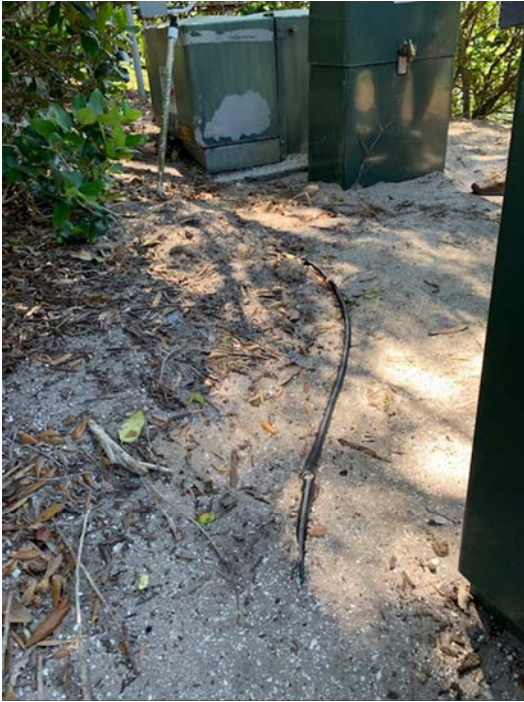
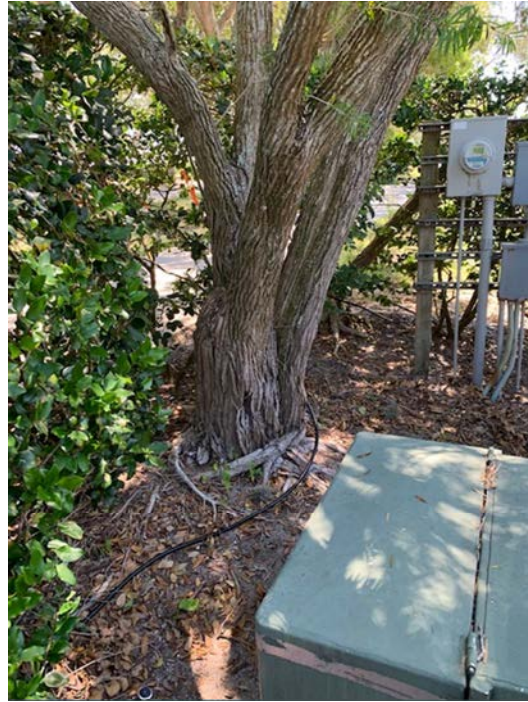
Photos 6.1 and 6.2 - Exposed cut wire near Wood Duck.

We recommend that these be repaired and placed back underground as originally intended.

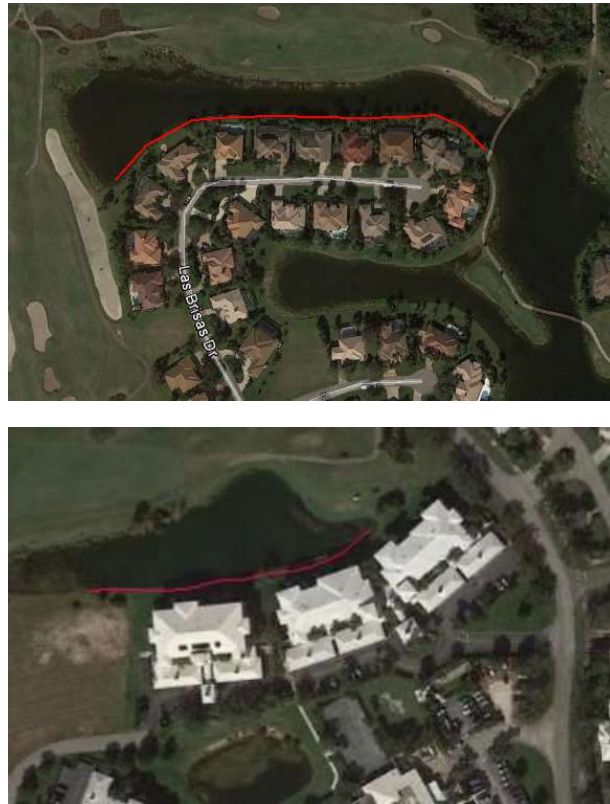
*Photo 8.1 and 8.2– Bank erosion area encroaching onto properties*

It is recommended that all pond areas experiencing erosion be repaired immediately to permitted design conditions and the ponds be kept at their design levels. Newland Erosion Control was consulted for their strategy in dealing with pond bank erosion. They install geotubes filled with silt along the pond banks to restore the shoreline to its original state and create a barrier against further erosion. The bags can be stacked on top of one another for areas with severe erosion. It is recommended to use technology such as this in restoring the pond banks back to permitted conditions.

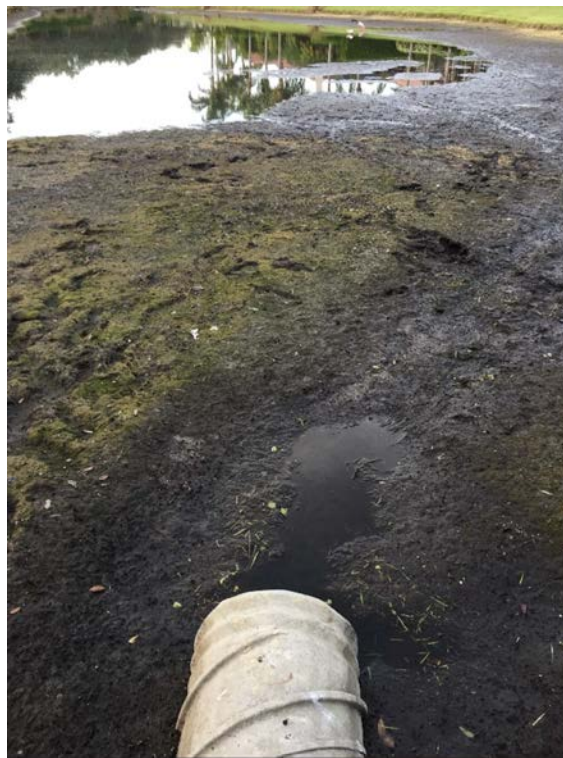
*Photo 8.4 – Siltation in Pond #16*

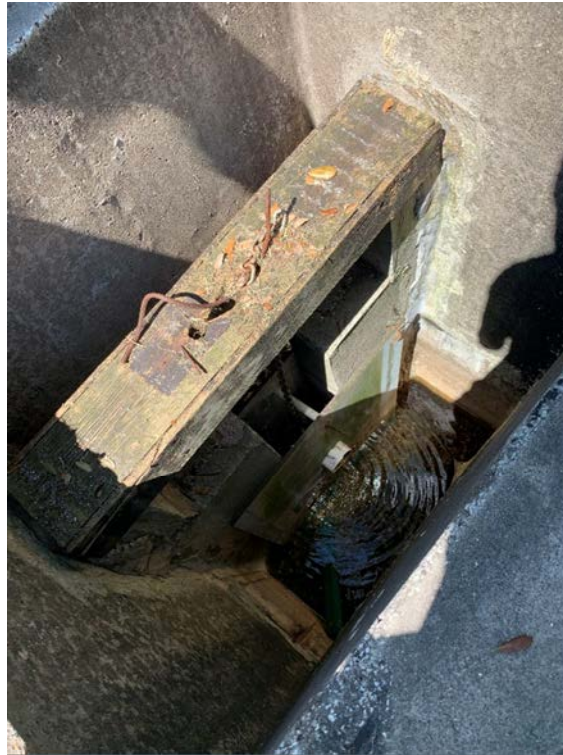
*Photo 8.5 – Un-permitted control structure*

Many permitted control structures were inspected and observed to be in generally good condition. They have experienced the normal deterioration that is to be expected for their age. No remediation is required at this time. However, an un-permitted control structure was found. For this modification, it is recommended to either remove it or modify the existing permit to include it.

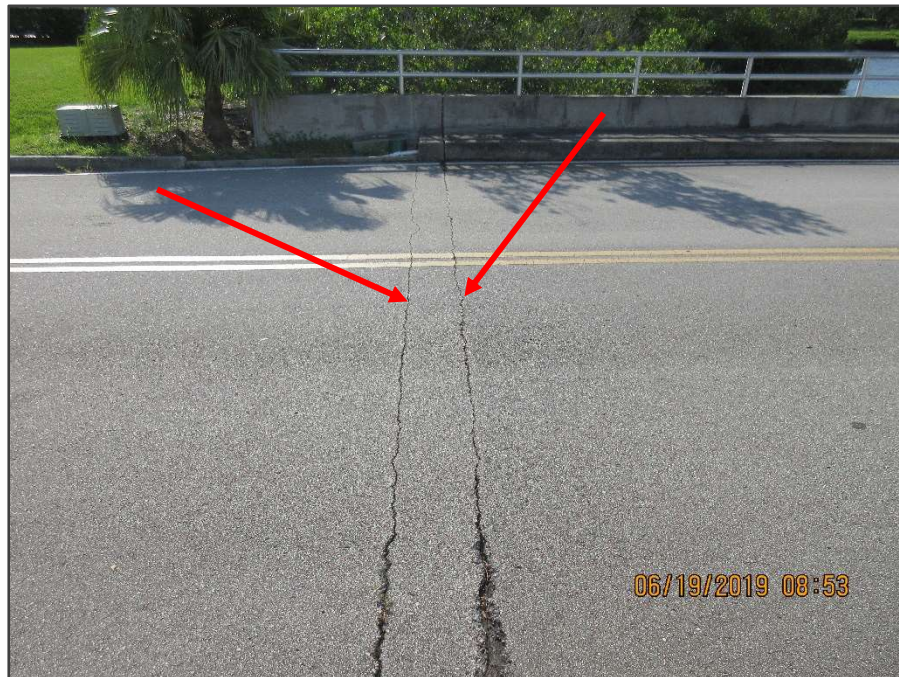
*Photo 16.1 – Cracking at bridge #2 approach*

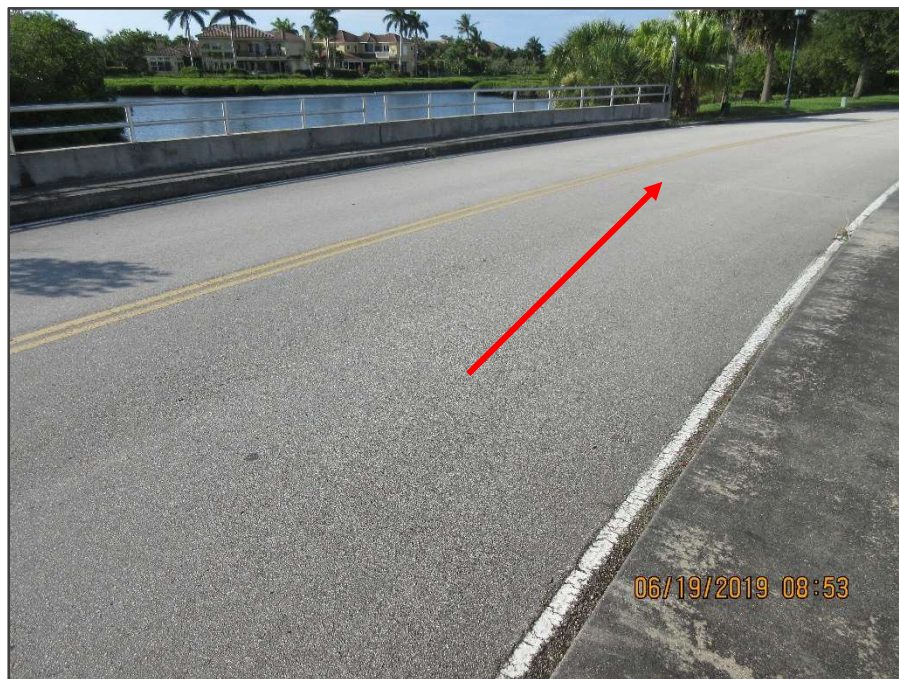
*Photo 16.2 – Transverse crack at mid-span of bridge #2*

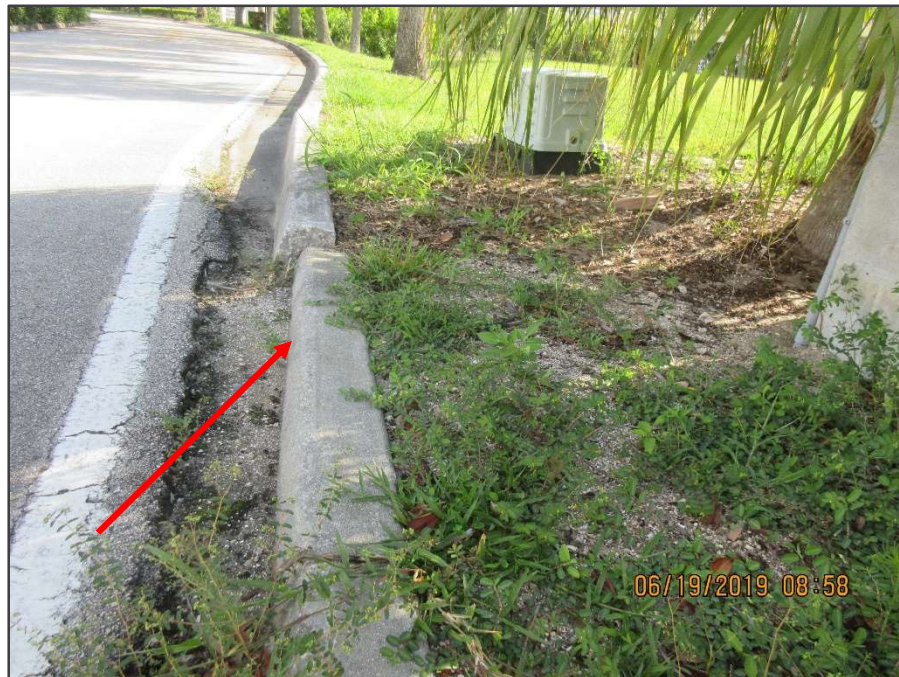
Photo 16.3 – Deflection of the curb and gutter at approach to bridge #2

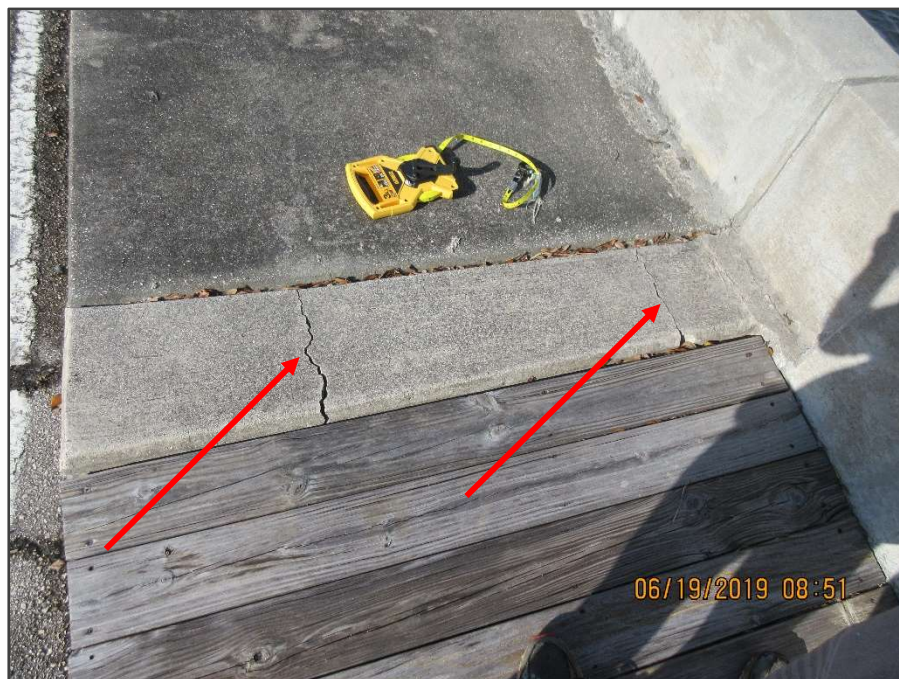
Photo 16.4 –Cracking in the abutment wall at the elevation of the sidewalk at bridge #2

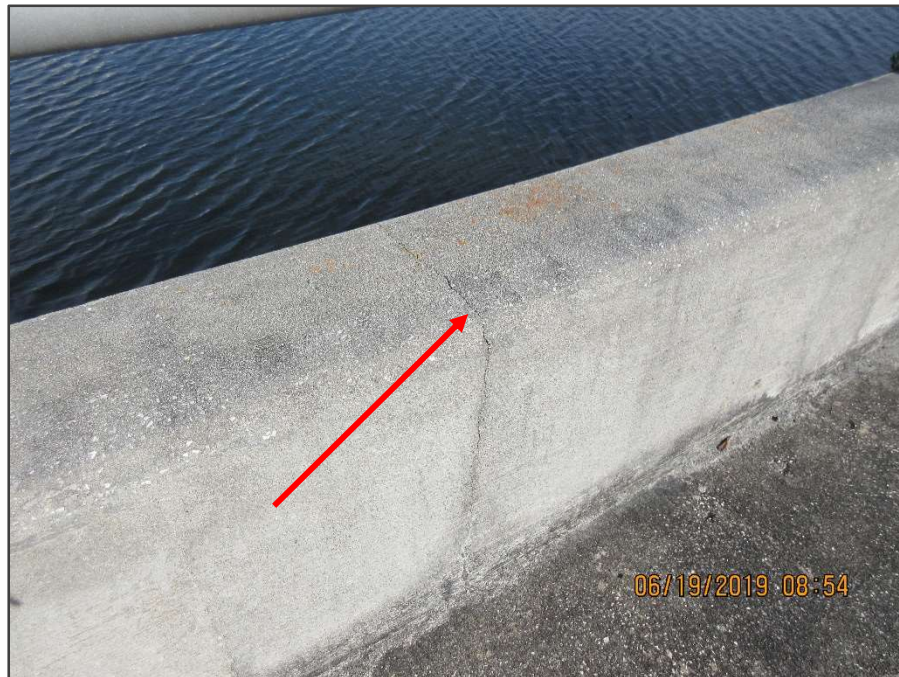
Photo 16.5 – Cracks in the concrete barrier wall (typical throughout) at bridge #2

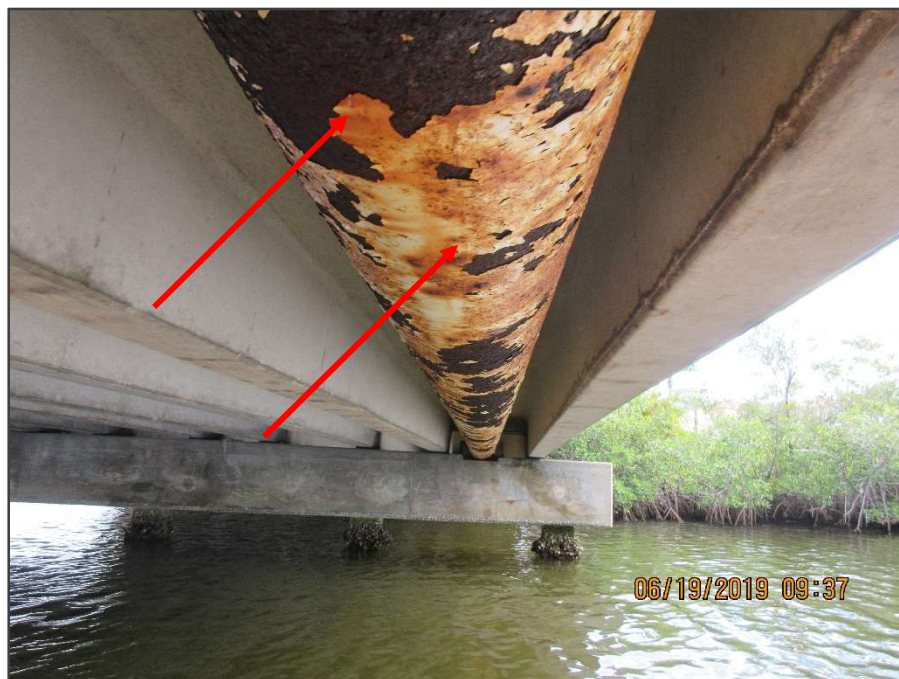
- Corrosion and paint failure on the utility piping spanning the length of the bridge Photo 16.6
- Marine growth observed on the concrete cap and concrete piles (typical throughout)
- Cracking and delaminations on the concrete pile cap at the intermediate bent, both north and south sides (Photos 16.7 and 16.8).
- Concrete spalls on the underside of precast flange of the Double T-Beam along the west side of the bridge. Photo 16.9
- Concrete spalls observed on the fascia of the Double T-Beams at the transverse reinforcing post tensioning duct grout pockets Photo 16.10

Photo 16.6 – Corrosion observed on the utility pipe spanning the length of the bridge under bridge #2

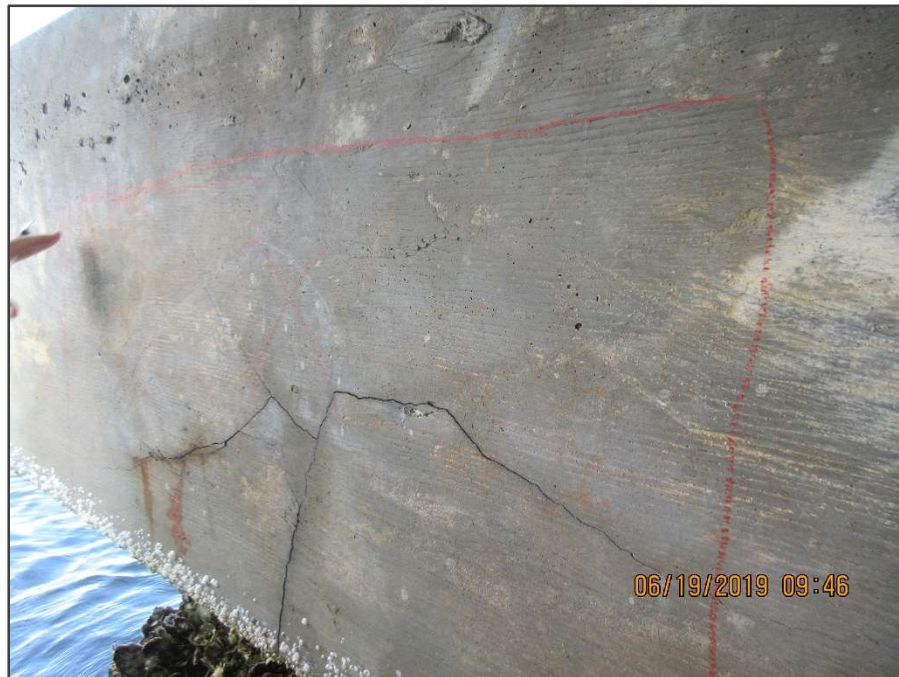
Photo 16.7 – Cracking on the intermediate bent on both north and south sides of bridge #2

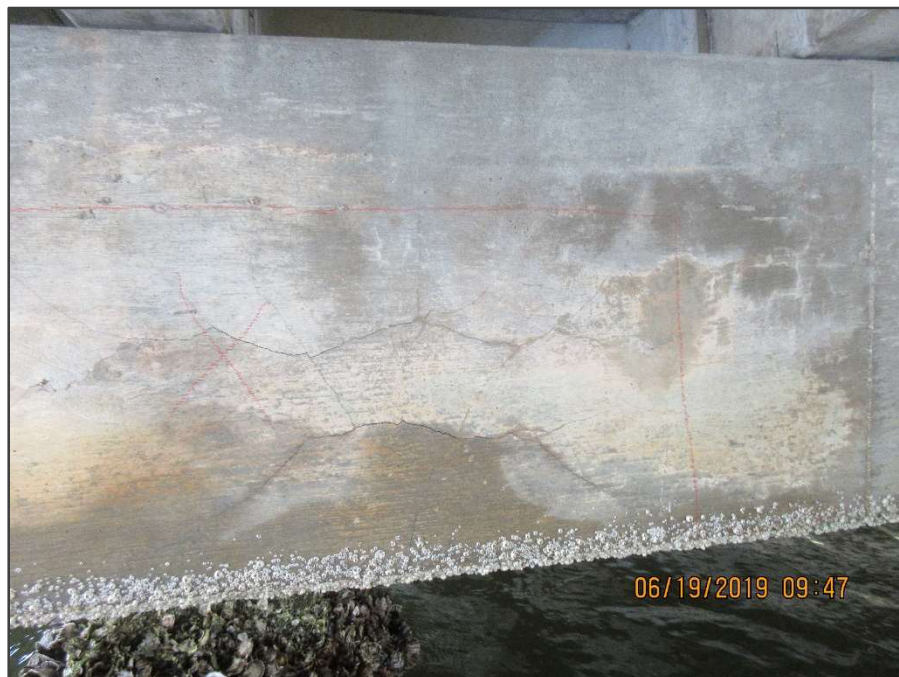
Photo 16.8 – Cracking on intermediate bent of bridge #2. Note vegetative growth on bent and piles (typical throughout)

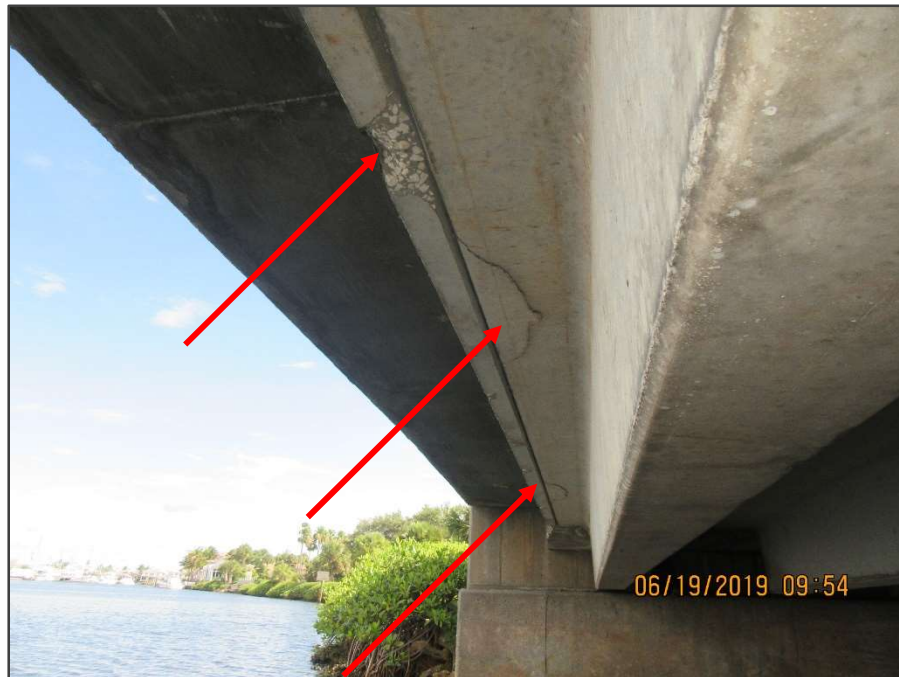
Photo 16.9 – Concrete spalls on the flange and fascia of the exterior Double-T beams at bridge #2

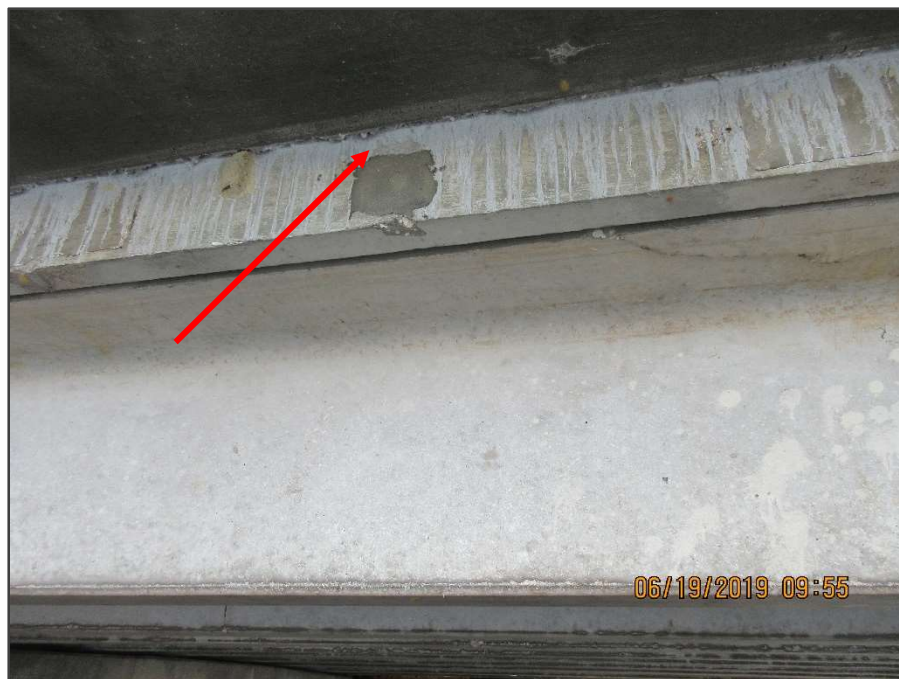
Photo 16.10 – Concrete spalls on the Double-T beam fascia at the post tension grout pockets at bridge #2

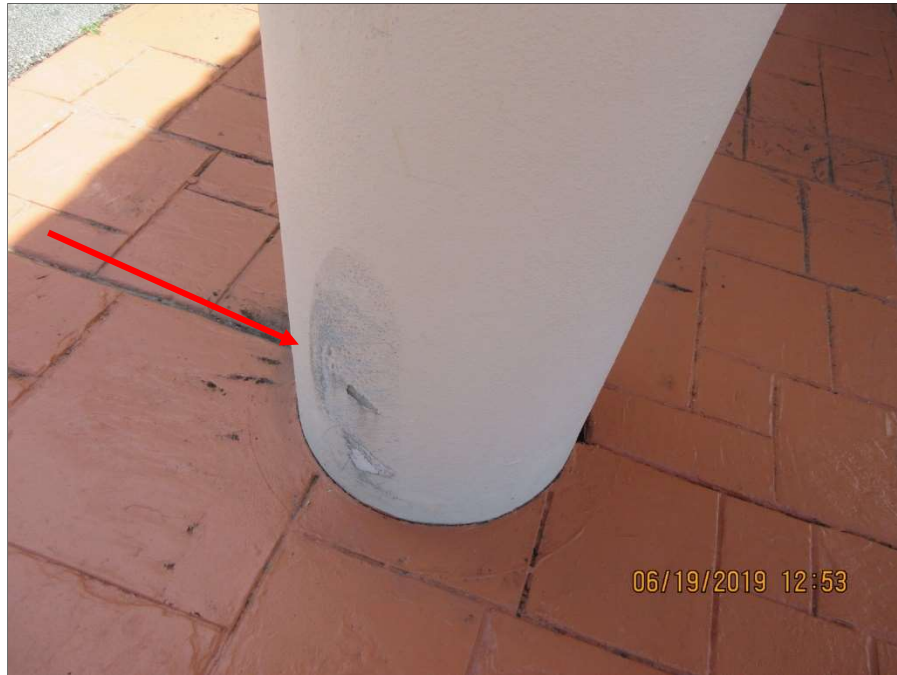
Photo 17.1 – Delaminated paint and impact marks on overhang structure column at Guard House #1

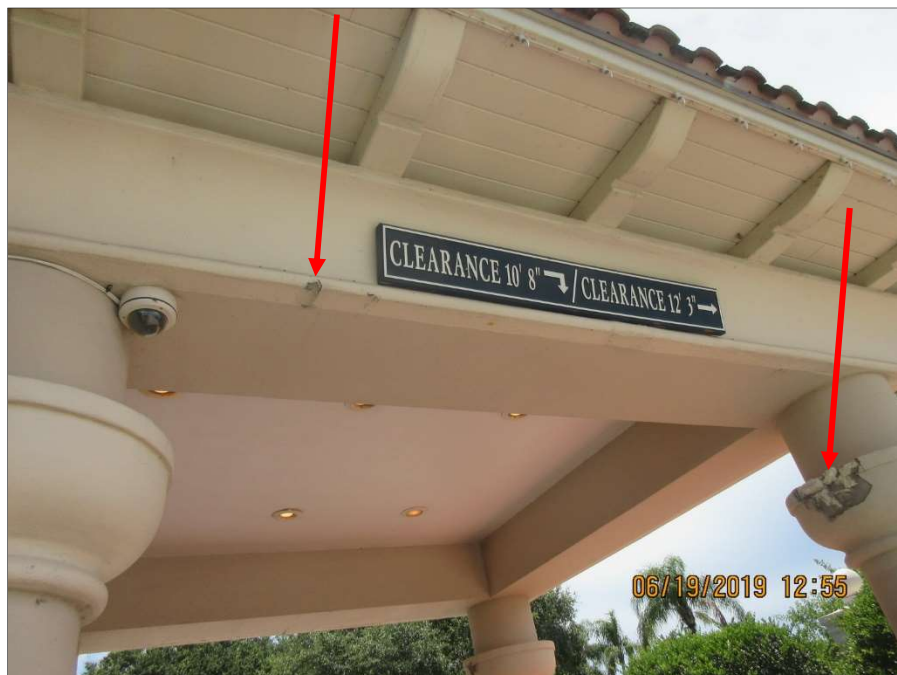
Photo 17.2 – Exposed stucco lath on overhead beam; damage to architectural feature on column at Guard House #1

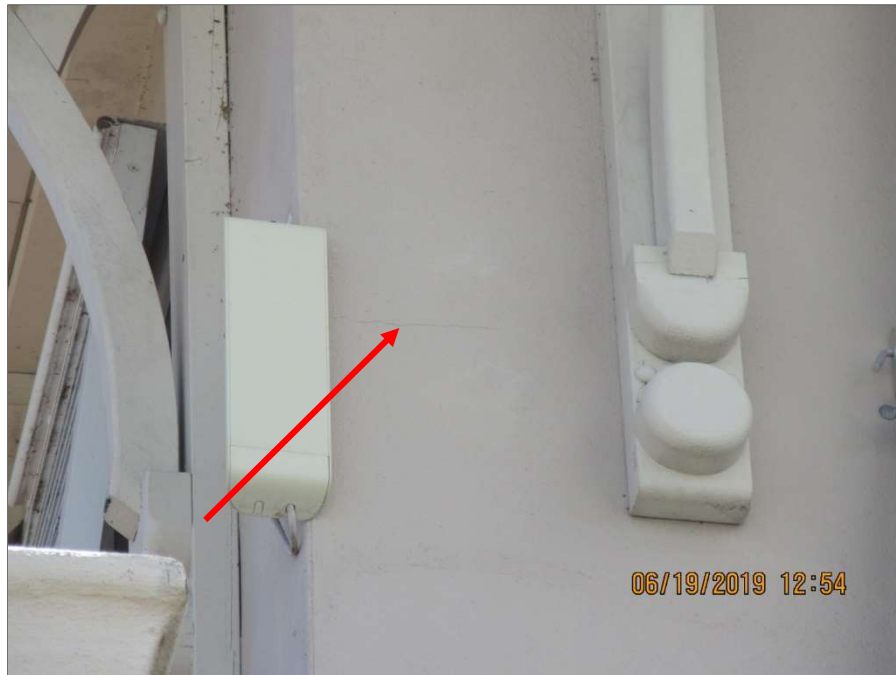
*Photo 17.3 – Stucco crack on Guard House #1*

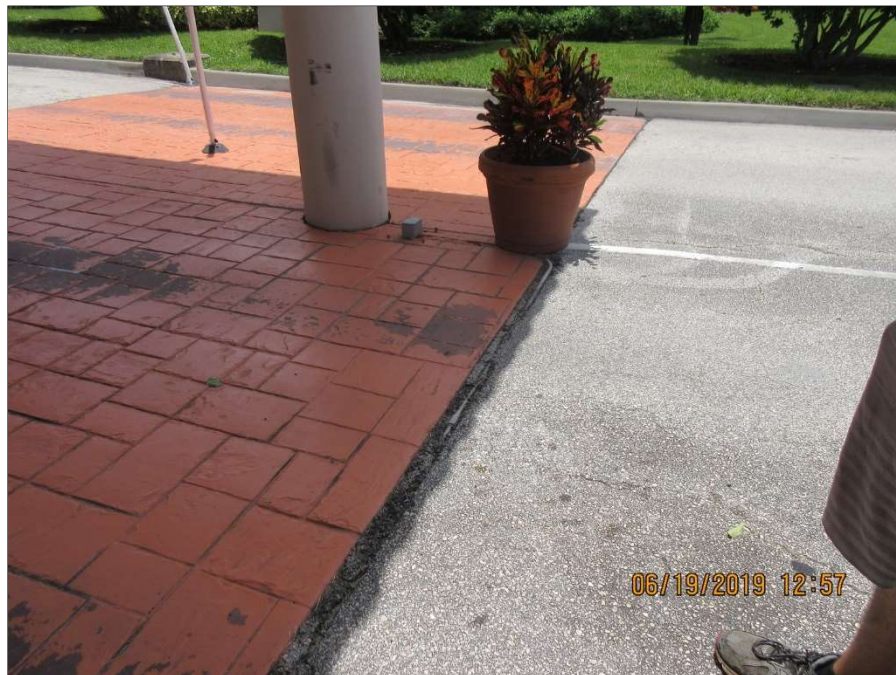
*Photo 17.4 – Exposed PVC conduit casing at Guard House #1*

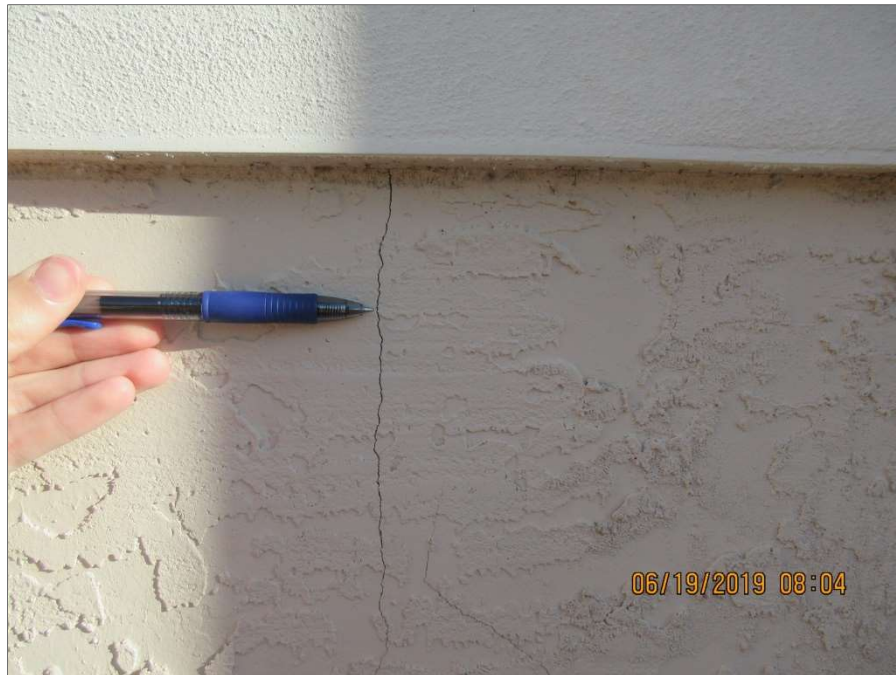
- Stucco cracks on the exterior envelope and at window sill ledges (typical throughout) Photos 17.5 and 17.6
- A crack in bathroom floor tiles Photo 17.7

*Photo 17.5 – Stucco crack on Guard House #2 (typical throughout)*

The observations listed in the previous section of this report are mostly aesthetic in nature and do not affect the structural capacity or integrity of the Guard House buildings. However, stucco cracks allow an entry point for water to infiltrate behind the stucco and penetrate the waterproof barrier. When water gets behind the stucco, it can cause the stucco to delaminate from the substrate. It is recommended that the stucco cracks be routed and sealed. In addition, the exposed lath and damaged architectural features at the overhang structure should be patched. The bathroom floor tiles had a continuous crack spanning from one wall to the other. This is likely related to natural settlement of the building's foundation. No repairs are recommended to the bathroom floor at this time.

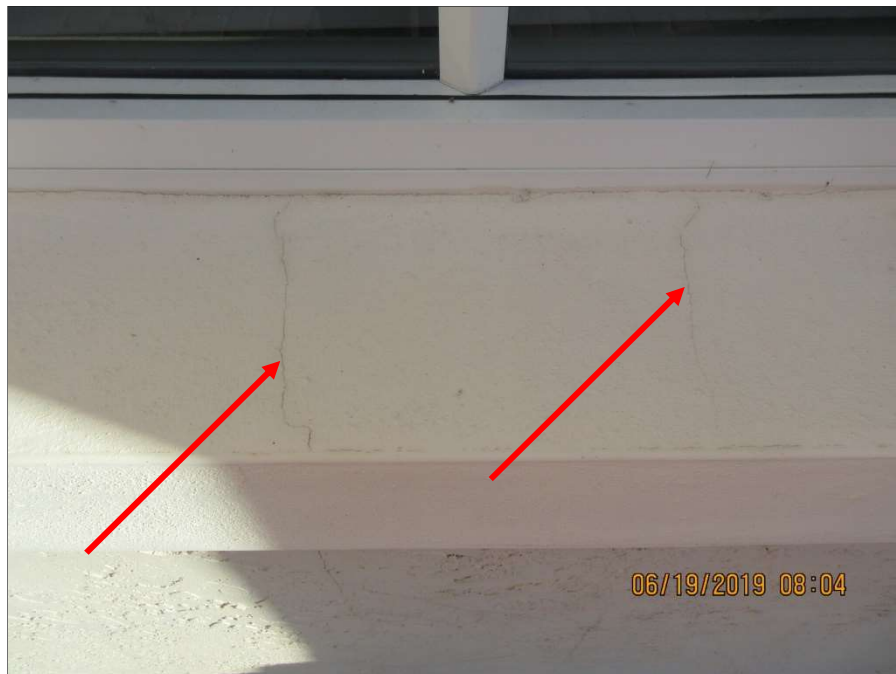
*Photo 17.6 – Stucco crack on window sill ledge at Guard House #2 (typical throughout)*

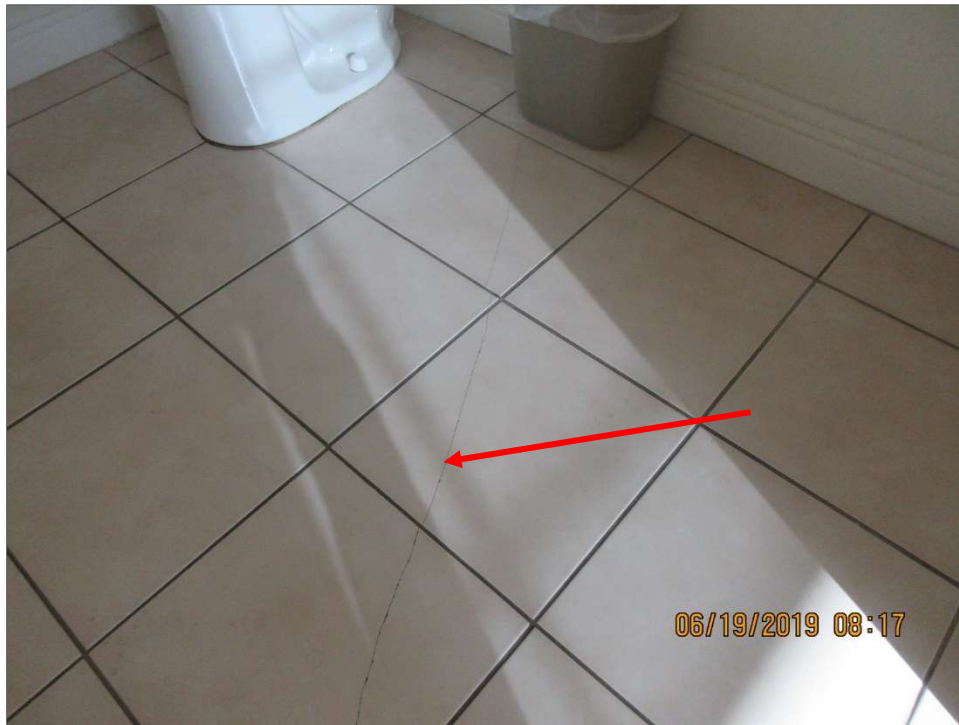
*Photo 17.7 – Cracking on bathroom floor tiles at Guard House #2*

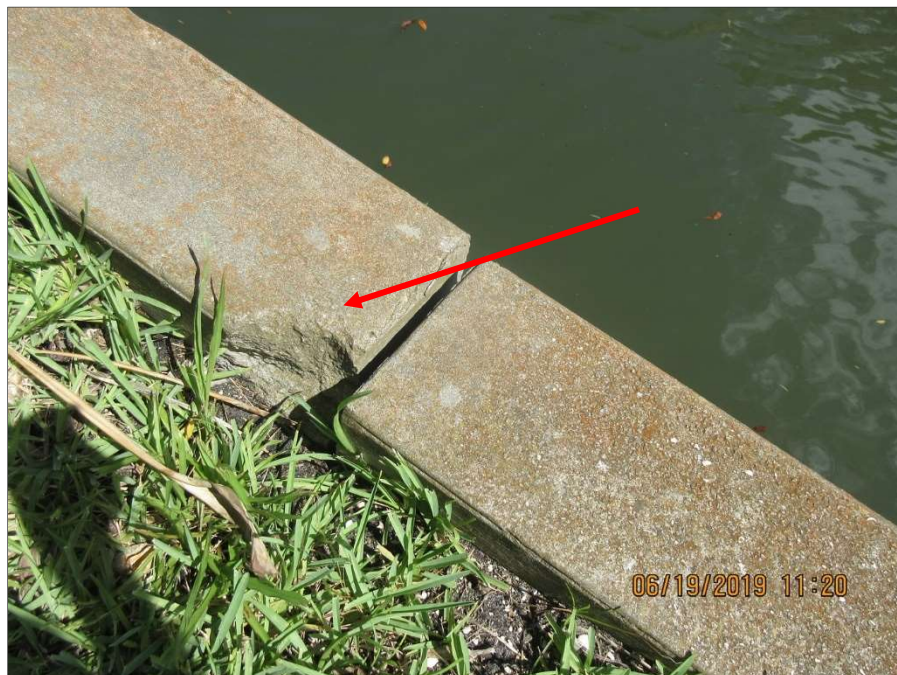
Photo 18.5 –Localized concrete damage to edge of retaining wall cap at Retaining wall Span #1

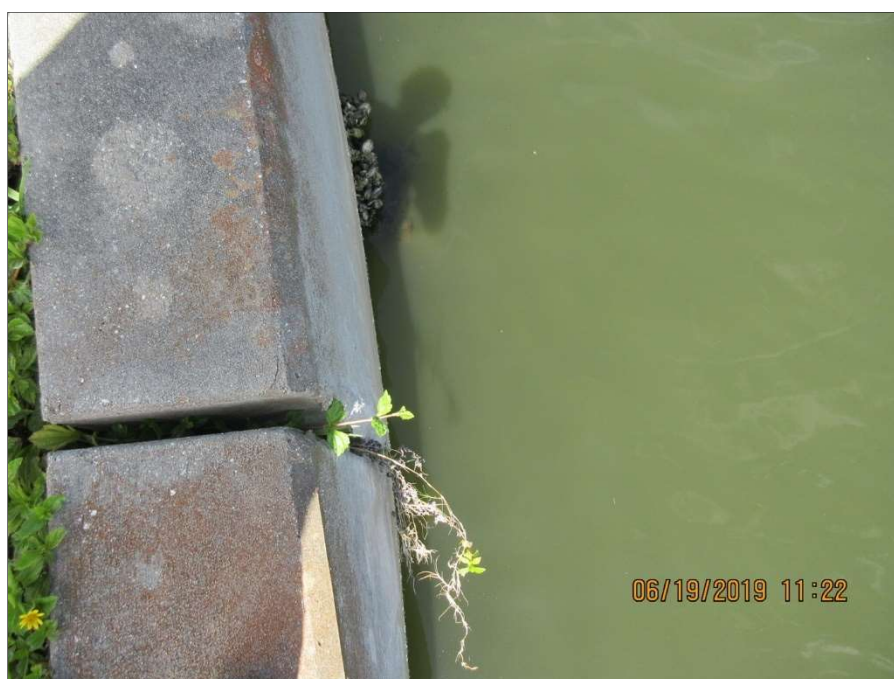
*Photo 18.7 –Vegetation observed at joints in Retaining wall Span #1*

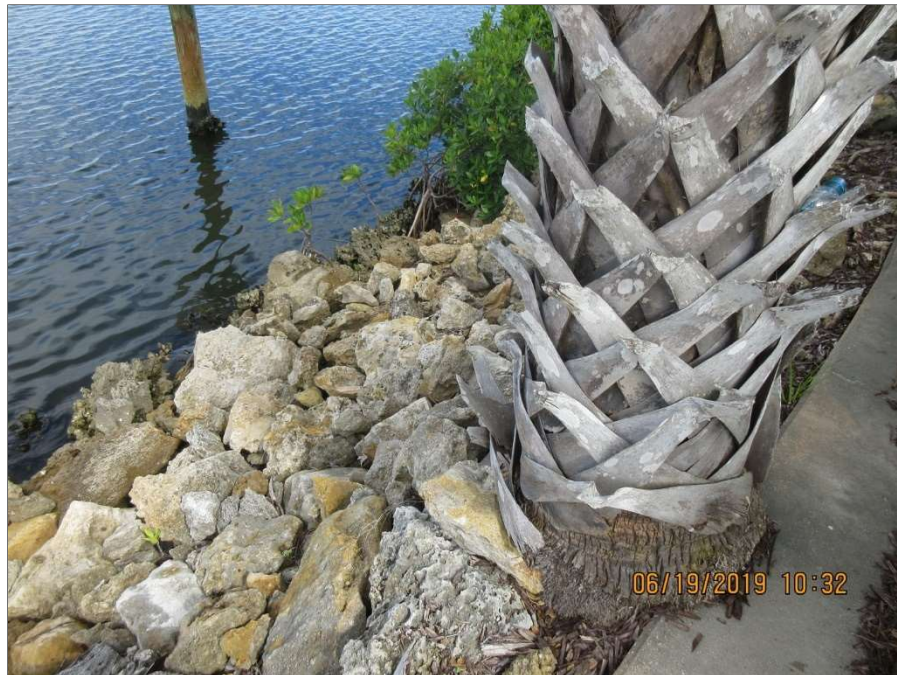
*Photo 18.8 –Palm encroaching on Retaining wall Span #2*

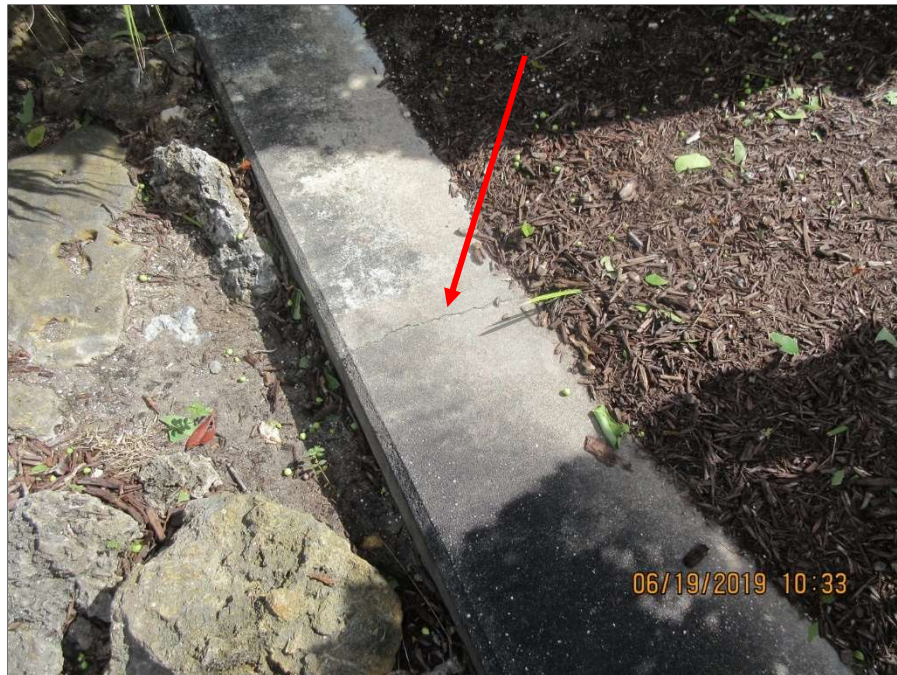
Photo 18.10 – Transverse crack on the cap of Retaining wall Span #2

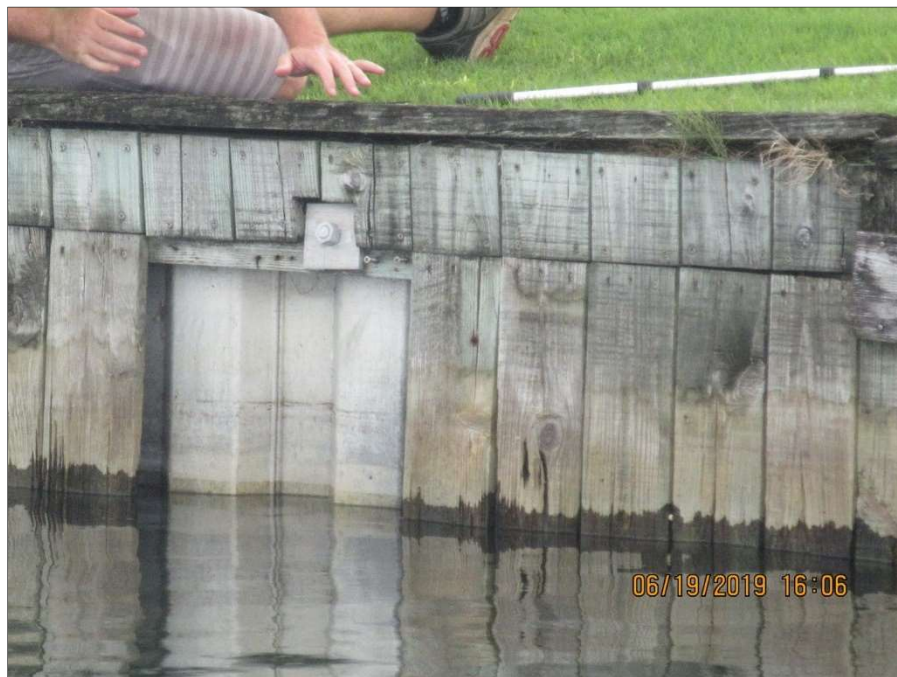
*Photo 18.15 –Missing timber boards on Retaining wall Span #4*

Regarding the timber post and lagging retaining wall #4, the wood is rotting, damaged and/or missing. We anticipate the system is nearing the end of its service life needs to be replaced. There is one section of the wall where the anchor block is not at an appropriate angle. It is unknown what the size the anchor block is but the tie-back rod should be corrected to prevent future issues. Additionally, it is recommended that the pond liner be patched in the areas with tears.

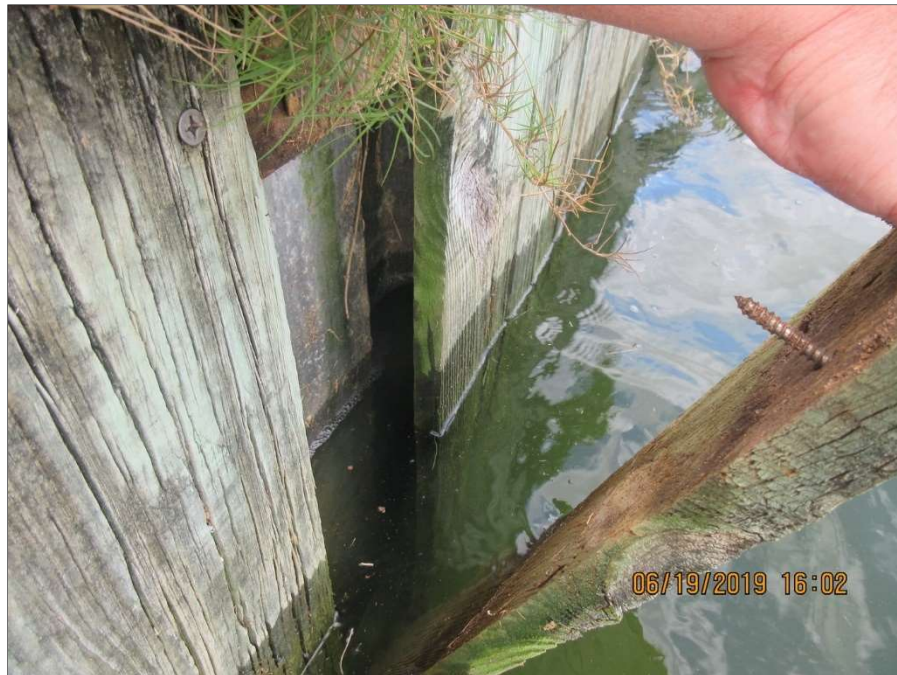
*Photo 18.16 –Missing timber boards on Retaining wall Span #4*

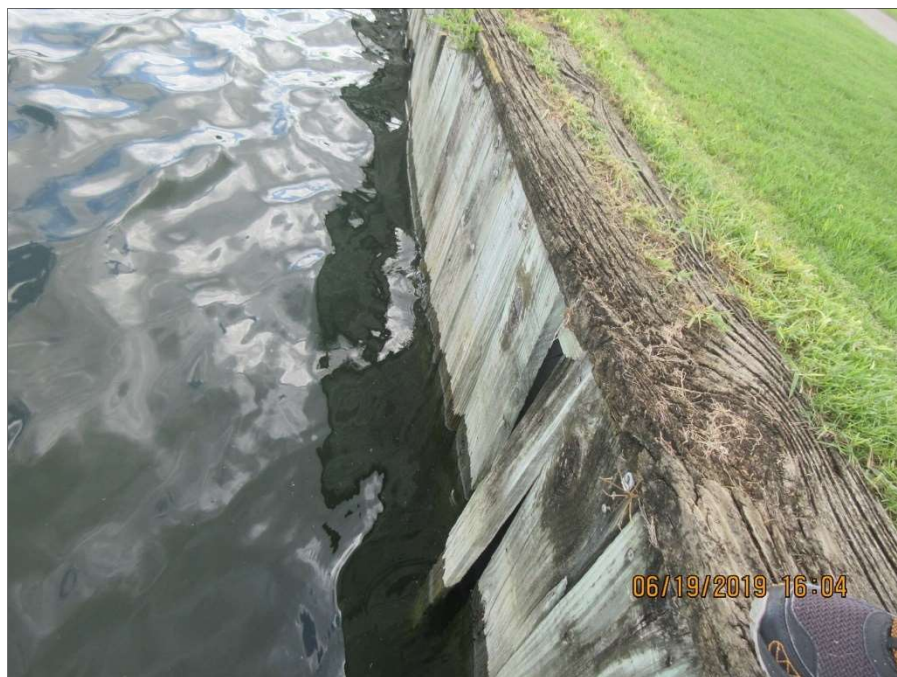
*Photo 18.17 –Damaged and rotting timber boards on Retaining wall Span #4*

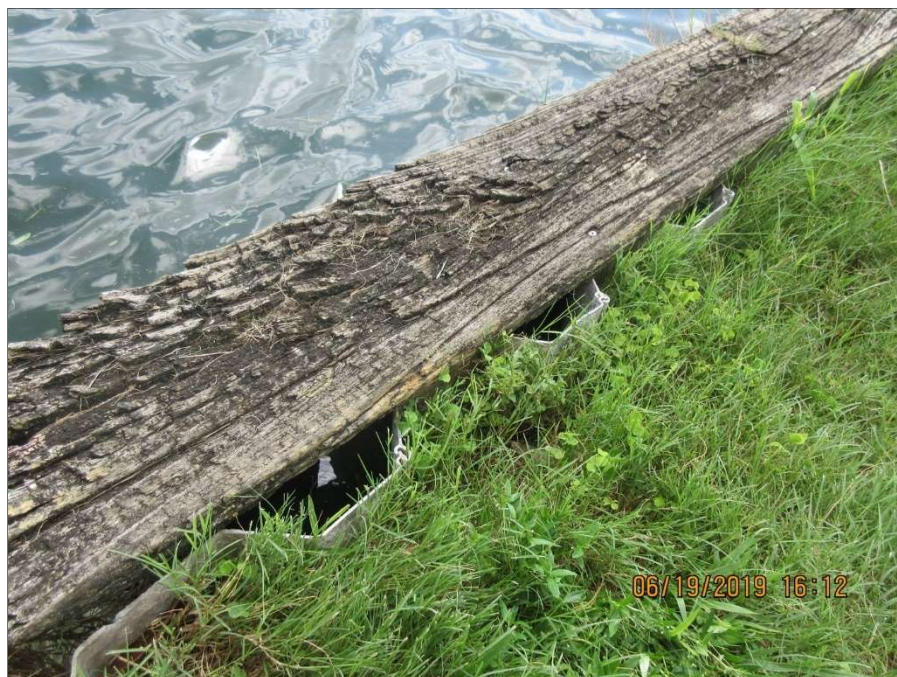
*Photo 18.19 –Cracking splintering and displacement of timber boards on Retaining wall Span #4*

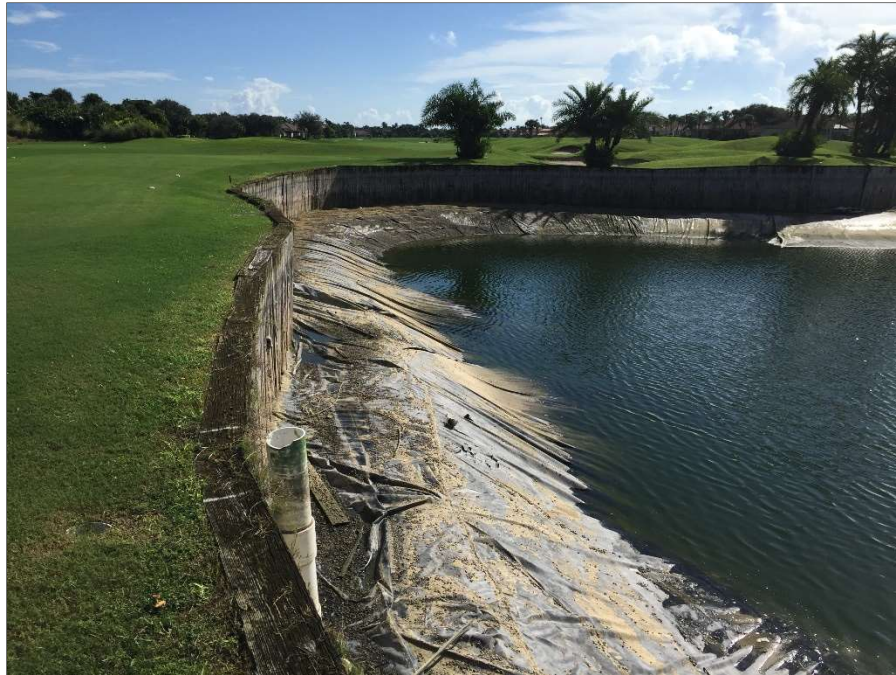
- Retaining wall span #4 is comprised of metal sheet piles with tie backs and covered by timber fascia boards on the water side of the wall and at the top of the wall, forming a cap.
- Damaged and missing timber boards as well as deterioration, cracking, splintering, displacement and rot were observed in the timber fascia covering the metal sheet piles.
- The landside of the sheet piles was exposed at some locations due to settlement
- Pitting of the metal was observed at the top an exposed portion of a metal panel
- While the pond was drained down, tears in the pond liner was observed.

*Photo 18.20 –Pond liner in the recycled water reservoir with Retaining wall Span #4*

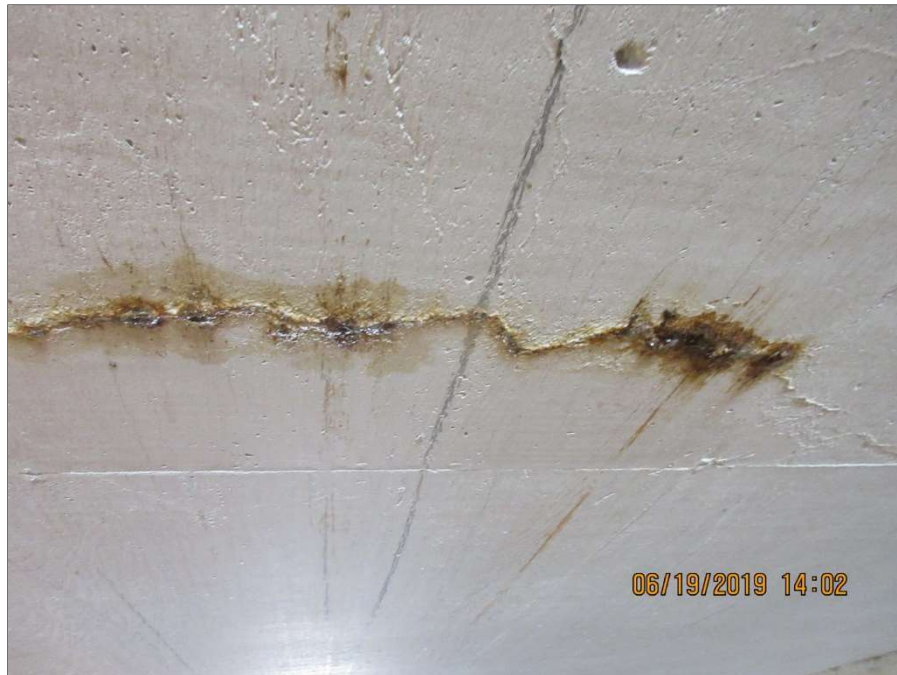
*Photo 19.3 – Ceiling crack with rust stains and water intrusion at Tunnel #1.*

In regard to the cast in place concrete tunnels (#1 through #4), we recommend sealing the overhead concrete cracks and leaks with a polyurethane chemical grout, and routing and sealing the cracks on slab on grade and tunnel walls of all four tunnels. We also recommend correcting the poor drainage deficiency to allow water to properly run off the surface. The localized concrete spalling should be repaired by chipping around the damaged area, cleaning the reinforcing steel, and applying a quick set grout. The patch can then be painted to match the existing paint on the tunnels. Additionally, it is recommended that the impact damages to the finish be corrected and re-painted at the entry of tunnel #4.

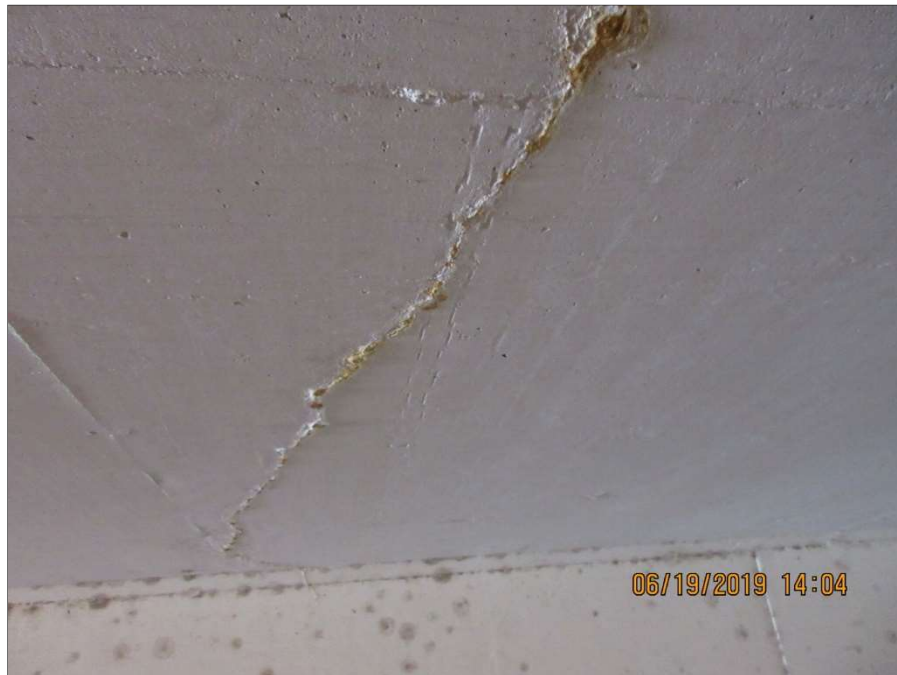
*Photo 19.4 – Ceiling crack with rust stains and water intrusion at Tunnel #1.*

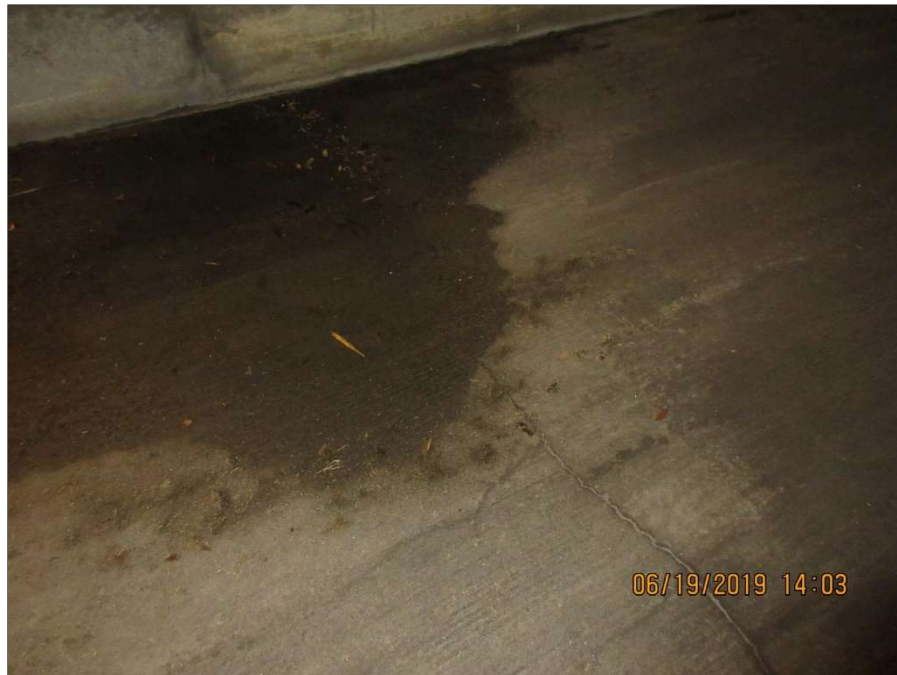
*Photo 19.5 – Evidence of ponding/poor drainage and crack in slab in Tunnel #1*

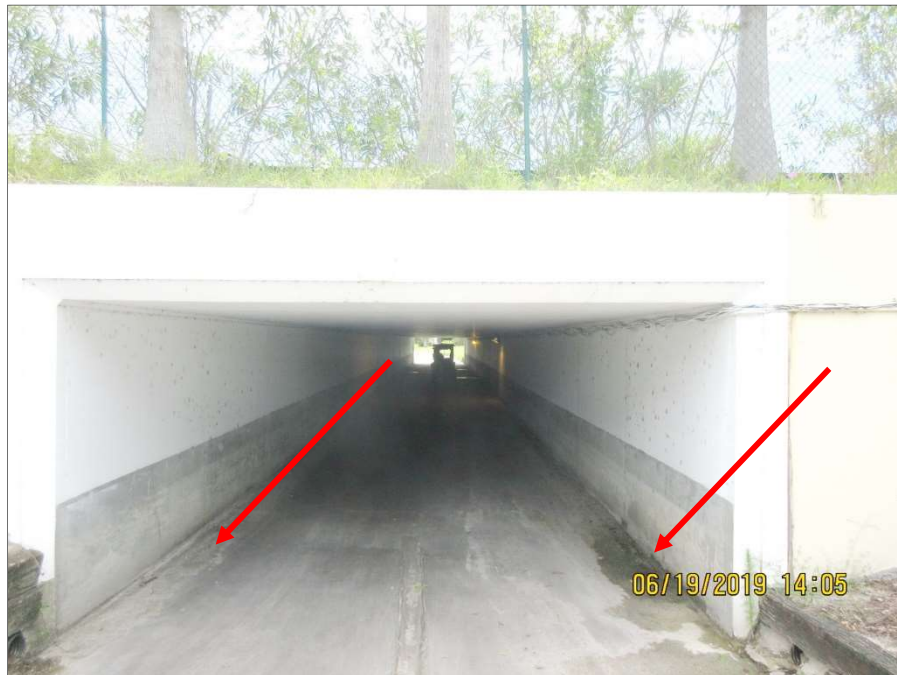
*Photo 19.6 – Evidence of ponding/poor drainage at edges of Tunnel #1*

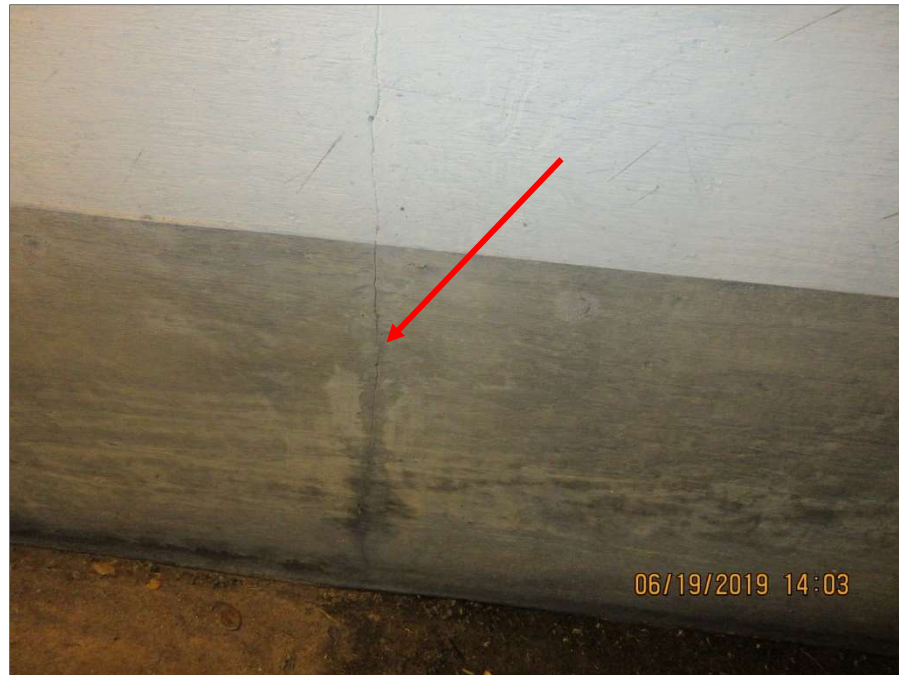
Photo 19.7 – Crack in wall of Tunnel #1
