# GRAND HARBOR COMMUNITY ASSOCIATION

## Property Condition Assessment Report of Findings

KHA No: 147699000

JANUARY 27, 2020

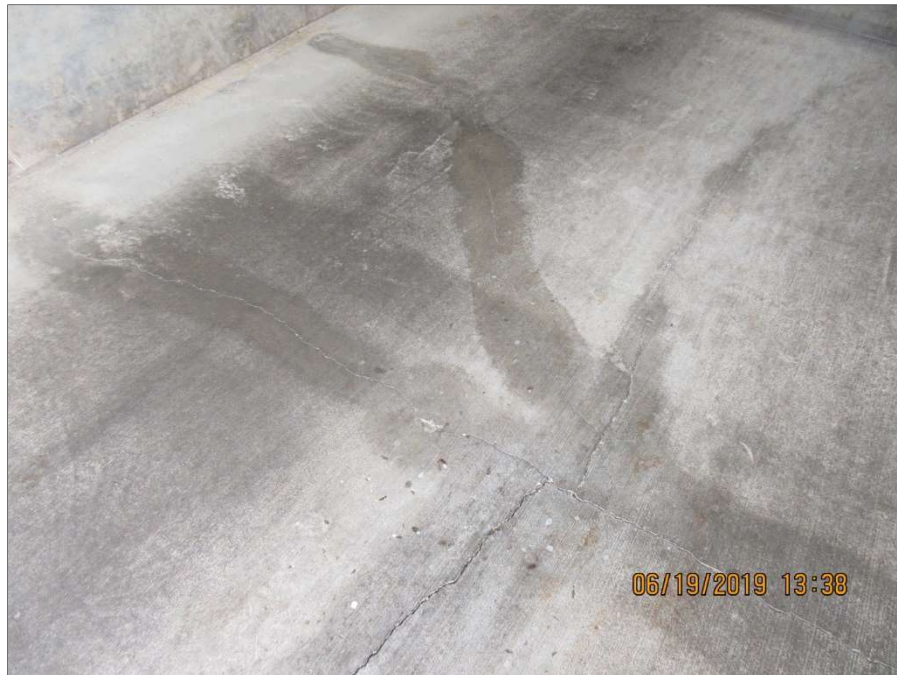
*Photo 19.9 – Cracks in topping slab at Tunnel #2 (typical throughout)*

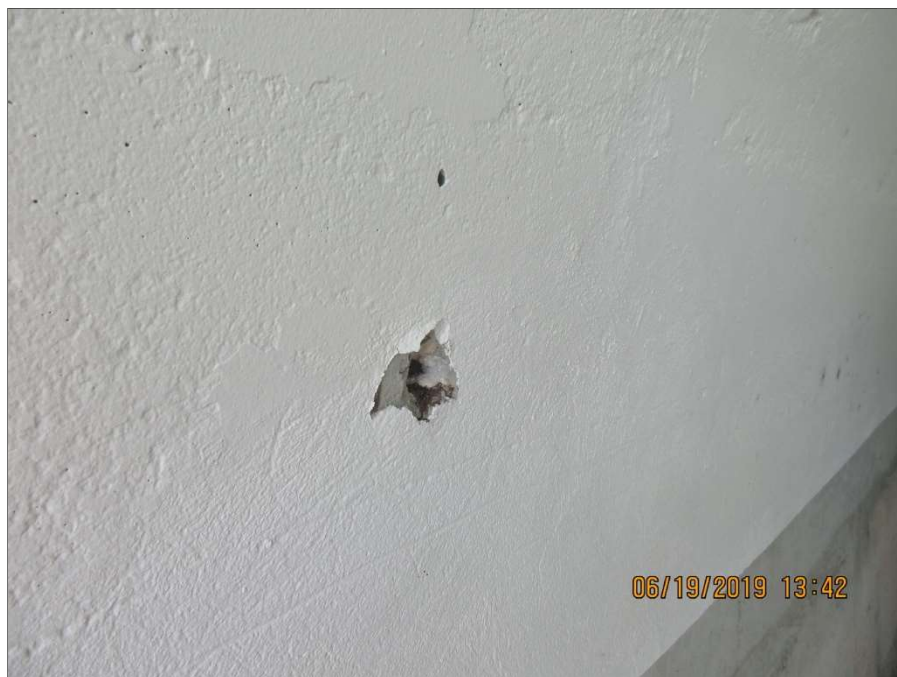
*Photo 19.10 – Localized concrete spall in wall of Tunnel #2*

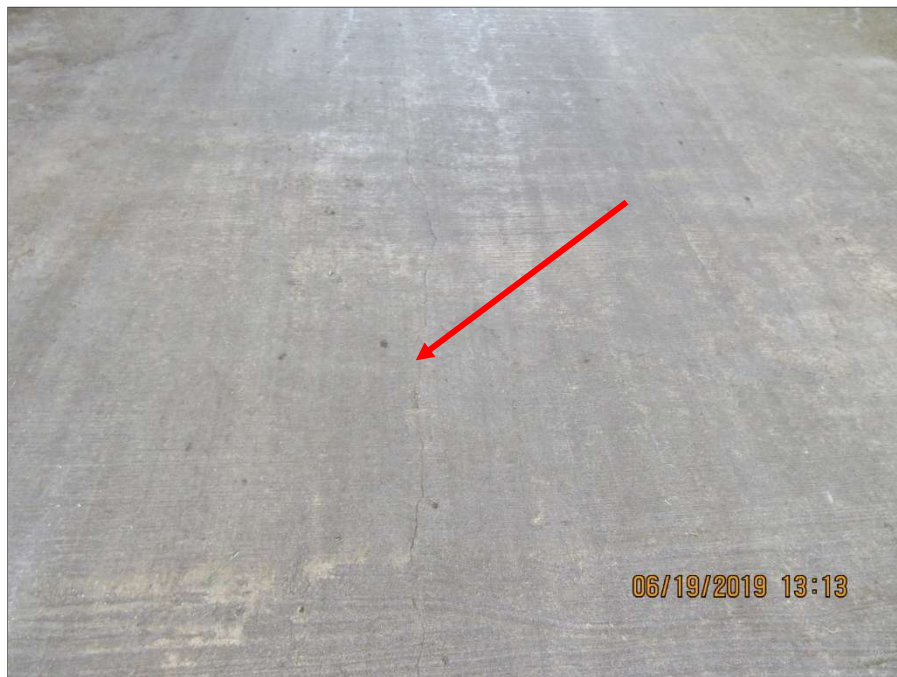
Photo 19.12 – Cracks in slab on grade of Tunnel #3

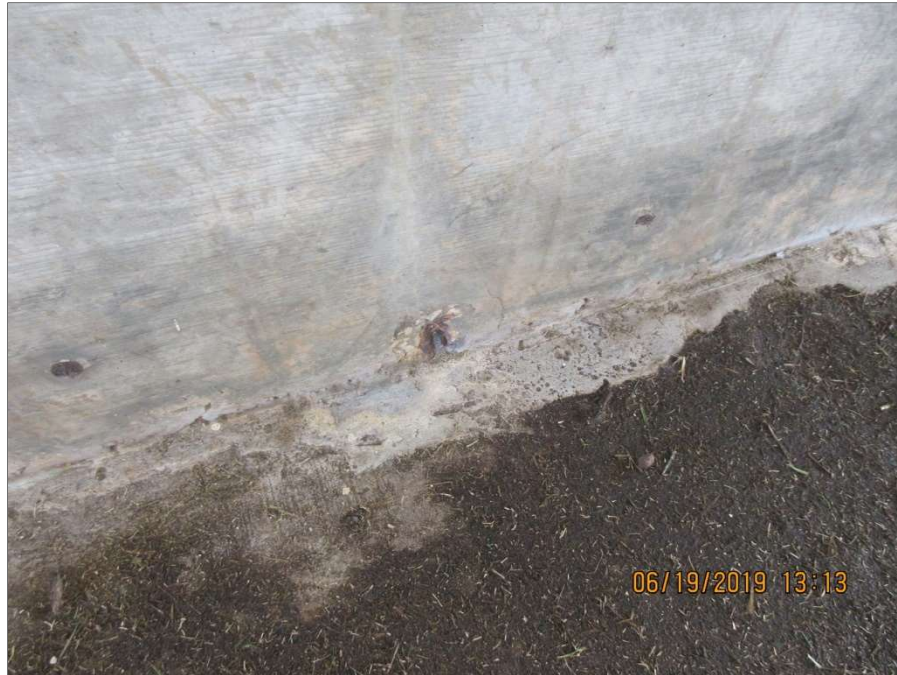
*Photo 19.13 – Exposed reinforcing in wall on Tunnel #3*

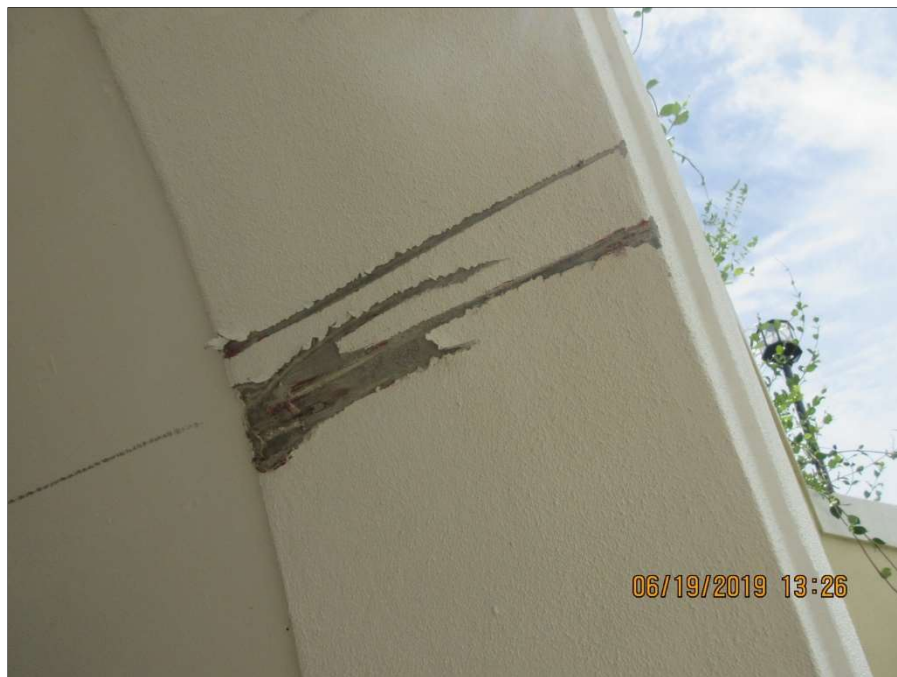
- Approximately 102 feet in length
- Evidence of impact damage on the architectural finish at the entry to the tunnel

*Photo 19.15 – Evidence of impact damage to the arch at the entry to the Tunnel #4*

In regard to the cast in place concrete tunnels (#1 through #4), we recommend sealing the overhead concrete cracks and leaks with a polyurethane chemical grout, and routing and sealing the cracks on slab on grade and tunnel walls of all four tunnels. We also recommend correcting the poor drainage deficiency to allow water to properly run off the surface. The localized concrete spalling should be repaired by chipping around the damaged area, cleaning the reinforcing steel, and applying a quick set grout. The patch can then be painted to match the existing paint on the tunnels. Additionally, it is recommended that the impact damages to the finish be corrected and re-painted at the entry of tunnel #4.

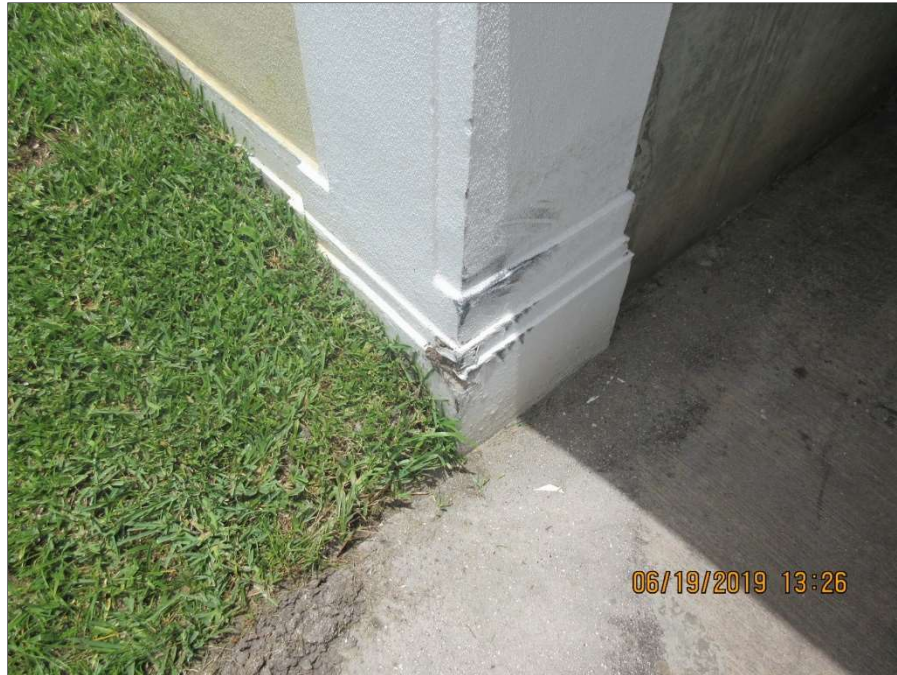
*Photo 19.15 – Evidence of impact damage to the base of the arch at the entry to Tunnel #4*

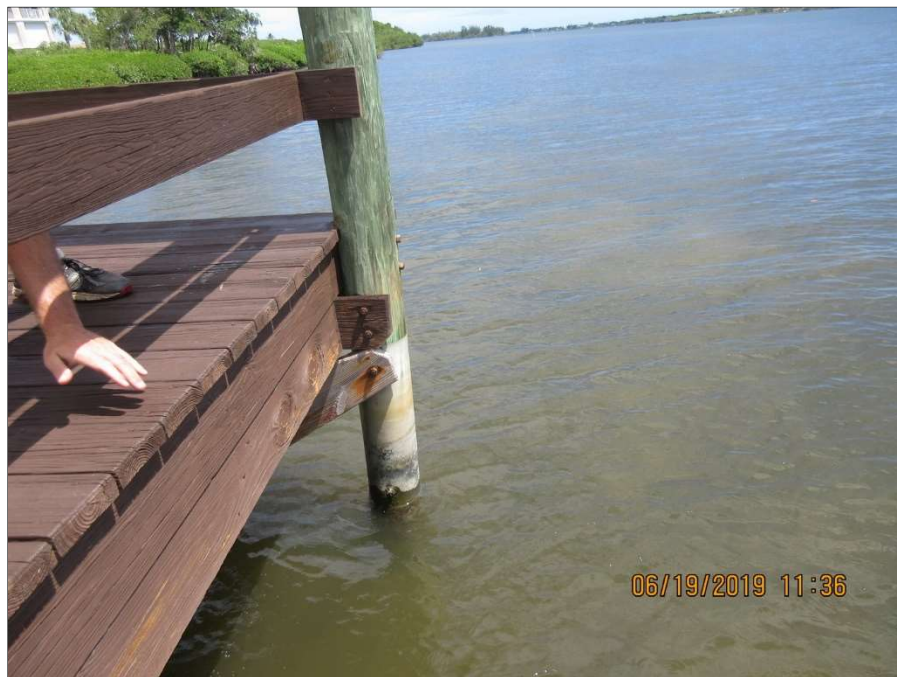
*Photo 20.2 – Corrosion stains (rust) were visible at the anchor bolts for the cross bracing of River Village Pier*

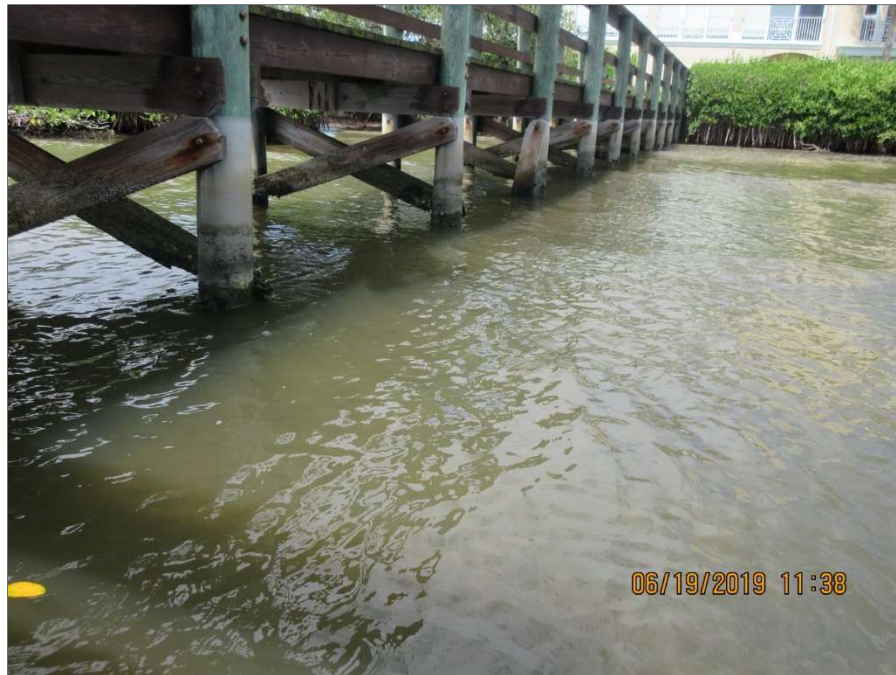
Photo 20.3 – The 2x8 timber cross bracing was rotted, splintered & deteriorated throughout.

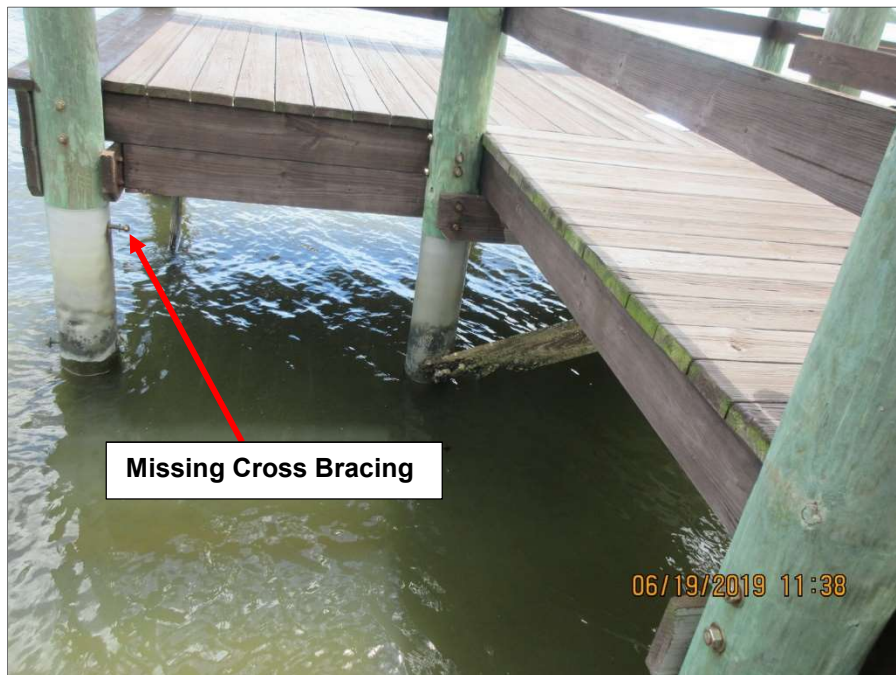
Photo 20.4 – The 2x8 timber cross bracing was rotted, splintered, deteriorated and/or missing throughout.

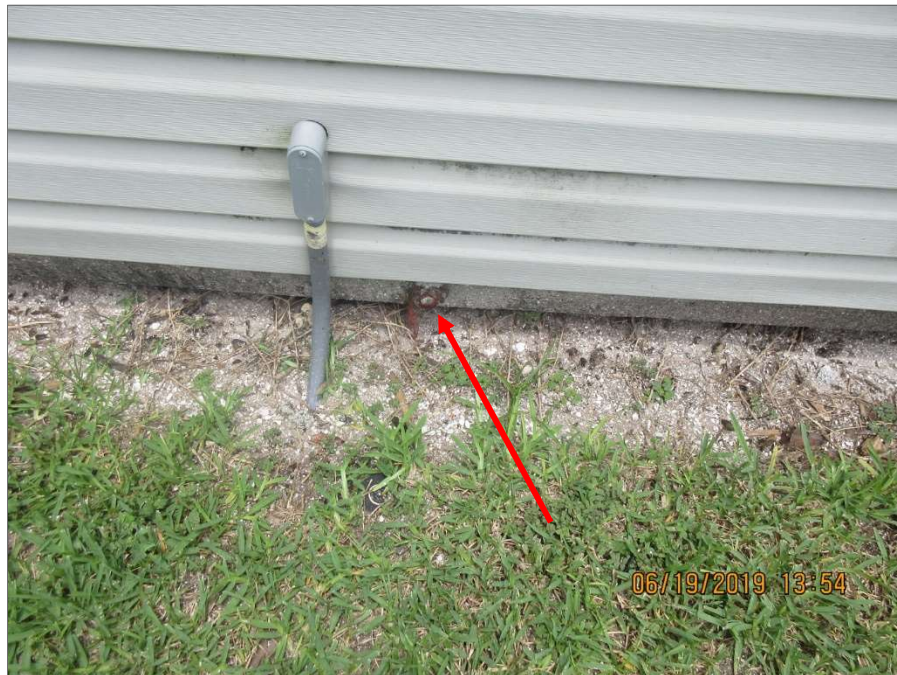
Photo 20.6 – Corroded anchor at Via Marbella Guard Shack

At the guard shack, we recommend it being removed and replaced.

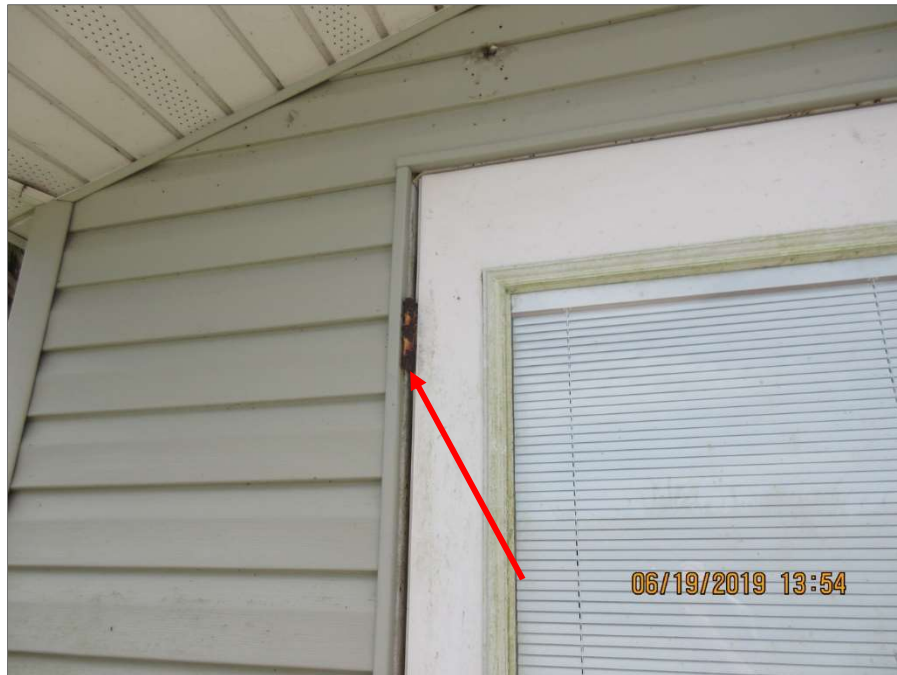
*Photo 20.7 – Corroded door hinges at Guard Shack*

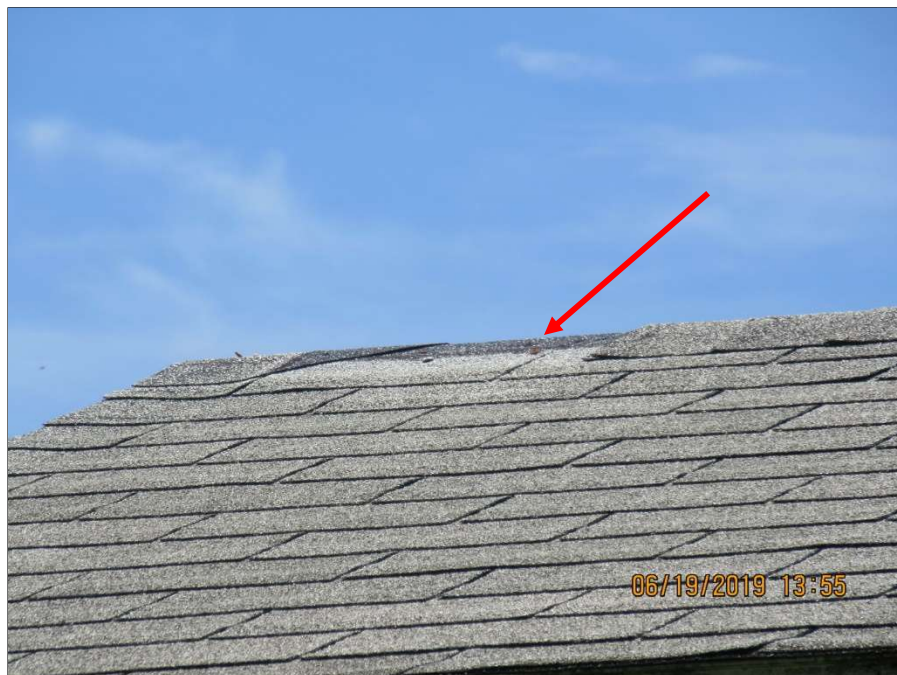
*Photo 20.8 – Missing shingle at Guard Shack*

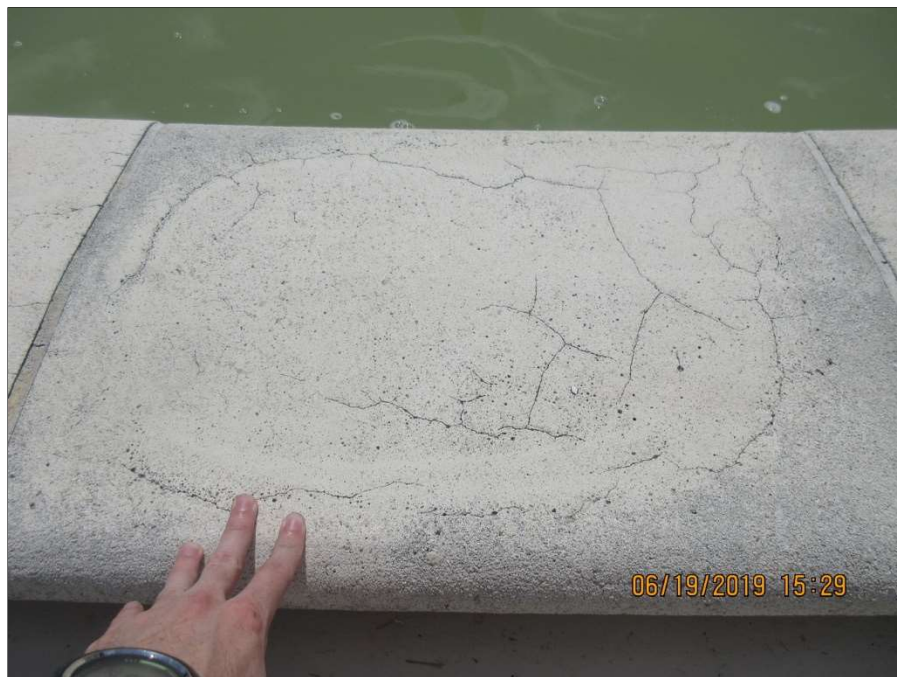
- Shrinkage cracks observed on the perimeter coping
- Bent skimmer plate
- Finish delamination on the walking surface surrounding the fountain
- Fountain lighting not working

*Photo 20.10 – Cracking on coping of Fountain*

At the fountain, we recommend re-sealing the coping to prevent water infiltration and degradation of the coping and slab. The lighting within the fountain was also found to be non-functioning. We recommend replacing all light bulbs or fixtures. There are approximately 30 fixtures.

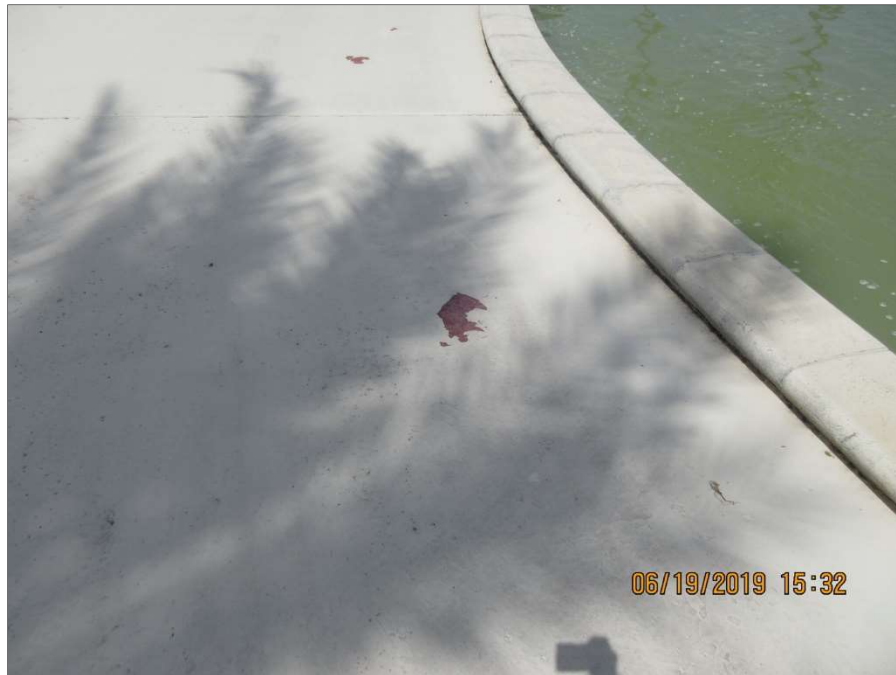
Photo 20.11 – Delamination of finish on sidewalk surrounding fountain
