# **Pond Interconnection and Estuary Culvert Inspection Report**

## Storm Water Management Pond Interconnections

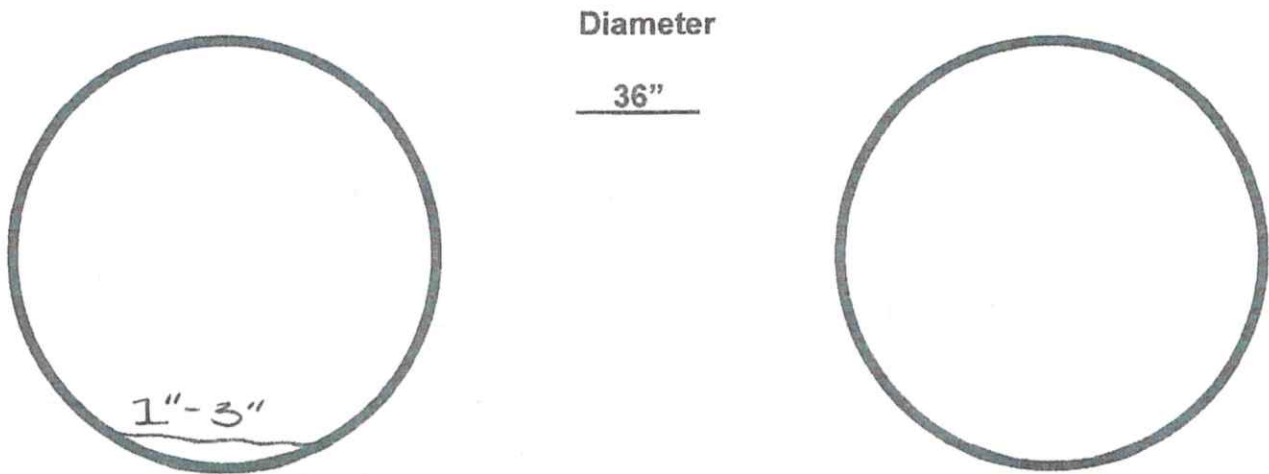
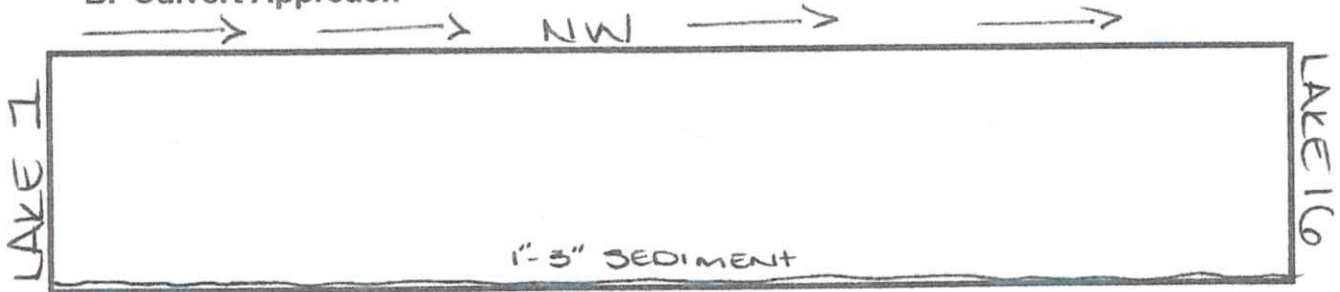
General Condition of Pipe: Dive team noted 1 to 3 inches of sediment throughout the pipe. Overall condition is good with no debris or obstructions.

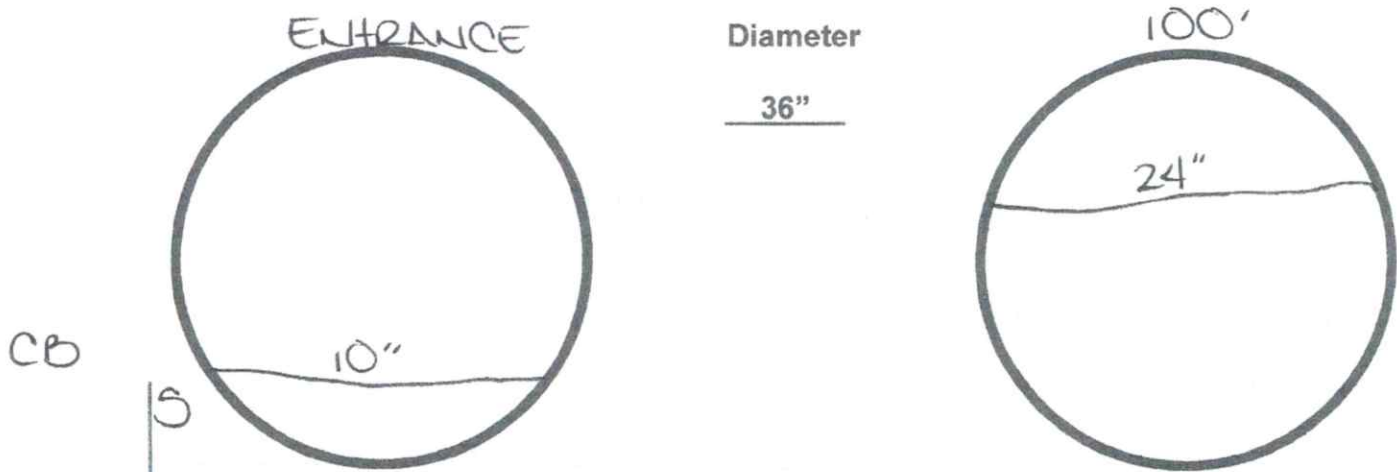
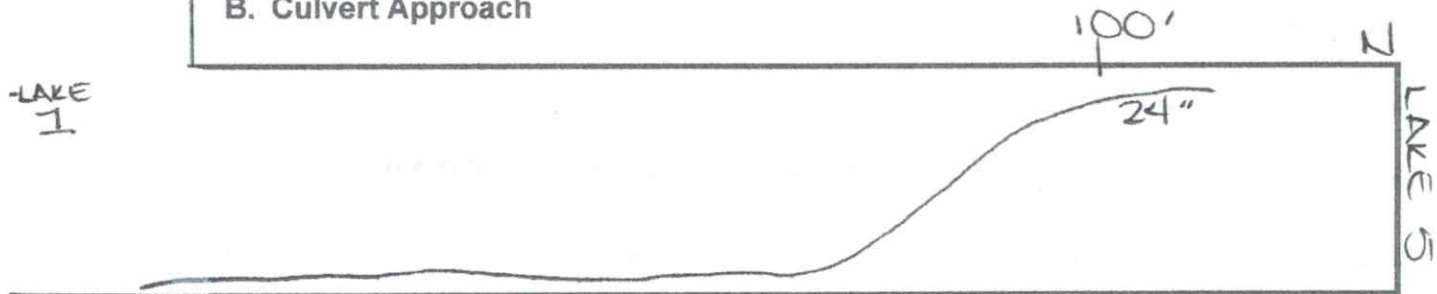
General Condition of Pipe: Dive team noted 10" of sediment at the entrance of the pipe. Slight sediment increases at catch basin 2. Catch basin 2 is in overall good condition. Sediment decreased to 2" to 8" after catch basin 2. At 100' into the pipe the sediment rose to 24". Dive is unable to further inspect the pipe due to clog at 100'.

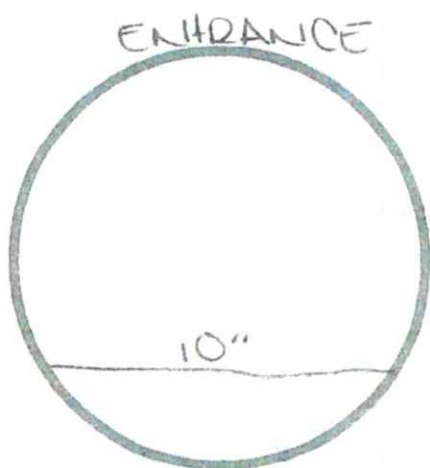
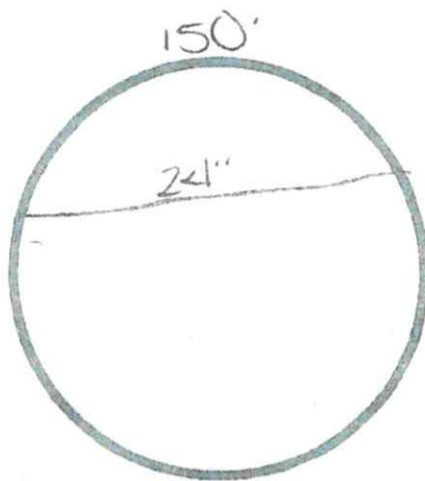
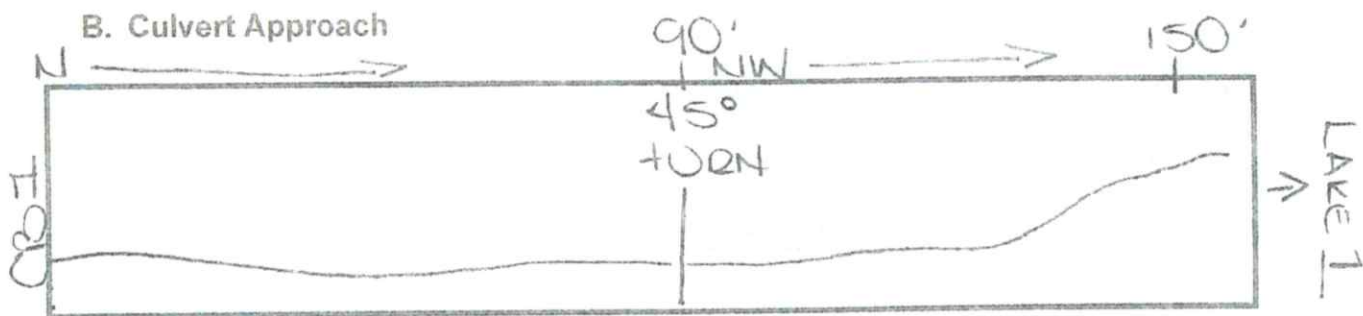
General Condition of Pipe: Dive team noted 10" of sediment at the entrance of the pipe. At 90' the pipe turns 45 degrees towards the North West. At 150' the sediment level rose to 2' diver unable to continue inspection due to the sediment levels.

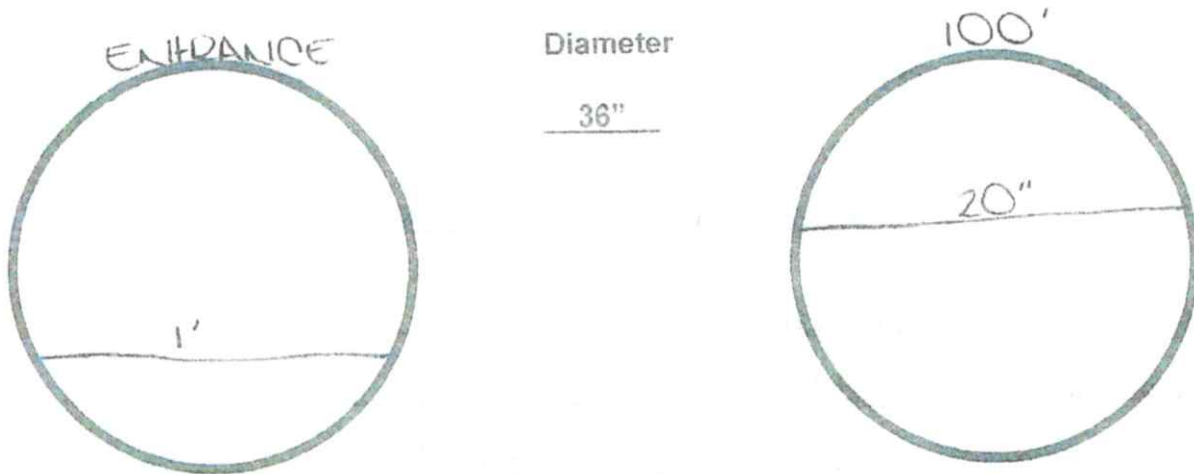
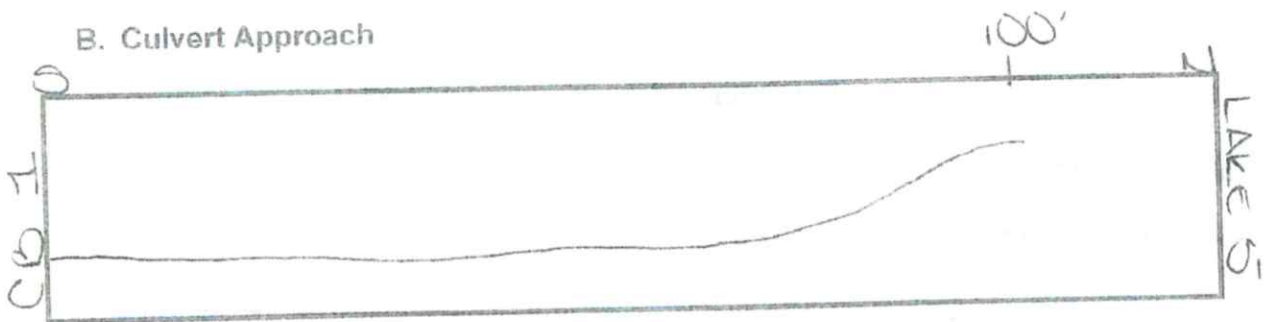
General Condition of Pipe: Dive team noted 1' of sediment at the entrance of the pipe. Slight sediment increases at CB2, CB2 in good condition. Sediment decreased after CB 2 to 8". Sediment increased to 20" at 100'. Diver unable to continue the inspection from this end. Overall condition of the pipe is good.  
Good water flow through the pipe.

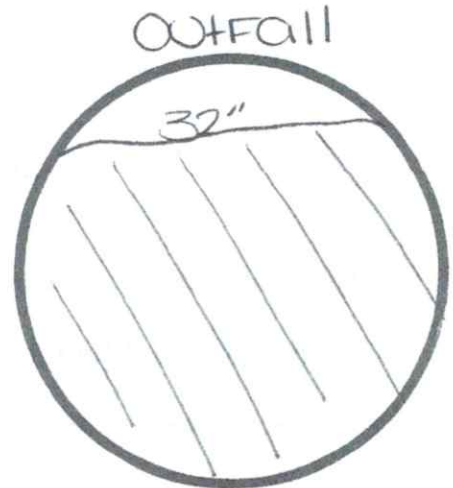
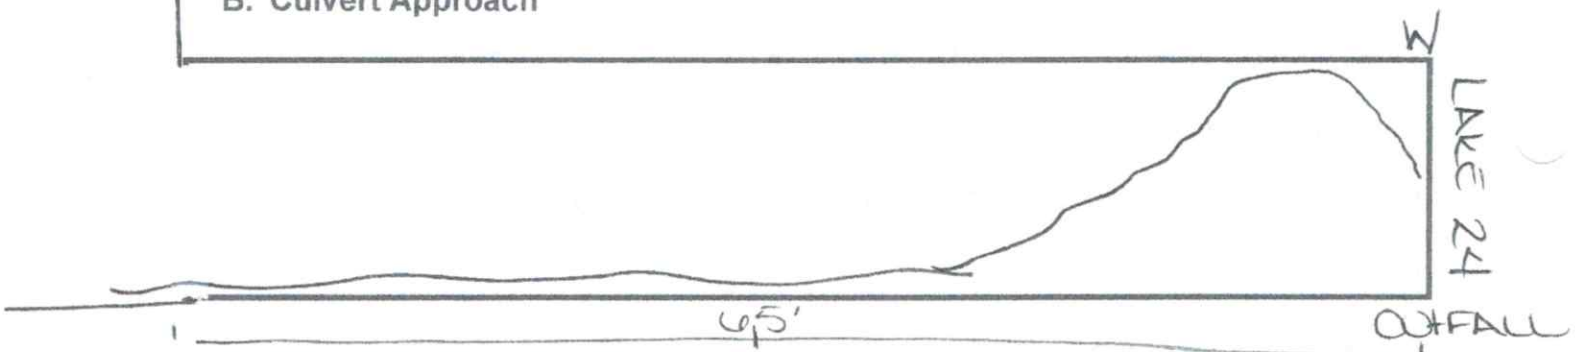
General Condition of Pipe: Dive team noted that the Pipe is clogged at the outfall in lake 24. Diver was able to make it to the outfall but was unable to exit. Lake 24 outfall pipe flows east to CS #6 at Mangrove estuary.

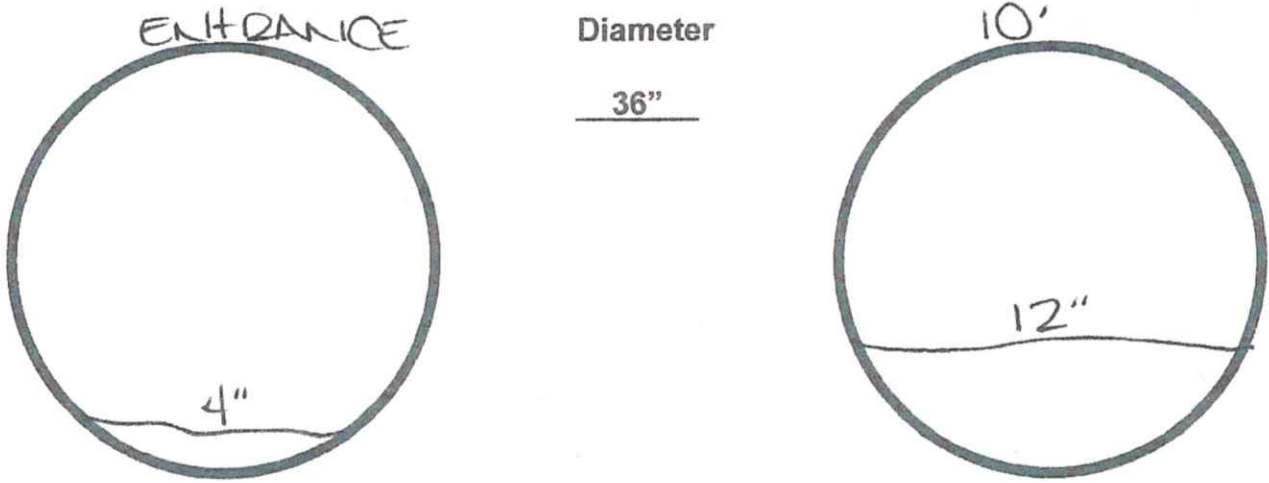
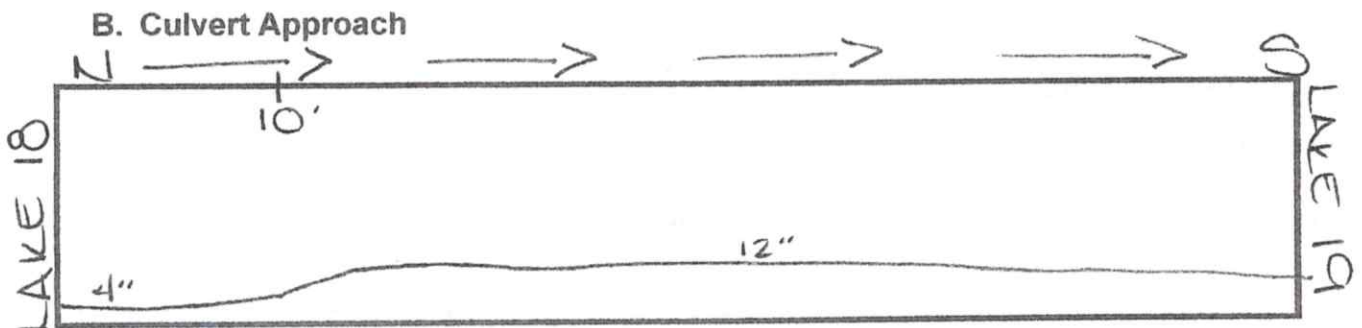
General Condition of Pipe: Dive team noted 4" of sediment at the entry of the  
pipe. Sediment level increases to 12" 10' into the pipe. Overall condition of the  
pipe is good.

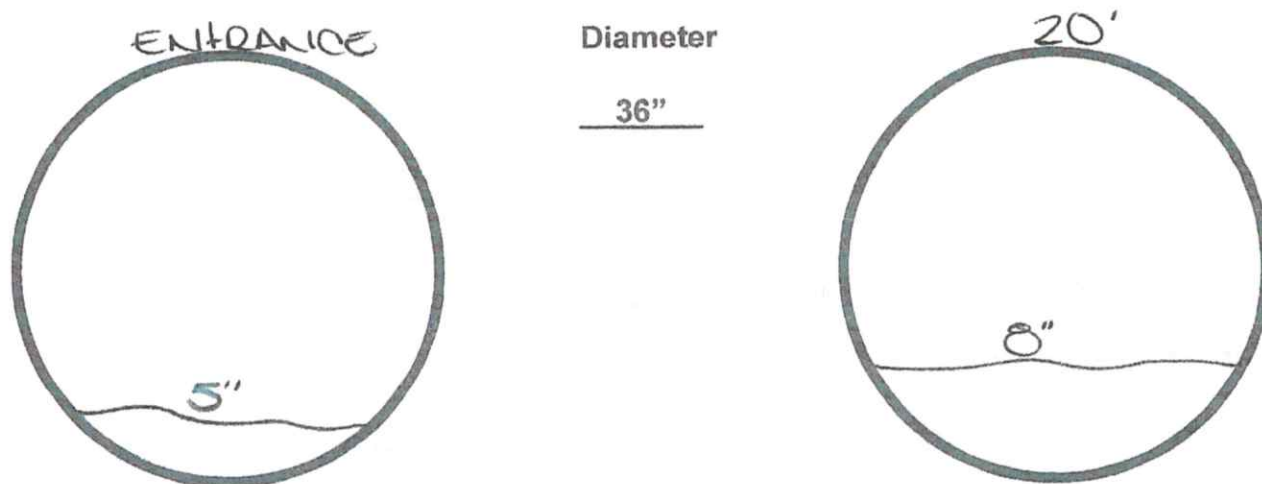
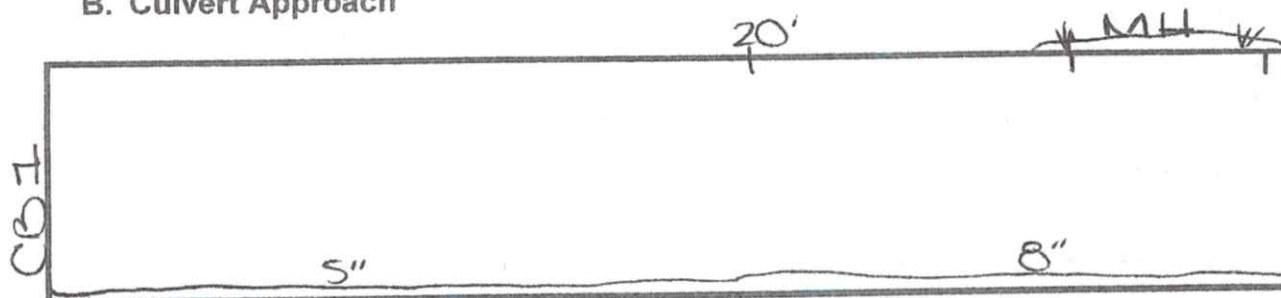
General Condition of Pipe: Dive team noted 5" of sediment at the entrance of the pipe. Sediment increasing at approximately 20' into pipe to 8" – 10". Diver arrived at a manhole that was not accessible from the top side due to overgrowth.

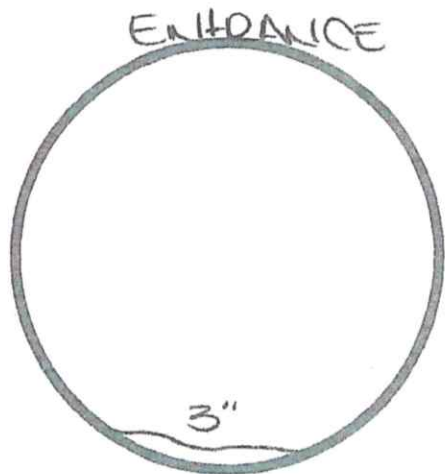
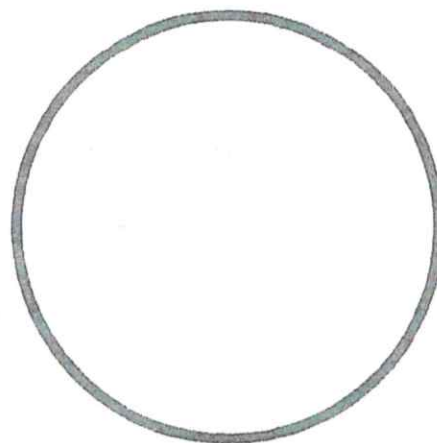
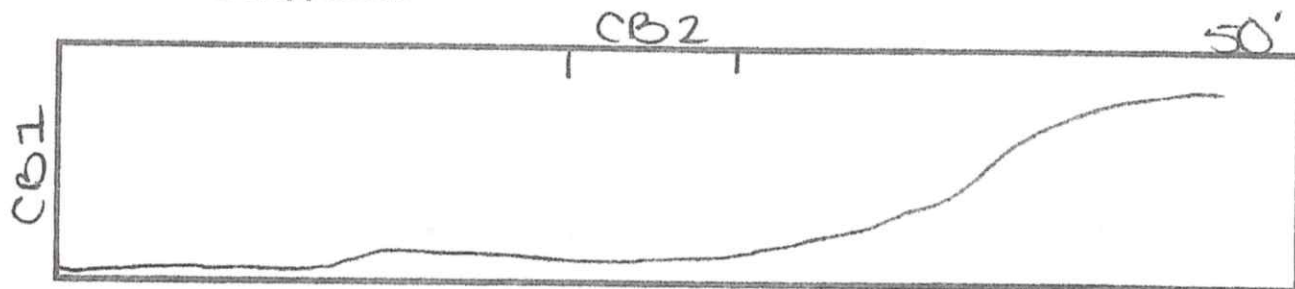
General Condition of Pipe: Dive team noted 3" of sediment at the entrance of the pipe. Catch Basin 2 is in overall good condition. Sediment increased to 8" – 10 " after CB 2 and continues to increase. Diver unable to continue inspection at the 50' mark due to sediment. The sediment throughout the pipe is a mixture of sand and shell.

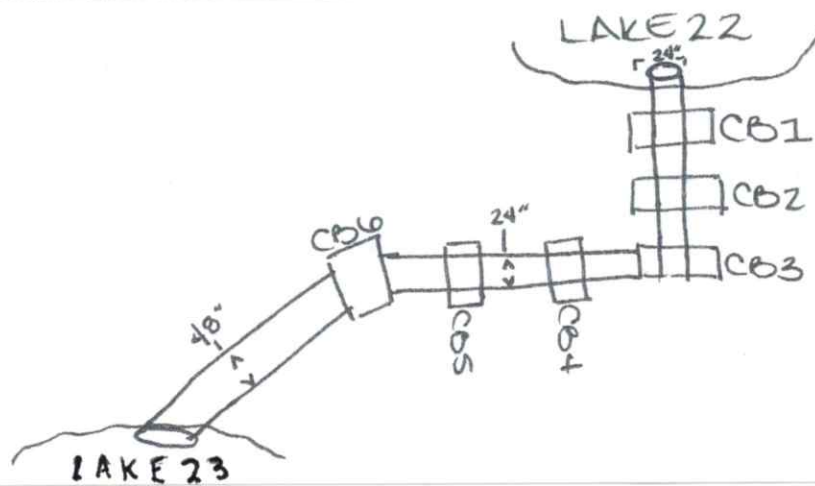
Lake 22 to Lake 23  
Basin 3

General Condition of Pipe: Diver noted 4" of sediment throughout the length of the pipe. Overall condition of the pipe is good with no damage or obstructions.

Comments: Diver noted that Lake 22 connects to Lake 23 through a series of 6 catch basins. The outfall in Lake 22 is a 24" pipe that runs through the first 5 catch basins. Dive was unable to inspect due to size.

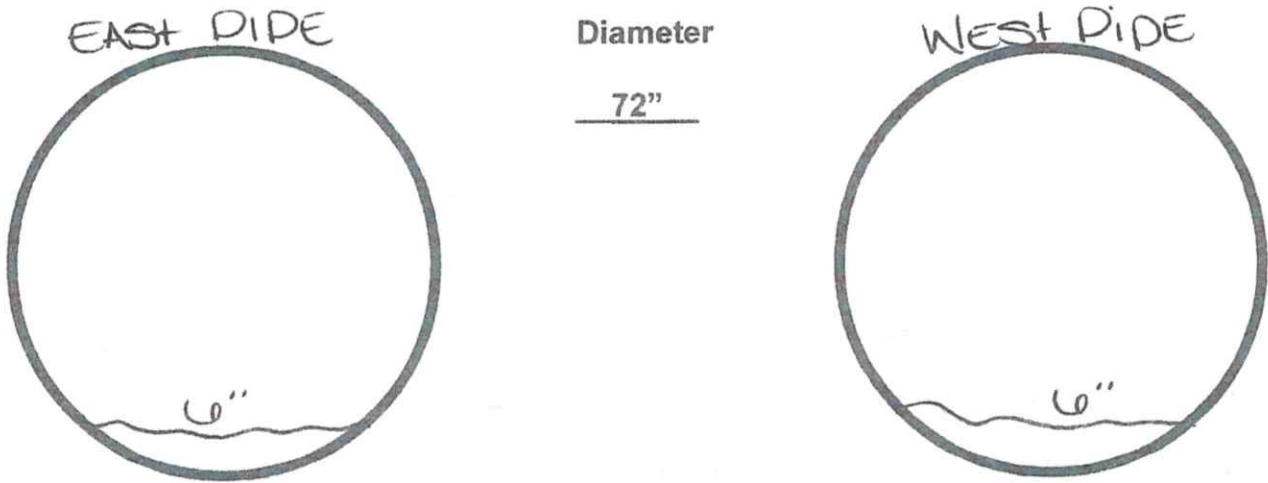
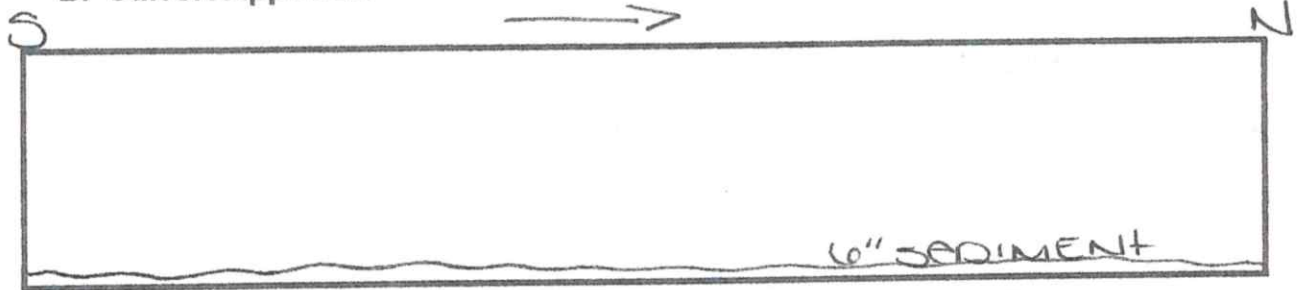
General Condition of Pipe: Dive team noted 6" of sediment throughout the length of both pipes. Overall condition of the pipes is good with no damage, or obstructions.

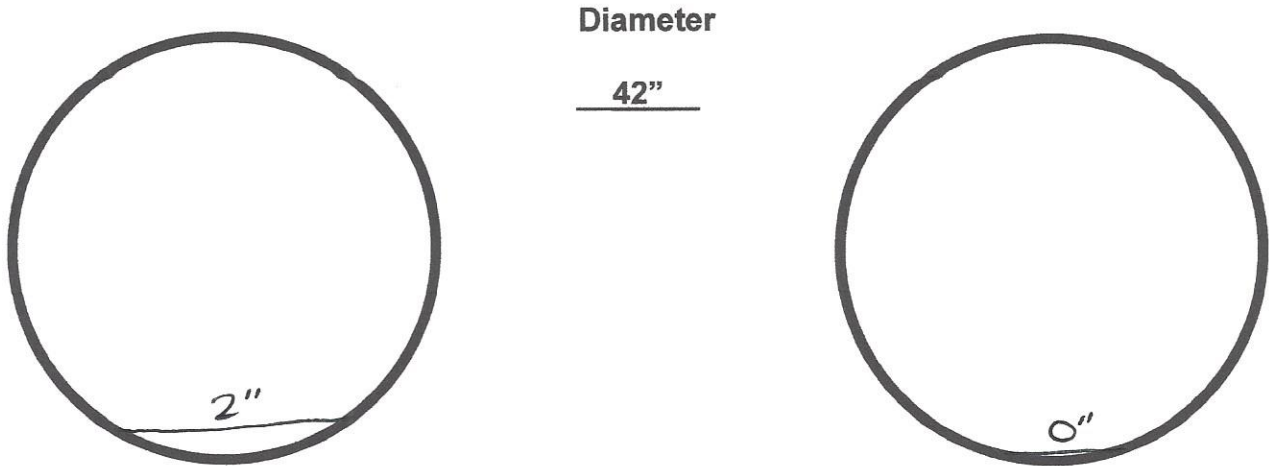
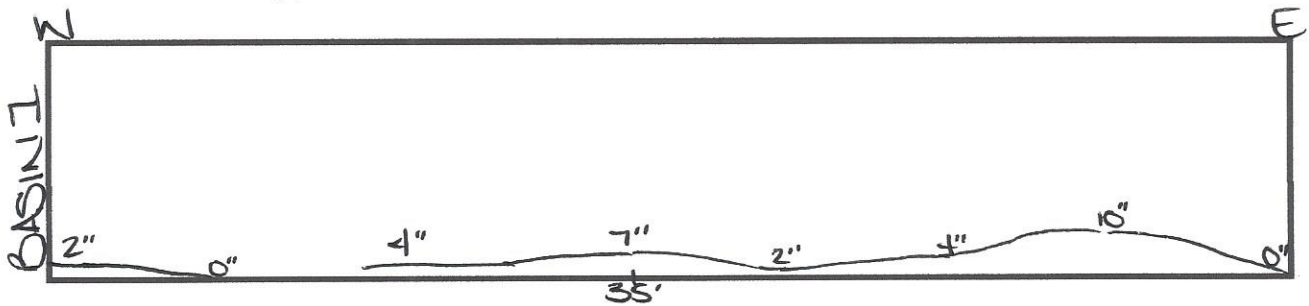
General Condition of Pipe: The mouth of pipe to basin 1 is 69' running South-West. Sediment buildup at the mouth is 2" then drops to 0" with no marine growth. Pipe Transitions from CMP to RCP at basin 1. Basin 1 is an RCP pipe with 1" of sediment with no marine growth. Basin 1 to MH2 is 100' running North-West. Sediment in structure at MH2 is 4" deep. Sediment increases to 7" deep at 35'. MH2 to MH3 is a 122' RCP pipe that runs North-West with a diameter of 42" and a sediment level of 2". Sediment level at MH3 structure is 6" deep. MH3 to basin 4 is a 133' long RCP pipe running South-East, and has a diameter of 42" with no 0" of sediment. At 73' Sediment increases to 4", Pipe has no Marine Growth. Basin 4 has a Sediment level of 10". Basin 4 to Basin 5 runs South-East for 157'. The RCP from basin 4 to basin 5 is 42" in diameter with a sediment level of 11" with no marine growth. Basin 5 has a sediment level of 12". Basin 5 to basin 6 South-East for 101', it is an RCP pipe with a diameter of 42", it has a sediment level of 4" and no marine growth. Basin 6 to Basin 7 is an RCP pipe that runs for 273' South-East, it is 42" in diameter with a sediment level of 13" and no marine growth. Basin 7 has a sediment level of 4" with two pipes connecting. The pipe to the left of diver runs North-East and is an RCP with a sediment level of 0".

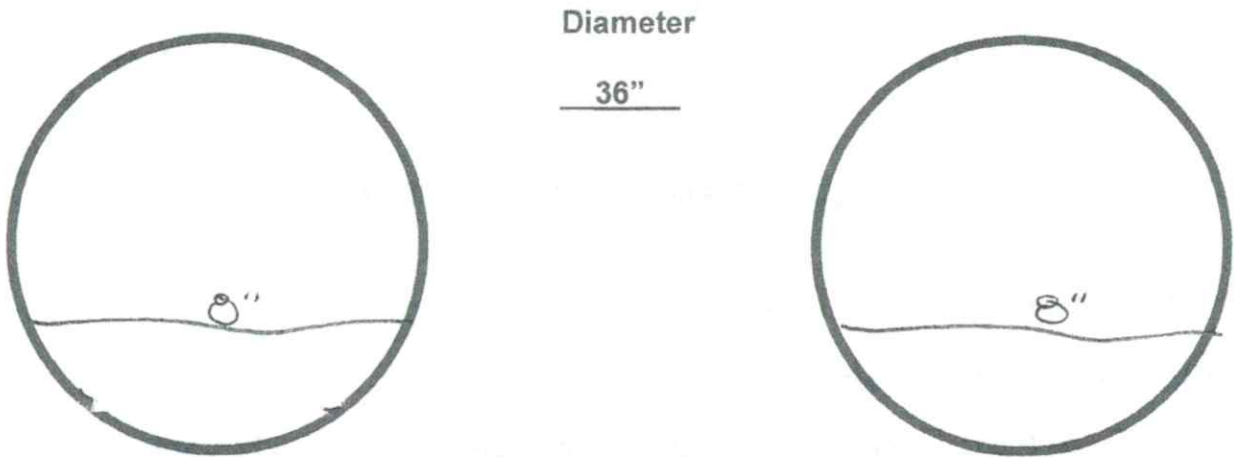
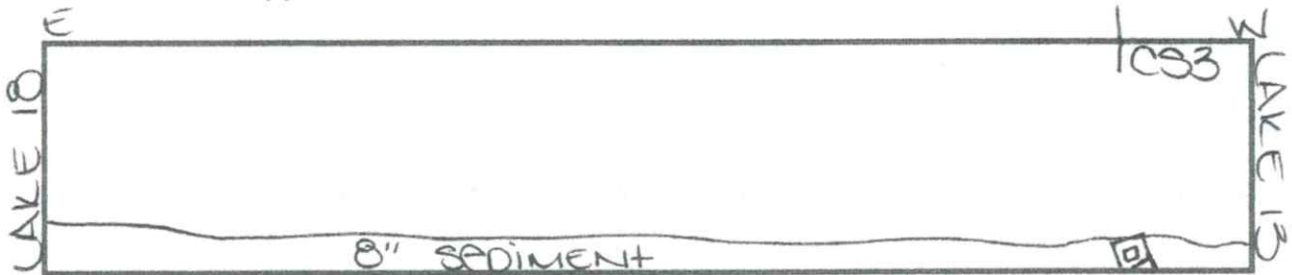
General Condition of Pipe: Dive team noted 8" of sediment throughout the length  
of the pipe. Sediment consisting of mud and shells. Also noted a cement block at  
the control station 3. Overall condition of the pipe appears to be good.

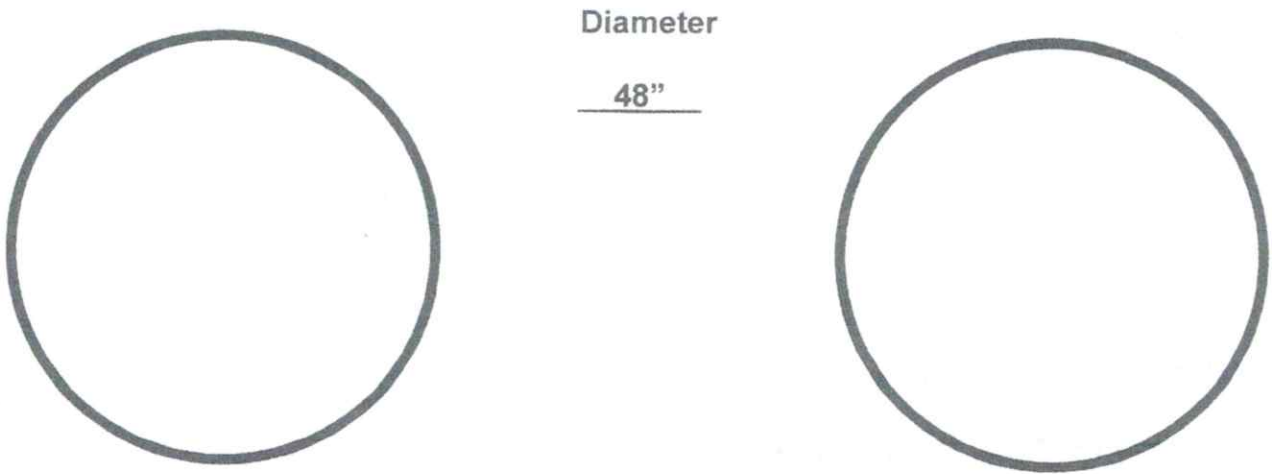
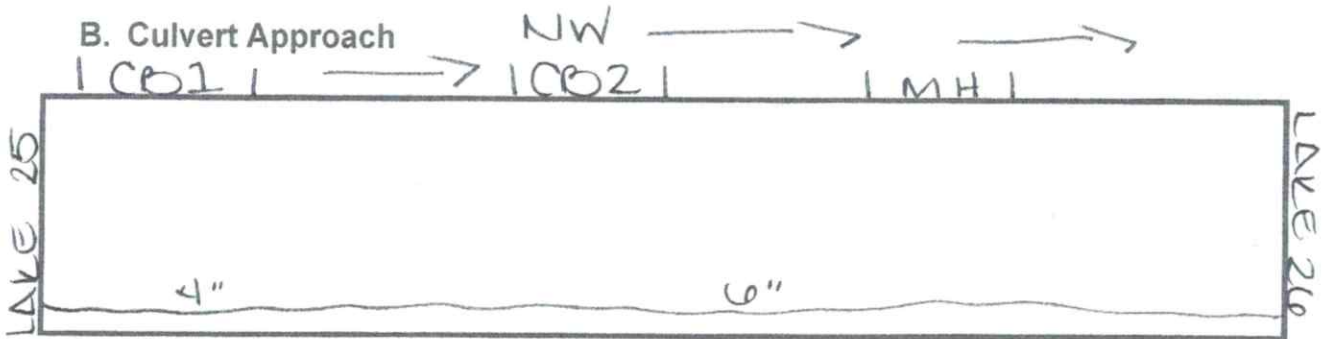
General Condition of Pipe: Dive team noted 6" of sediment throughout the pipe.

Overall condition of the pipe is good. Dive team reported a man hole between  
lakes 25 and 26.

**Comments:** Dive team noted that the pipe started as CMP and transitioned into RCP at the 45 degree turn.

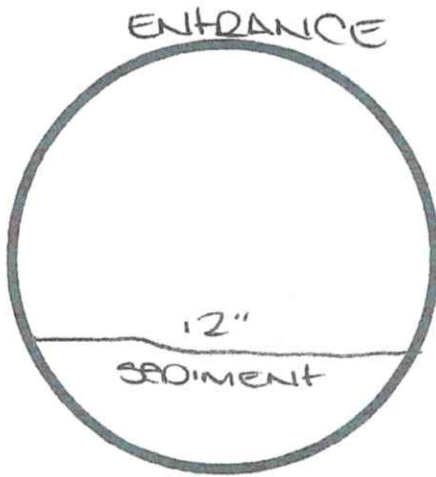
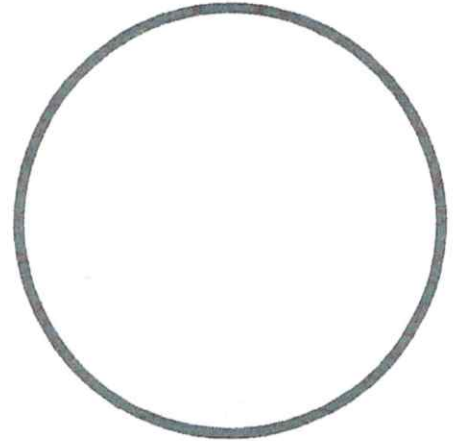
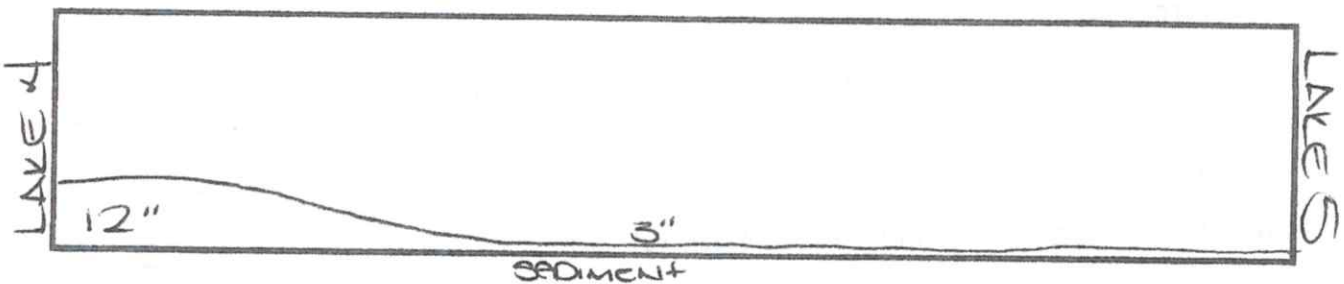
General Condition of Pipe: Dive team noted 1' of sediment at the pipe entrance.

Sediment decreased to 3". Overall condition of the pipe is good.

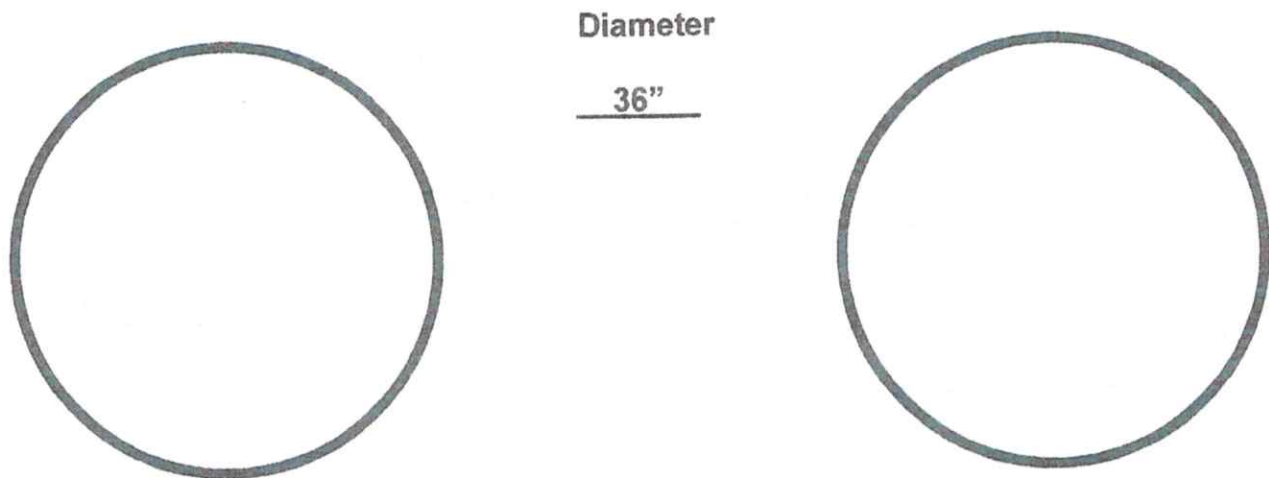
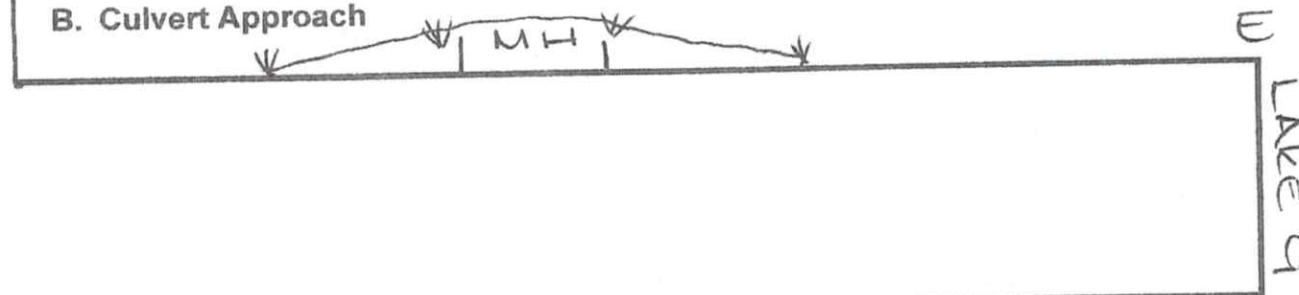
General Condition of Pipe: Dive team noted little to no sediment throughout the length of the pipe. Overall condition of the pipe is ok, with joints and concrete in ok condition. Good and steady flow of water through pipe. Dive team noted a manhole at 190' into the pipe.

Comments: The manhole located 190' into pipe was located and marked on the topside. The manhole is covered by grass and cannot be accessed unless unearthed.

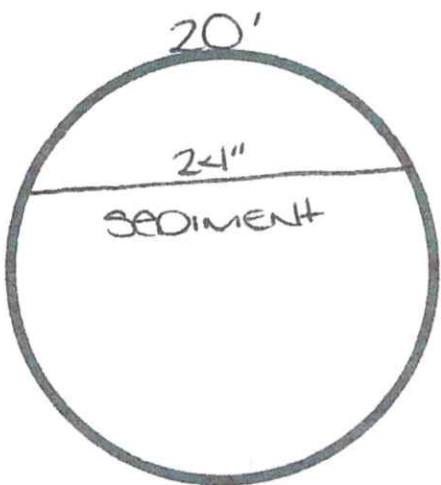
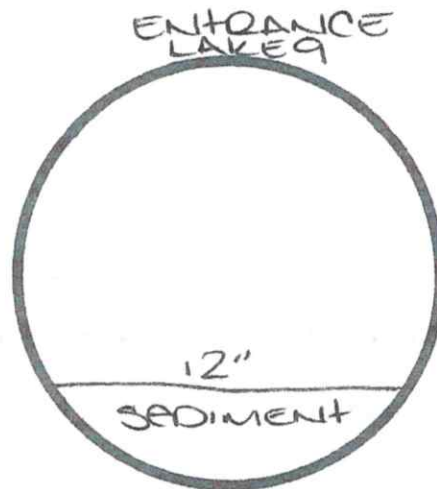
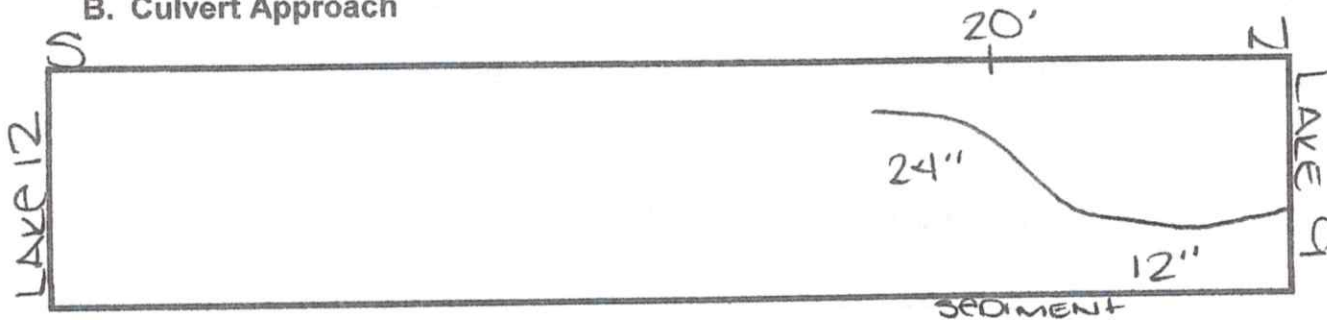
Describe access to the pipe: Cleaned pipe and found hole in pipe 30 feet from lake 9 end of pipe at 6 O'clock Position and bottom of pie is rusted and has small holes throughout pipe.

General Condition of Pipe: Diver noted that the pipe is heavily corroded

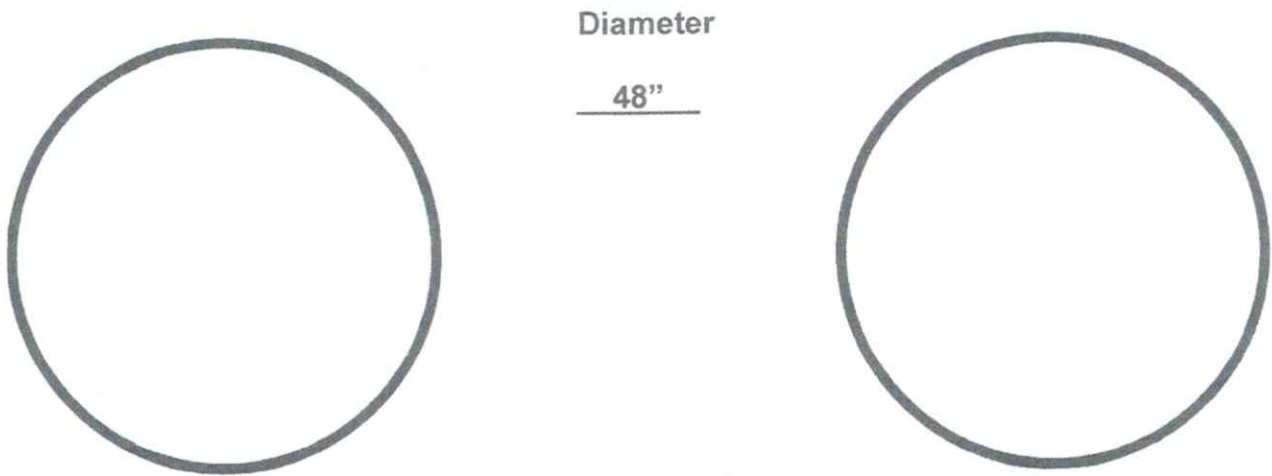
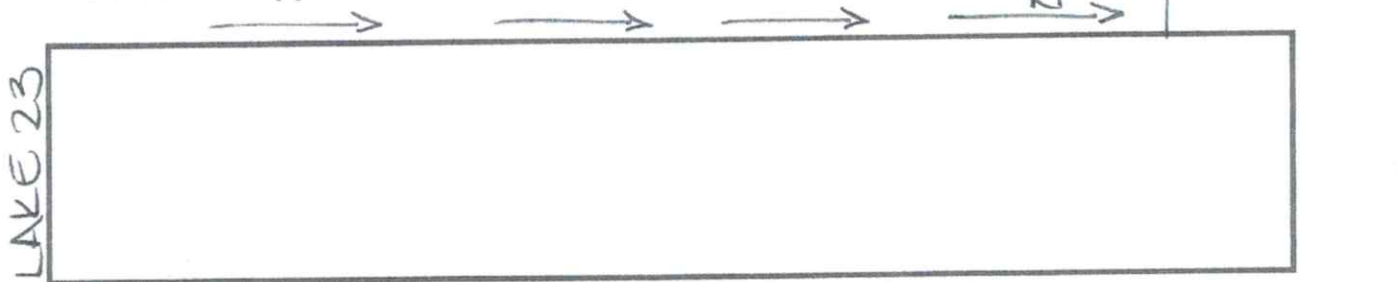
General Condition of Pipe: Pipe is a CMP pipe in good condition, with a diameter of 42", is 35' in length, with 1" of sediment buildup, and has light marine growth.

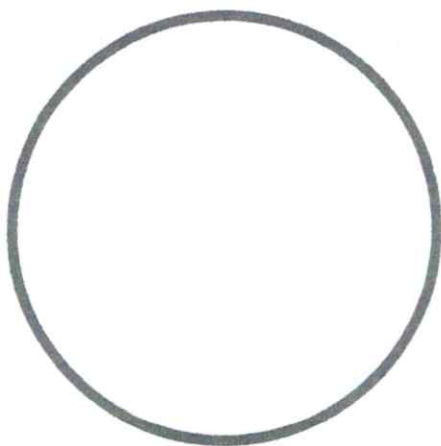
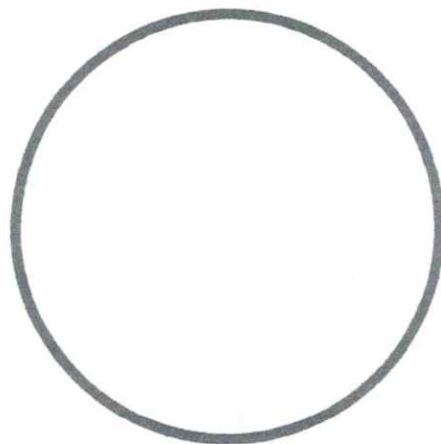
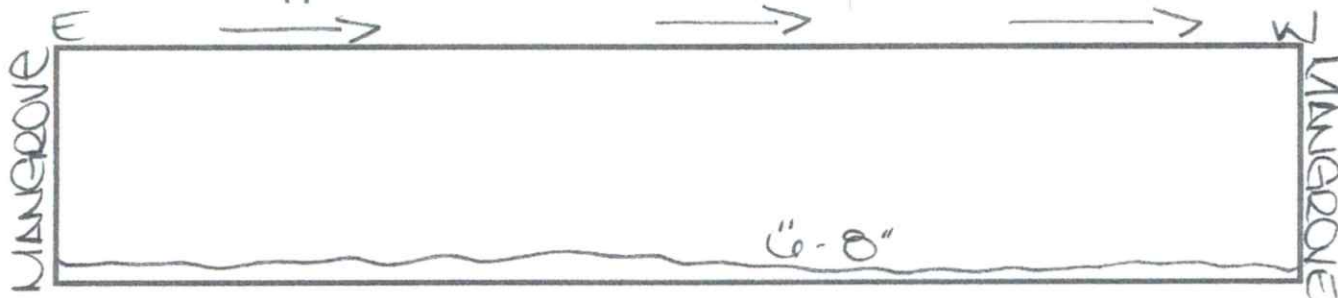
General Condition of Pipe: Dive team noted 6 – 8" of sediment throughout the  
length of the pipe. Overall condition of the pipe is good. With no obstructions.

**Comments:** Very low visibility inside of the pipe.

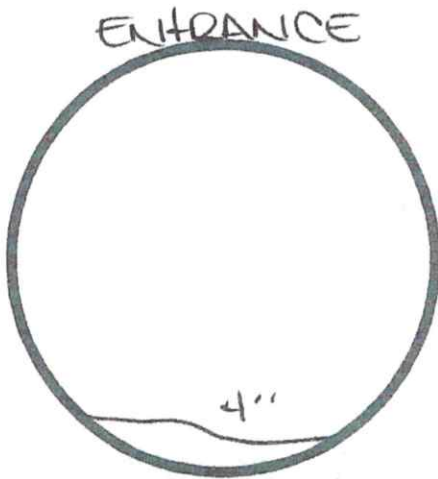
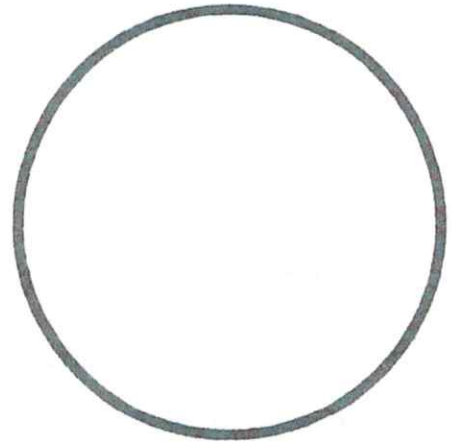
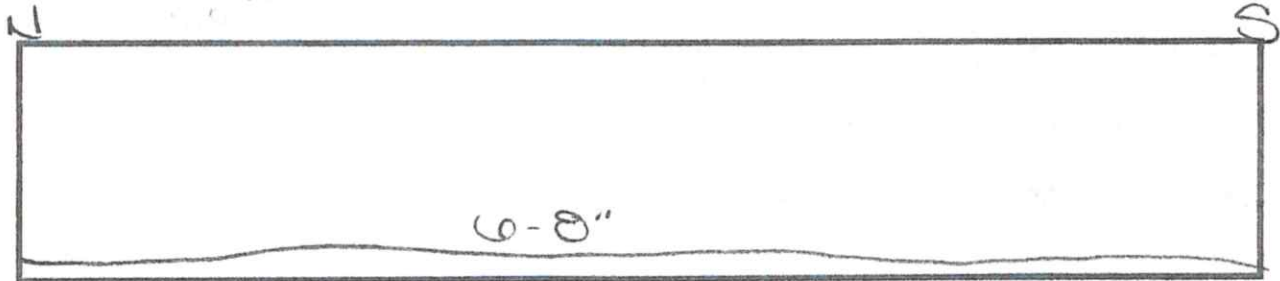
General Condition of Pipe: Dive team noted 4" of sediment at the entrance of the  
pipe. Also noted tree branches and roots in the pipe. Sediment consists of sand  
and leaves. Sediment is 6" to 8" throughout the length of the pipe.

**Comments:** Very low visibility inside of the pipe.

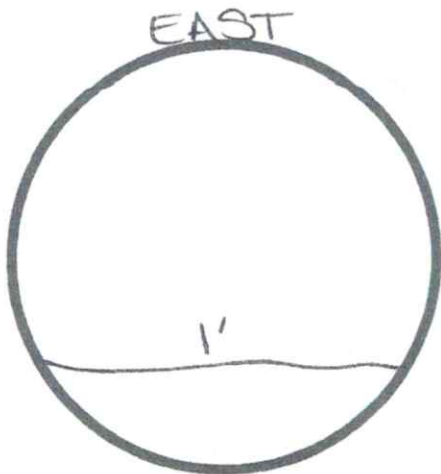
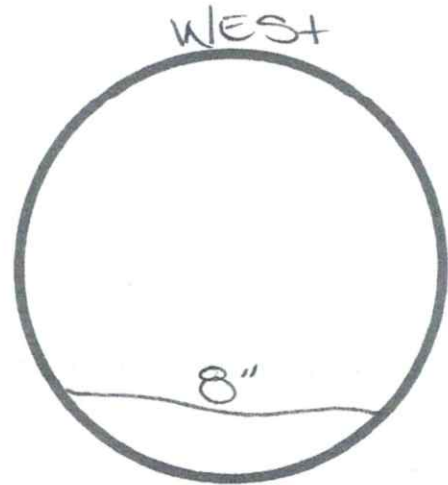
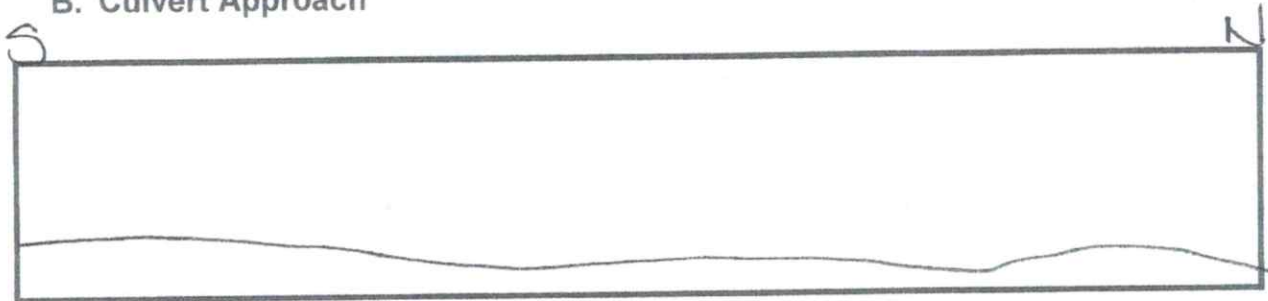
General Condition of Pipe: Dive team noted approximately 12" of sediment at the entrance. Over all condition of pipe is good. Sediment between 8 and 12" throughout pipe.

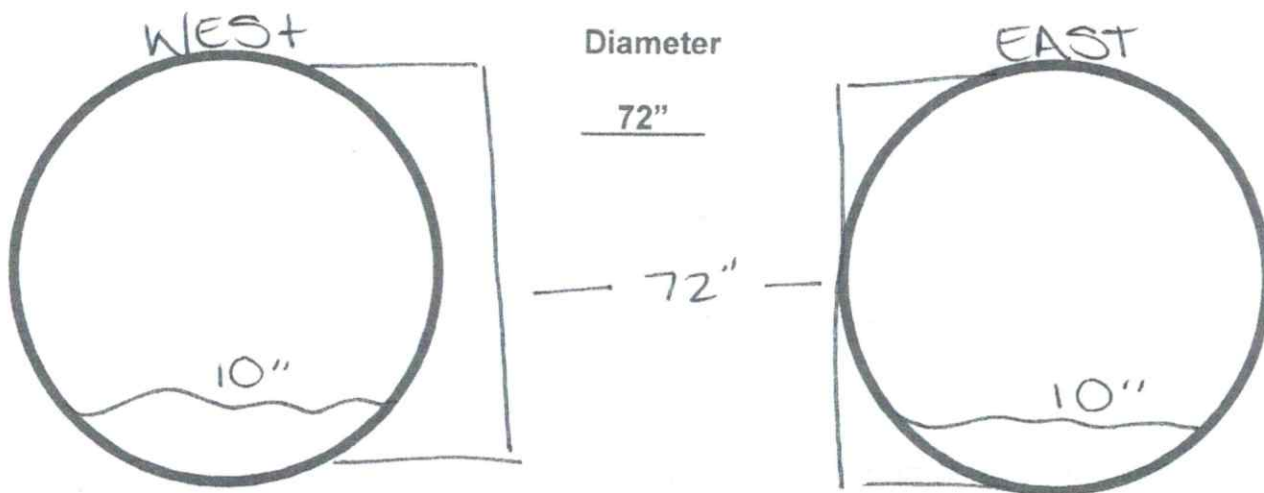
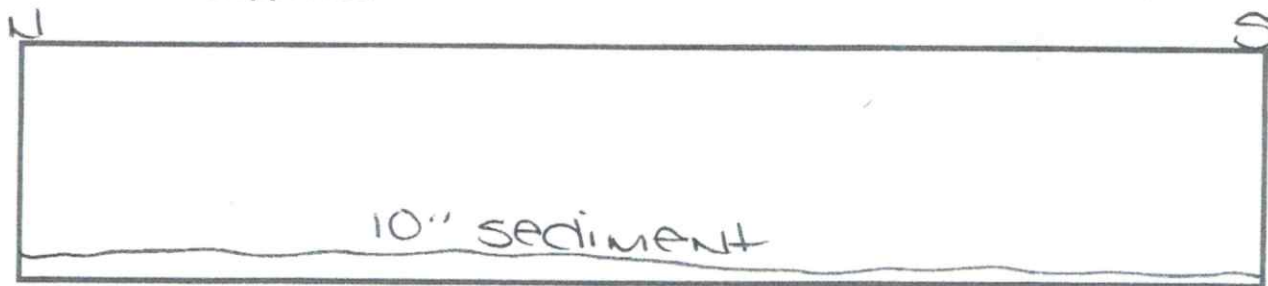
General Condition of Pipe: Dive team noted 10 inches of sediment throughout  
both East and West pipes. Overall condition is good with no debris or  
obstructions.

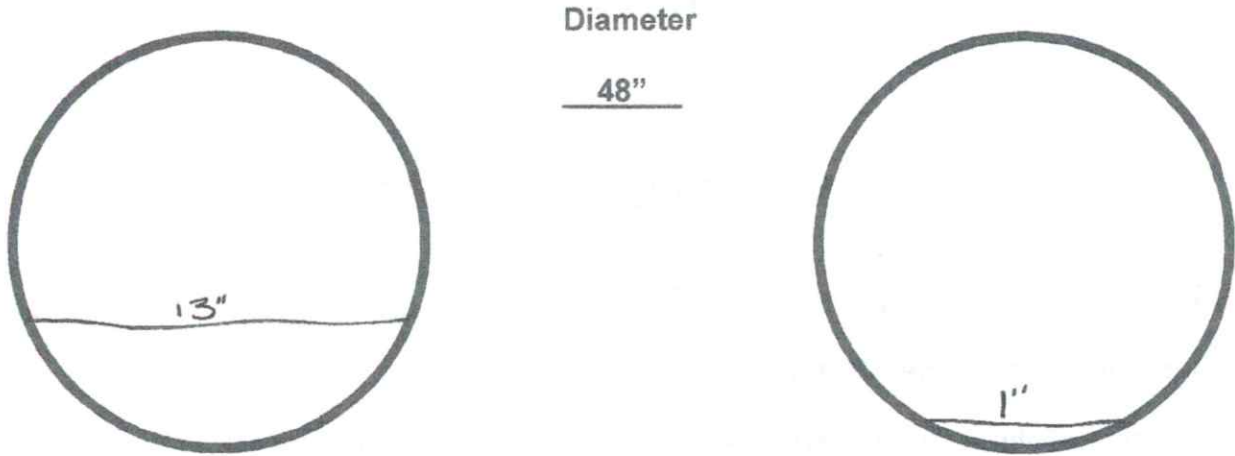
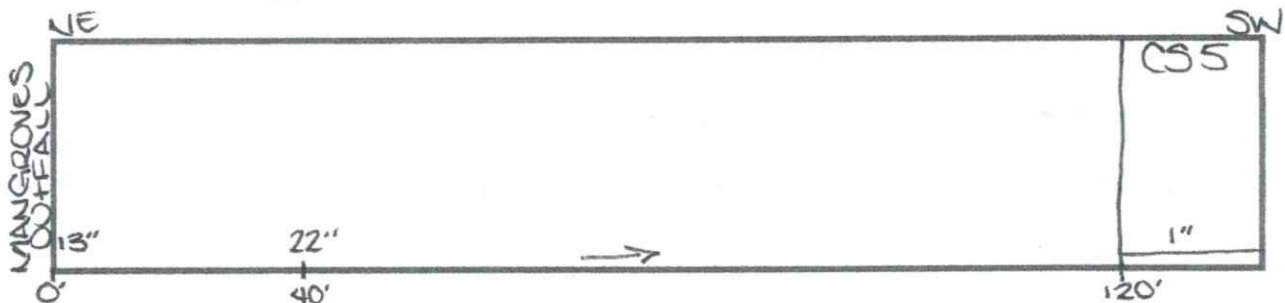
General Condition of Pipe: Diver noted the sediment levels increased heading toward CS5 then decreased. Diver also noted heavy marine growth along the sides.

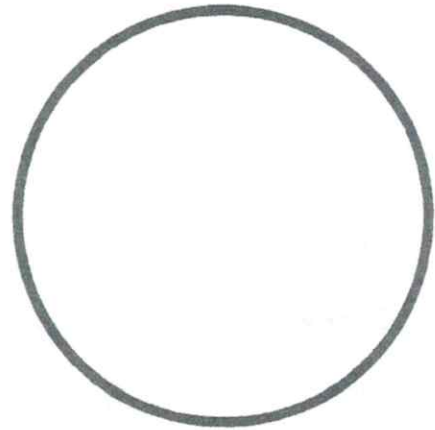
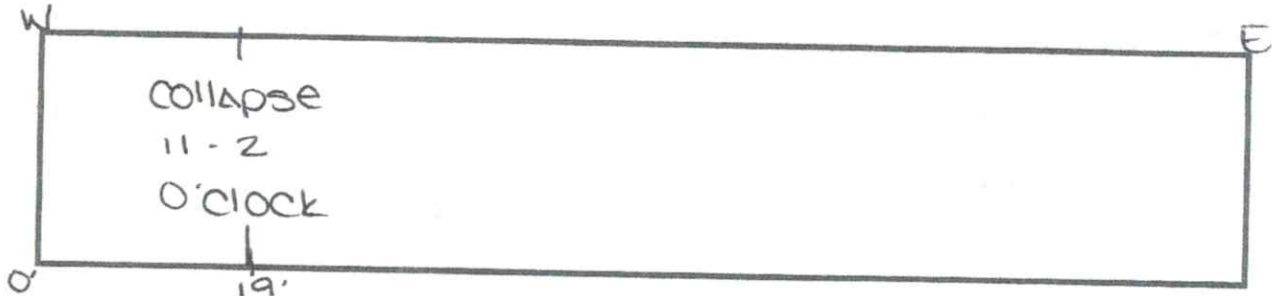
General Condition of Pipe: Diver noted moderate growth on the sides of the pipe.  
Pipe collapsed 19' into pipe from the 11 to 2 O' clock position.

**Comments:** Diver was unable to continue inspection past 19' due to pipe collapse.

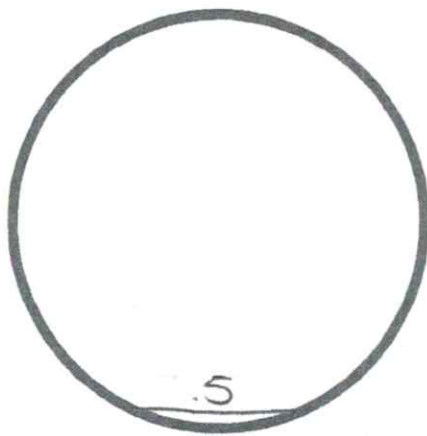
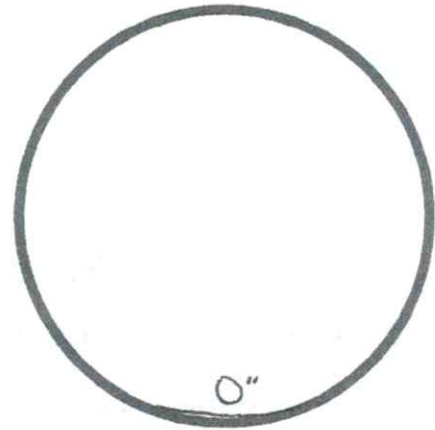
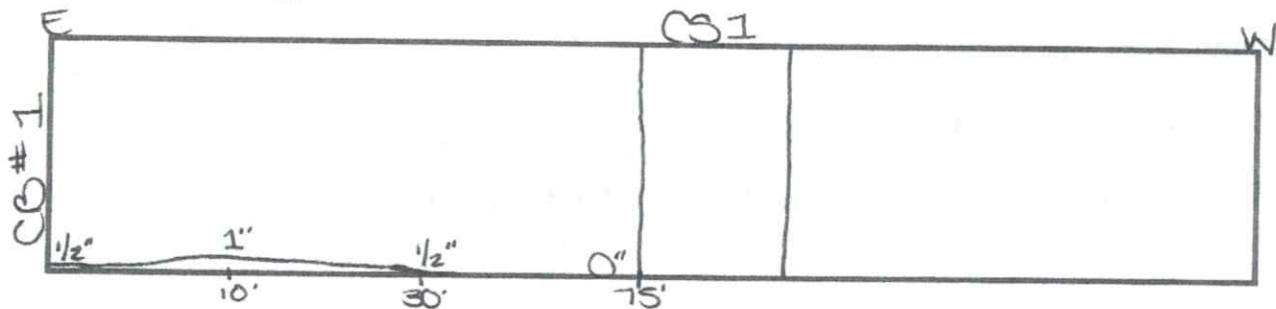
General Condition of Pipe: Diver noted minor cracking at the mud work at the mouth of the pipe in CB1. Also noted moderate growth.
