# **Pond Interconnection and Estuary Culvert Inspection Report**

## Storm Water Management Pond Interconnections

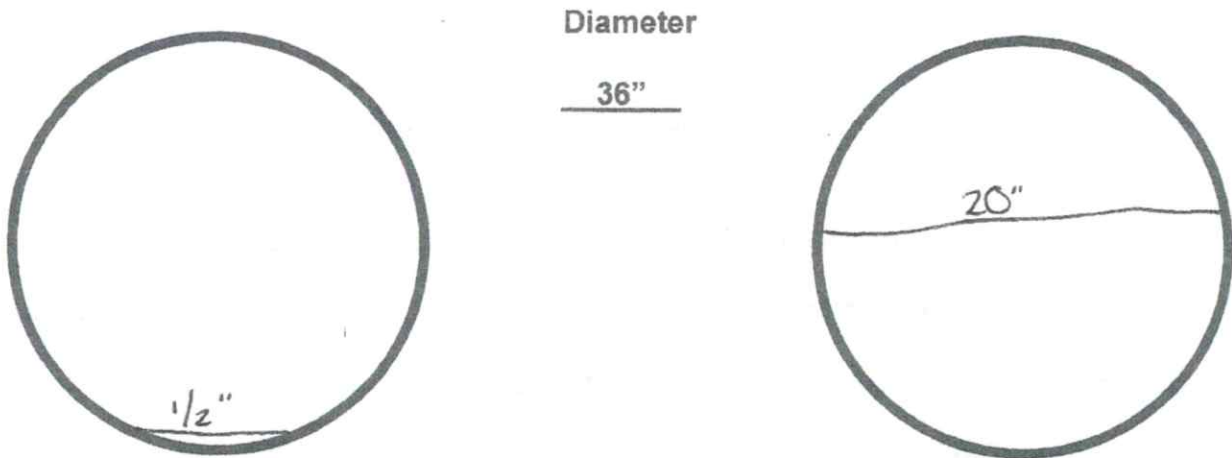
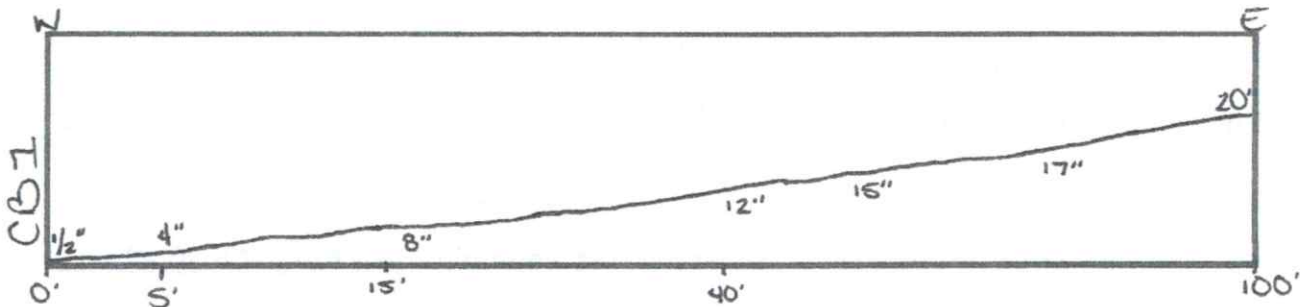
General Condition of Pipe: Diver noted that the sediment rose from 1/2" to 20"  
throughout the length of the pipe. Also noted minor marine growth along the  
sides of the pipe.

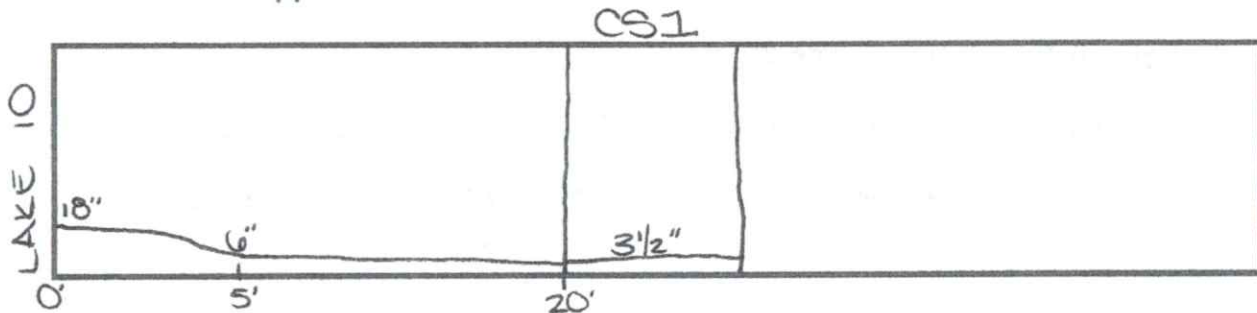
General Condition of Pipe: Diver noted a rebar trash rack at Lake 10 outfall, heavy corrosion on the trash rack along with heavy marine growth and mild corrosion. Control structure 1 has some rebar exposed. Diver also noted the sediment levels decreased throughout the pipe.

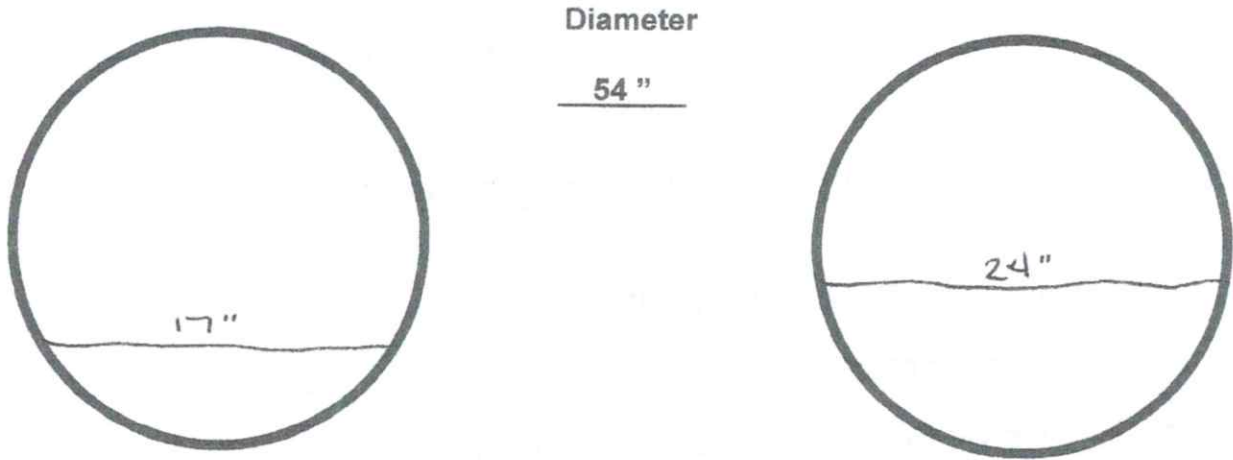
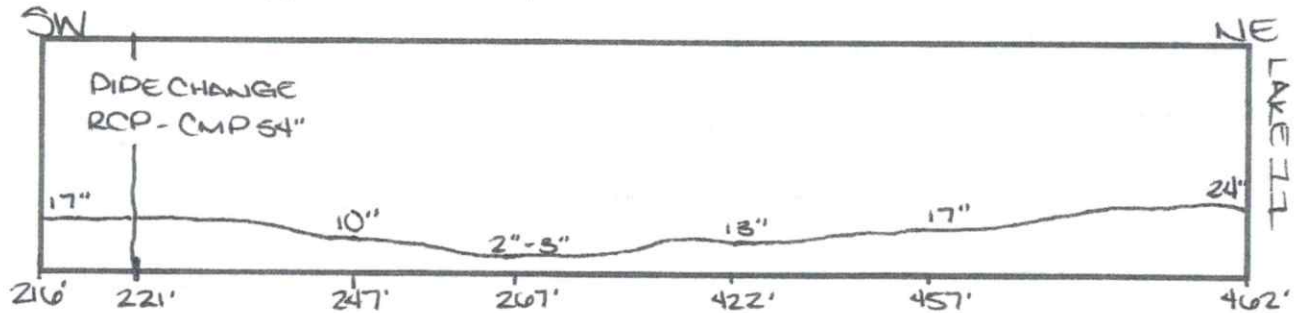
General Condition of Pipe: Diver noted 2" – 2' of sediment throughout the length of the pipe along with moderate growth and minor corrosion. Overall condition of the pipe appears to be good. Diver also noted that the sediment build up at outfall in Lake 11 is natural bottom and is half up the sides of the pipe covering 50%.

**Comments:** Diver noted that the pipe changes from RCP to 54" CMP at 221'.

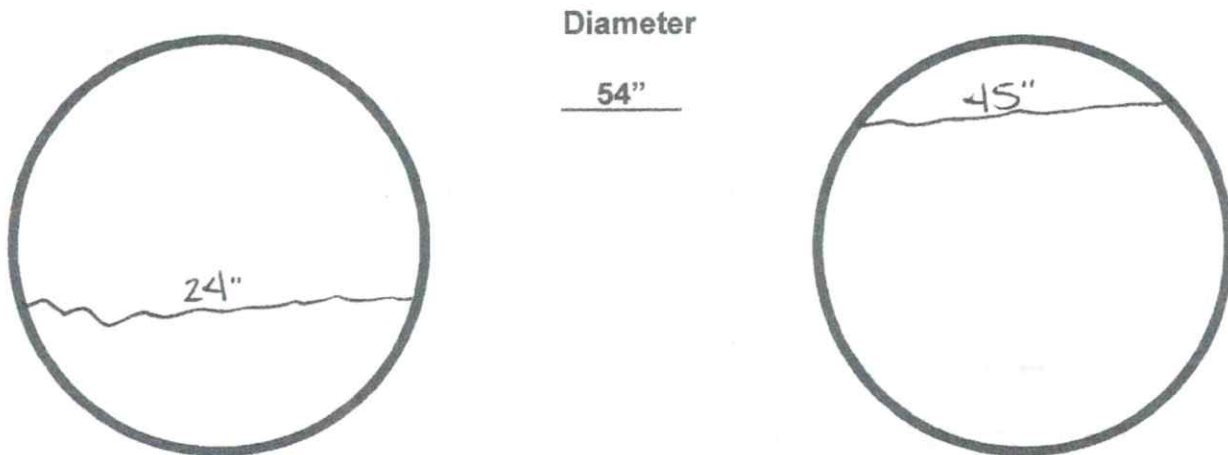
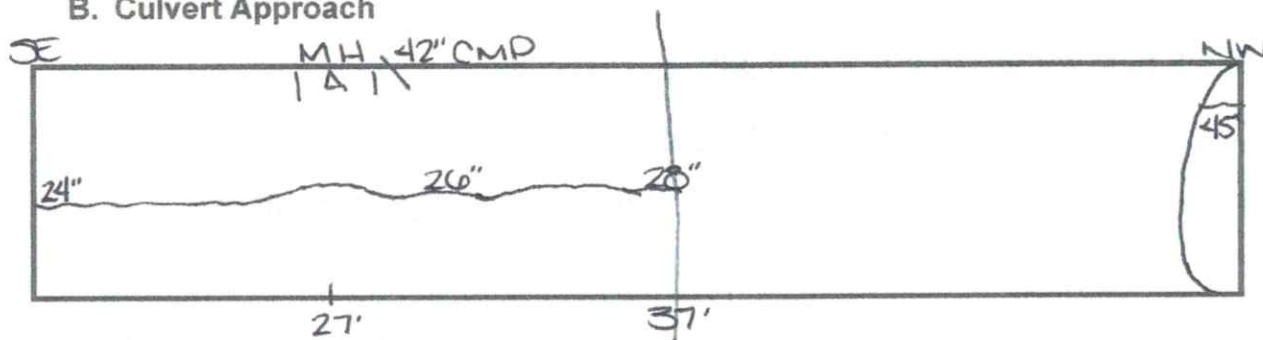
General Condition of Pipe: Diver noted 24" of sediment at the South East outfall along with minor growth. Also noted the pipe changed to 42" CMP after Manhole A. Sediment level rose to 26" after manhole A and continued to rise to 28" at 37' into the pipe. Diver was unable to inspect past 37' due to sediment levels.

**Comments:** Diver located outfall and noted 45\"  
to enter the pipe at the outfall.

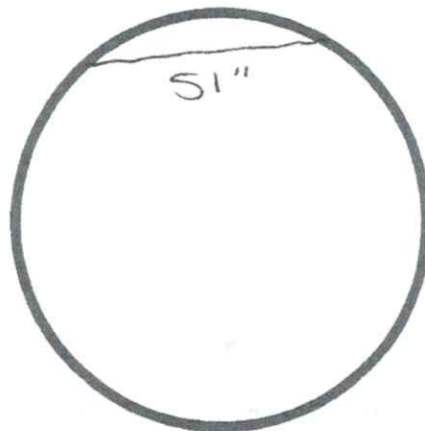
General Condition of Pipe: Dive team noted that the pipe is completely full of mud at the entrance.

**Comments:** Diver located outfall and noted 51" of sediment. Diver was unable to enter the pipe at either end.

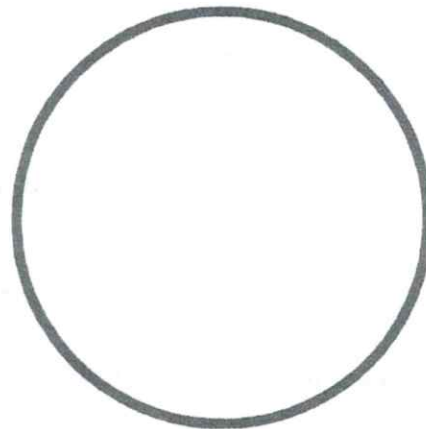
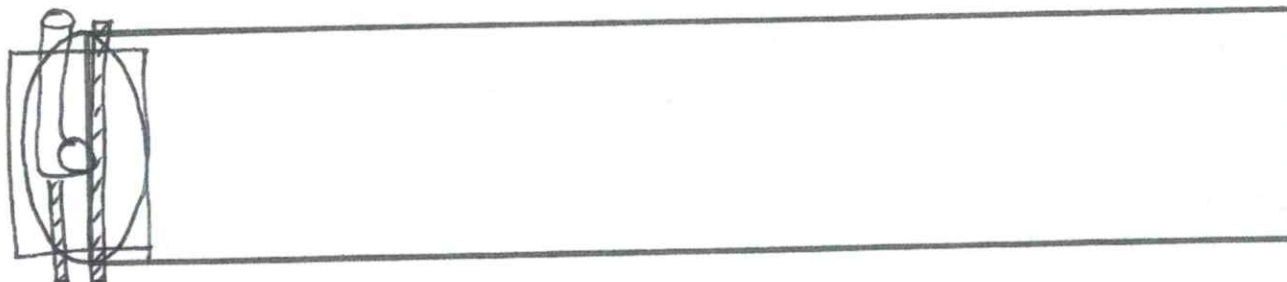
General Condition of Pipe: Dive team noted that the outfall has a homemade control structure. The control structure is not flush against the mouth of the pipe, and is not secured to the pipe. Diver also noted a 4" gap at the 6 O'clock position.

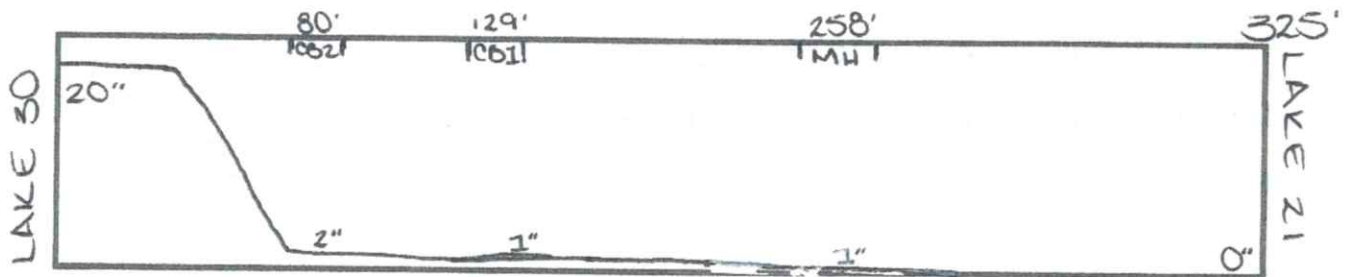
General Condition of Pipe: Diver noted that the pipe has 20" of sediment at the outfall in Lake 30. Also noted 1" of sediment from Lake 21 to CB 2.

**Comments:** Diver noted that the pipe is CMP from Lake 30 to CB1 then turns  
into plastic out to Lake 21.

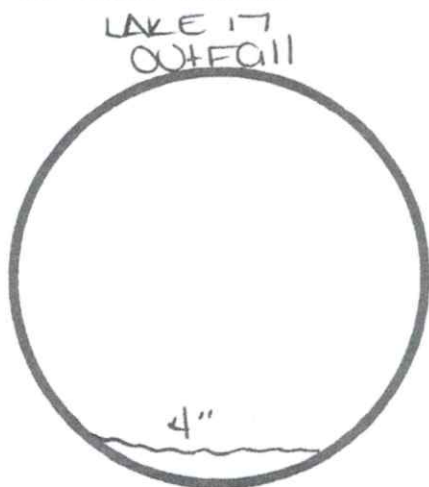
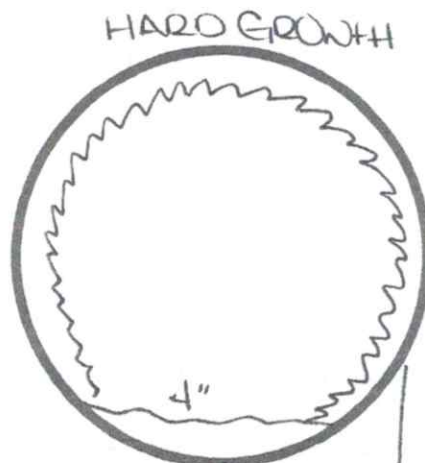
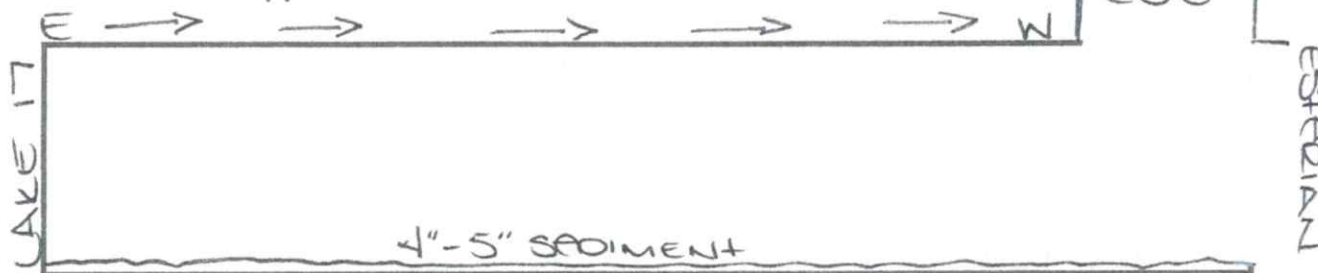
General Condition of Pipe: Dive team noted 4" to 5" of sediment throughout the  
length of the pipe. Dive team also noted excessive hard growth throughout the  
pipe that becomes substantial in the last 50' of the pipe. Other than the hard  
growth the overall condition of the pipe is good.

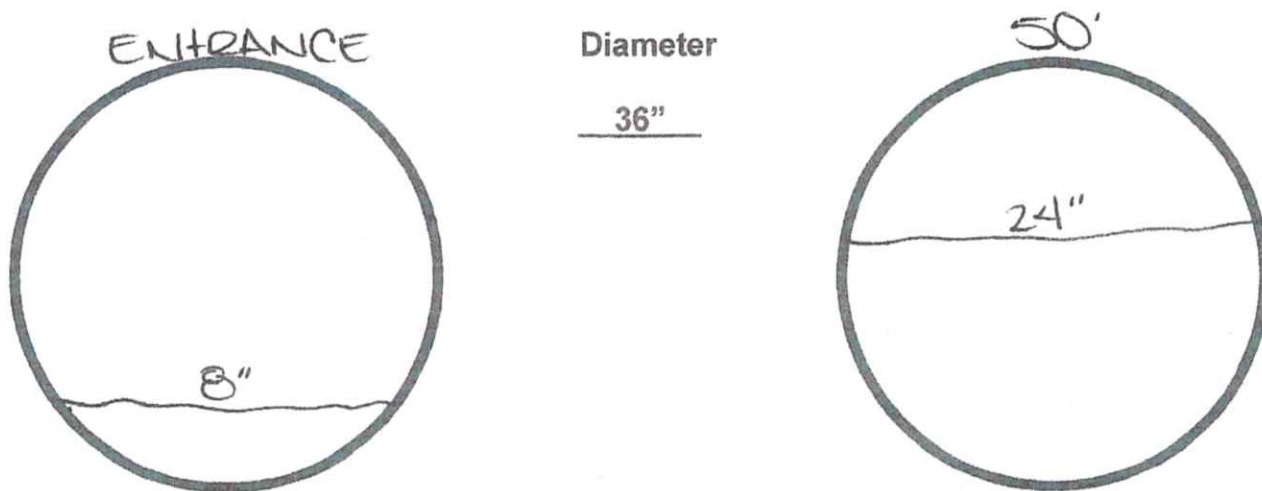
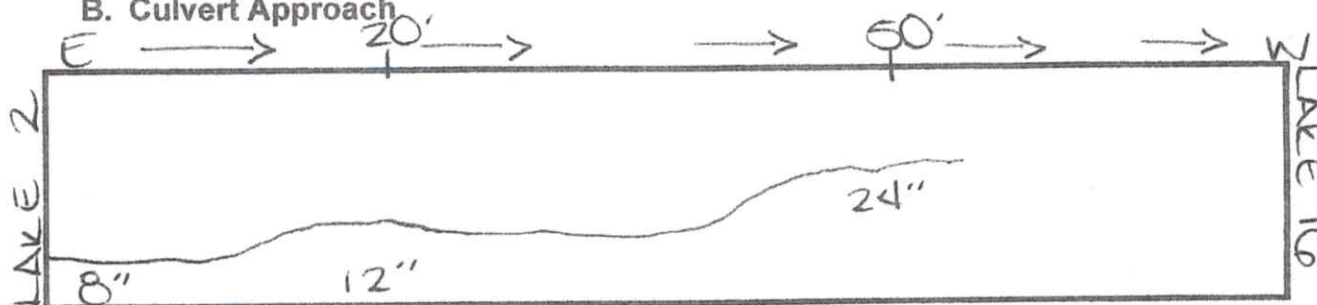
General Condition of Pipe: Dive team noted that the sediment is 8" at the pipe entrance and rises to 1' at the 20' mark. Pipe has very little water flow due to sediment increase at 50". Diver unable to continue past the 50' mark.

Comments: Inspection ended at 50' due to sediment levels.

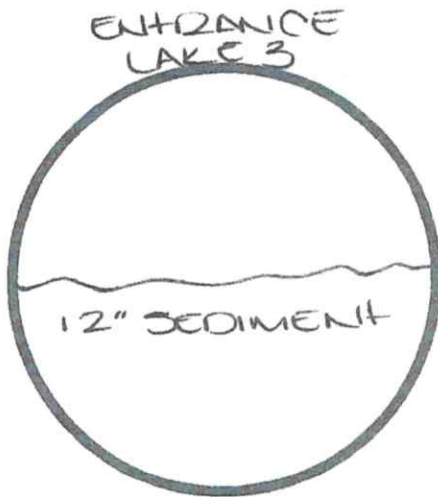
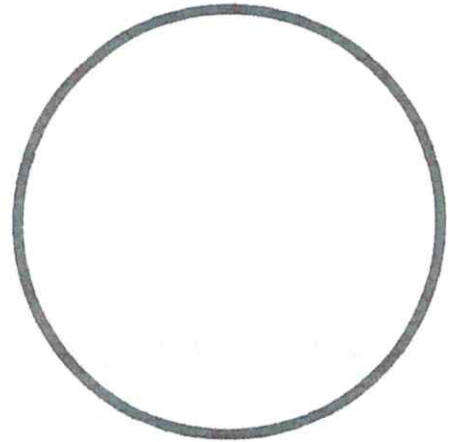
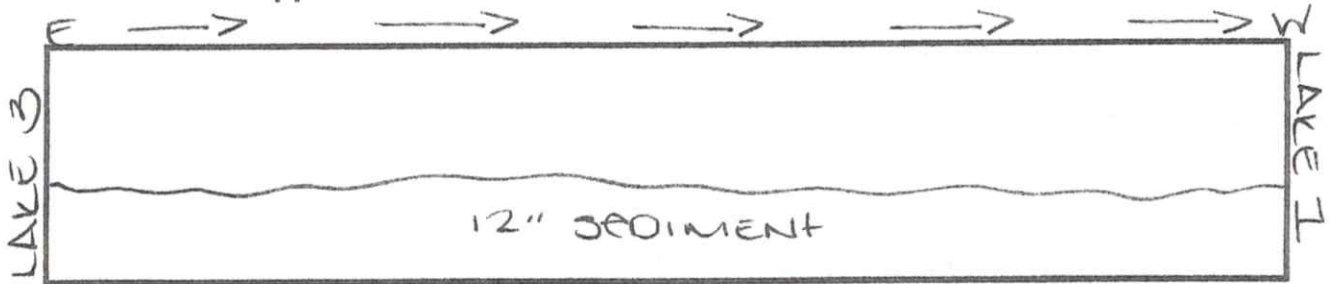
General Condition of Pipe: Dive team noted 12" of sediment.

Comments: Diver unable to inspect pipe due to sediment level.

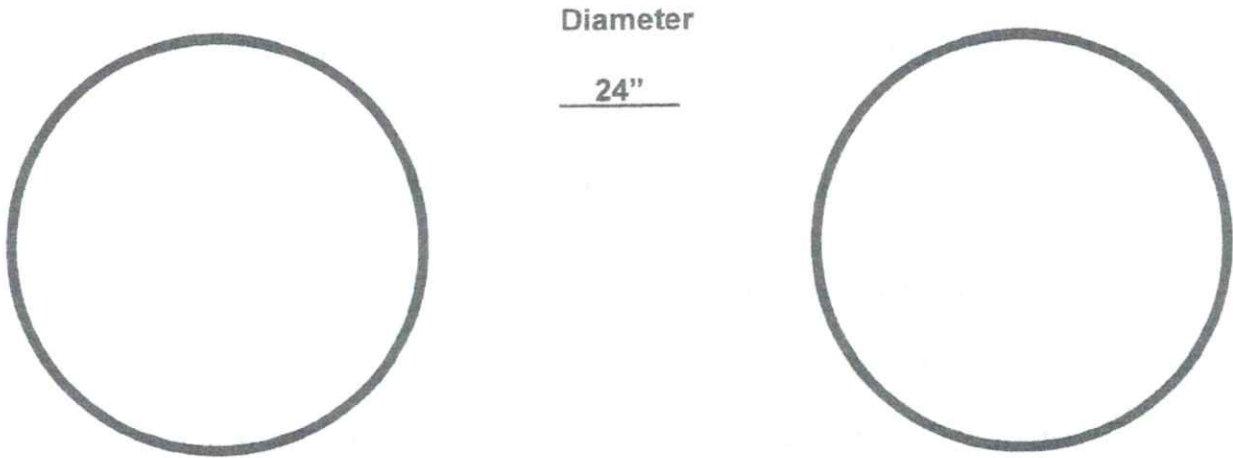
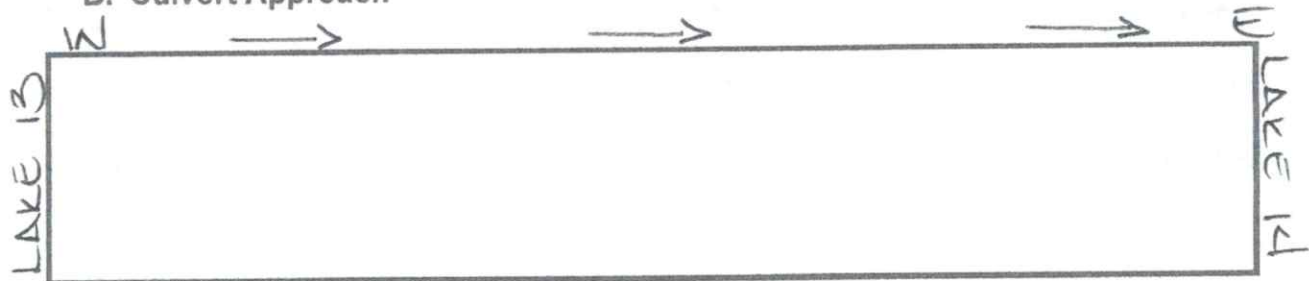
General Condition of Pipe: Dive team noted a steady stream of water coming out of the outfall.

**Comments:** Dive team was unable to penetrate the pipe due to the size.

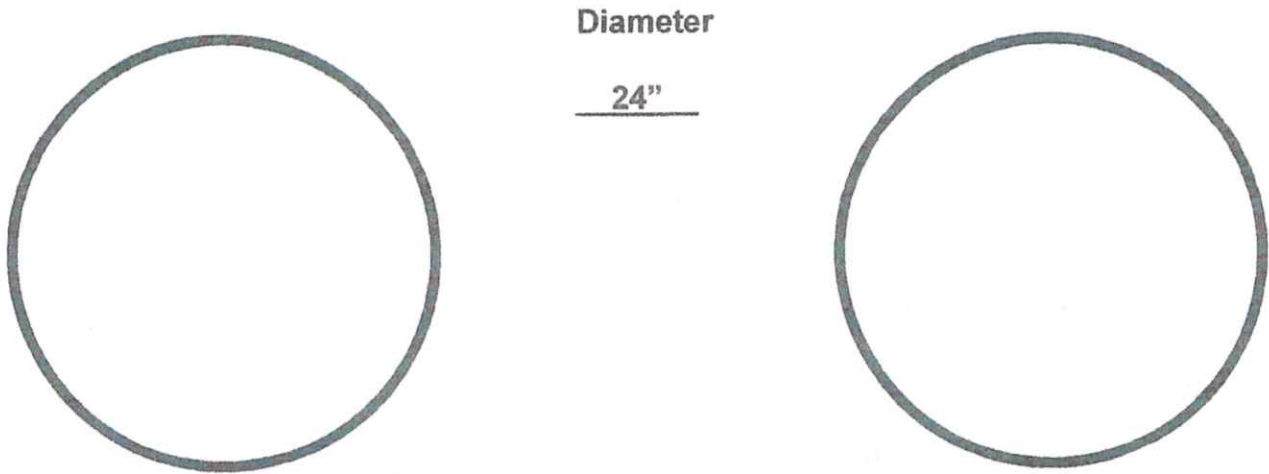
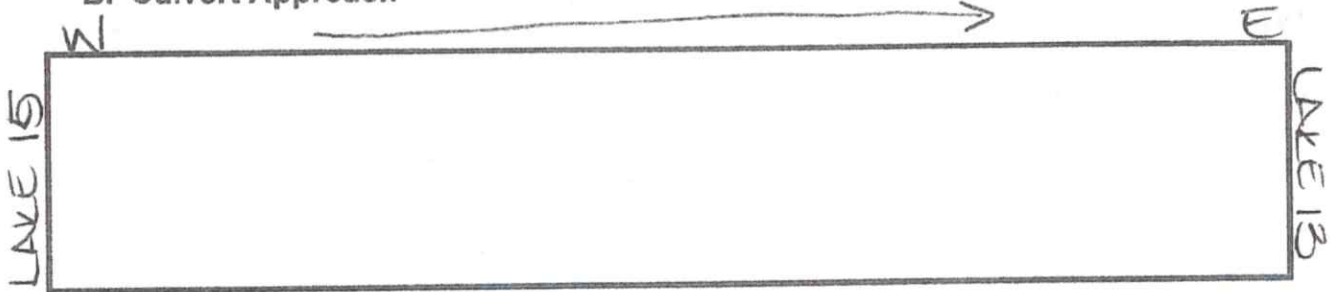
General Condition of Pipe: Dive team noted a steady stream of water coming out of the outfall.

**Comments:** Dive team was unable to penetrate the pipe due to the size.

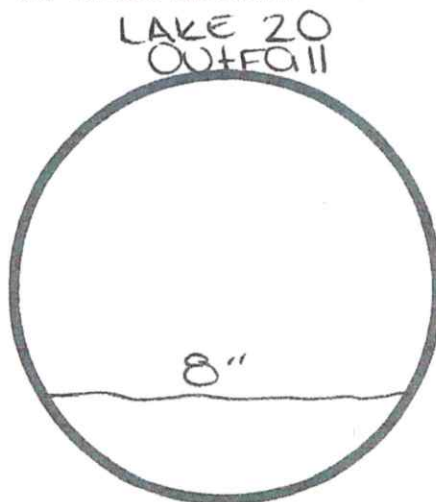
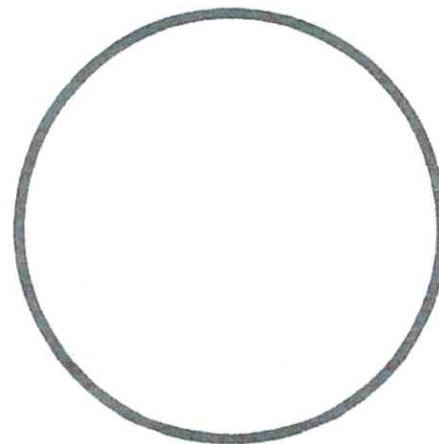
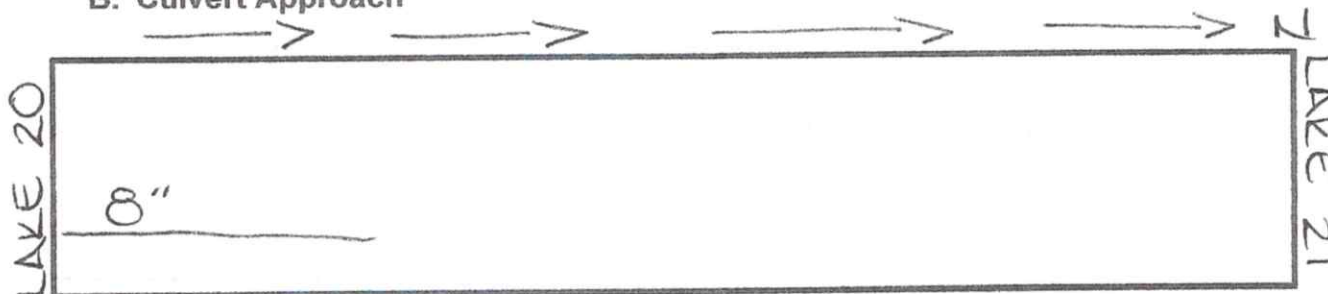
General Condition of Pipe: Dive team noted 8" of sediment at the entrance of the pipe. Also noted a strong water flow at the outfall.

Comments: Dive team unable to penetrate the pipe due to size and sediment.

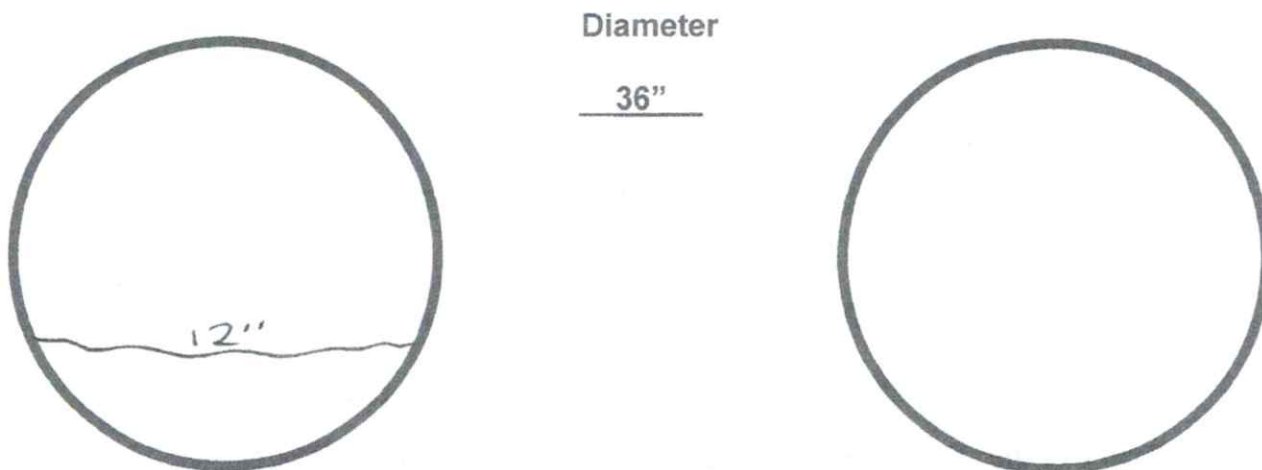
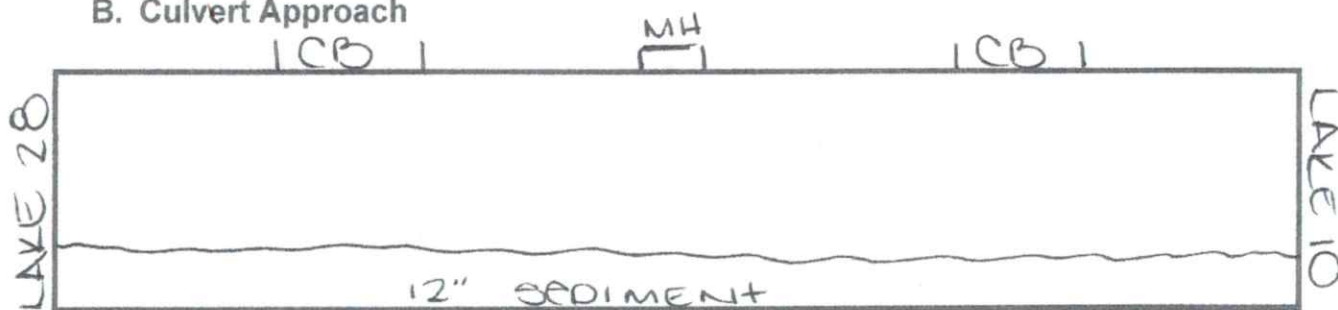
General Condition of Pipe: Dive team noted 12" of sediment throughout the  
length of the pipe. Overall condition of the pipe is good. No damage or  
obstructions with good water flow.

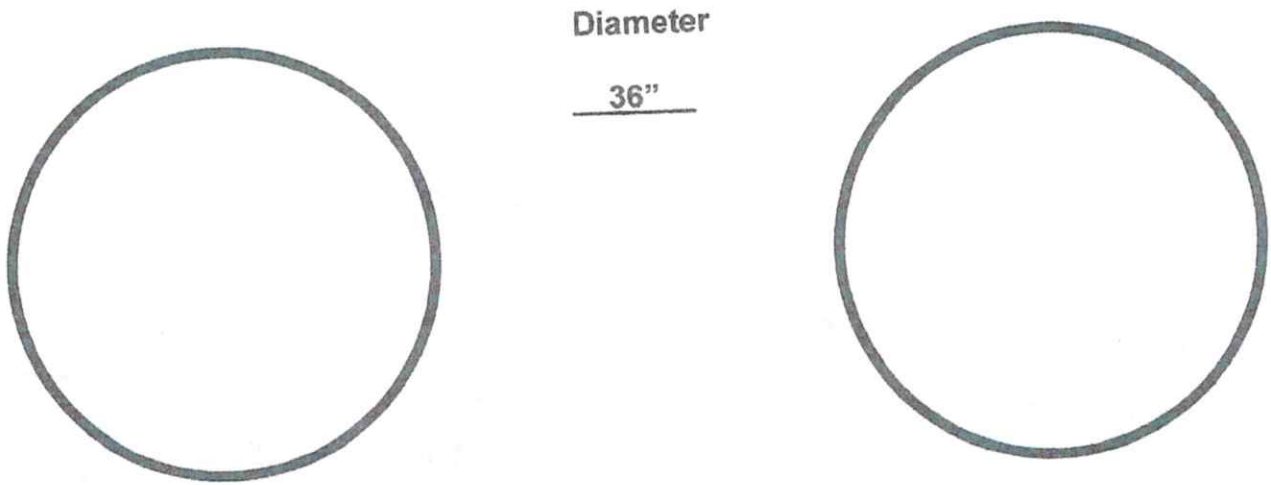
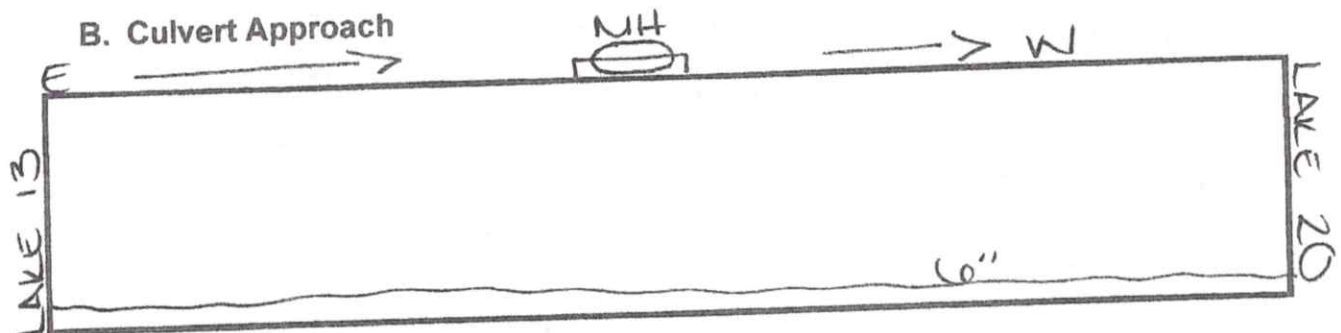
General Condition of Pipe: Dive team noted 4" to 6" of sediment throughout the  
length of the pipe. Overall condition of the pipe is good with no damage or  
obstructions.

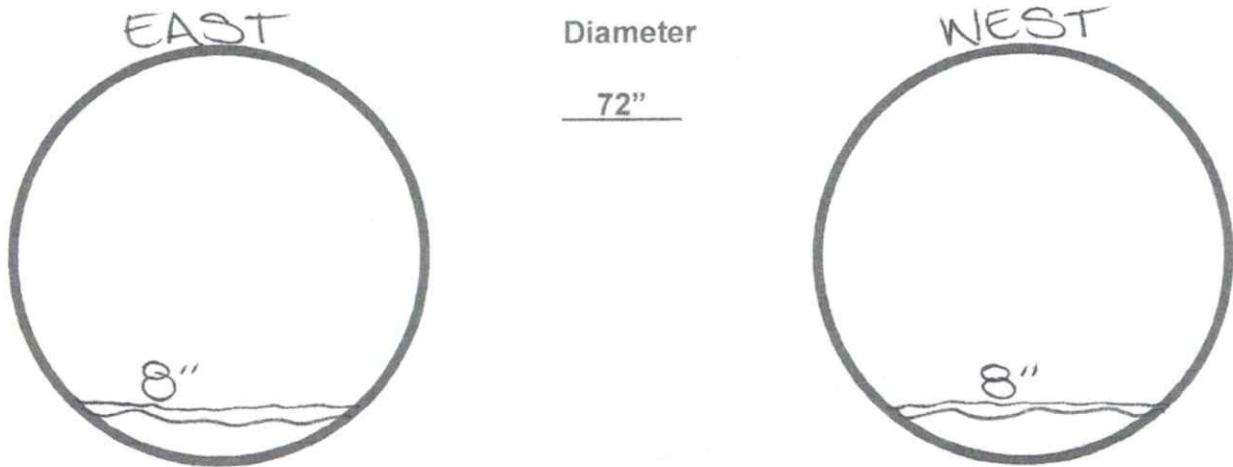
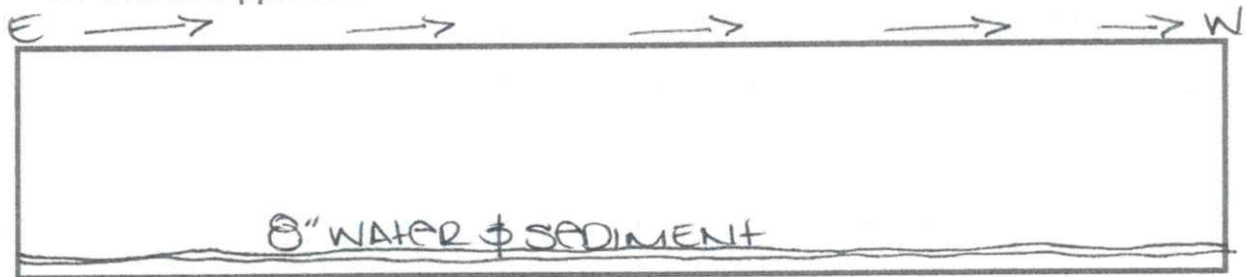
General Condition of Pipe: Dive team noted that the Pipe has only 8" of water in both the east and west pipes with 8" of sediment at the entrance. Both pipes are in overall good condition with no obstructions.

**Comments:** No video due to the pipe being dry.

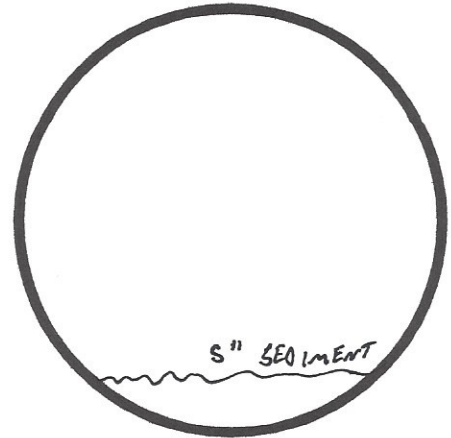
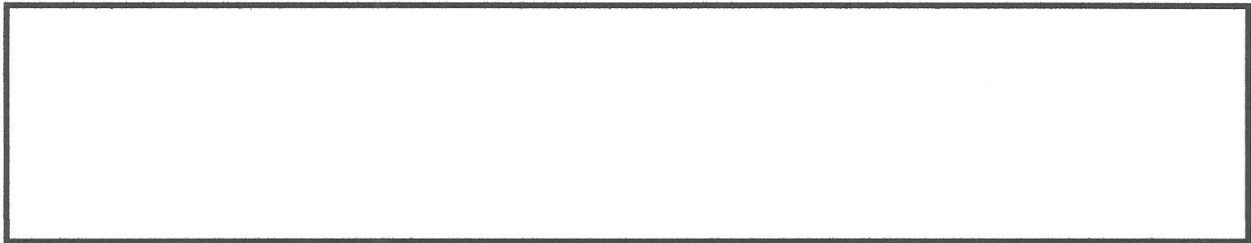
General Condition of Pipe: South side of pipe in Lake 16 is crushed and diver is unable to enter. Crushed area of pipe is 4ft with the top crushed downward. The pipe feels loose and is able to be moved by hand.

Comments: Inspection of Pipe called off due to diameter of pipe, and  
crushed outfall the dive could not be performed safely.

**Damaged E L16-L1 pipe to be inspected**

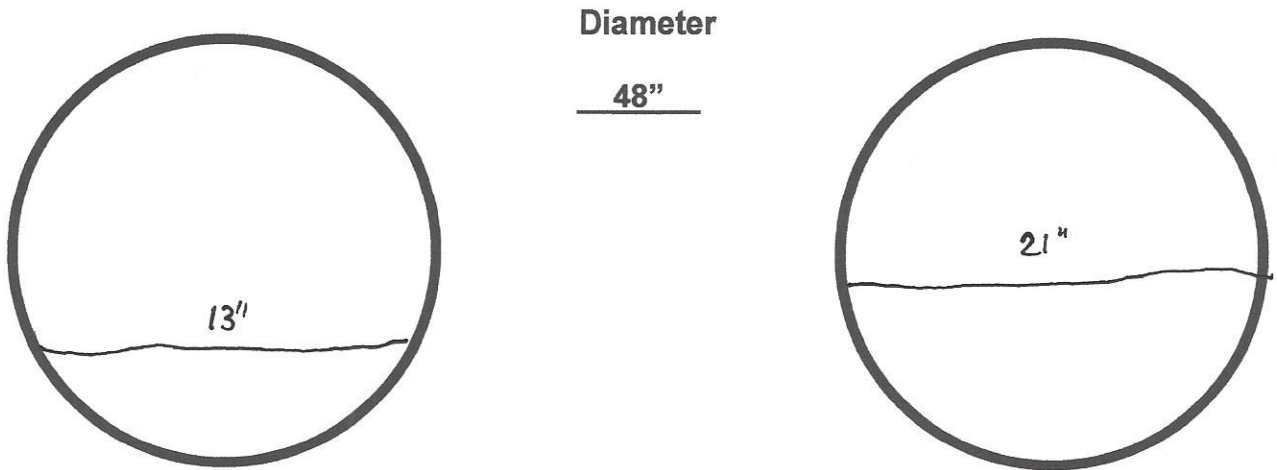
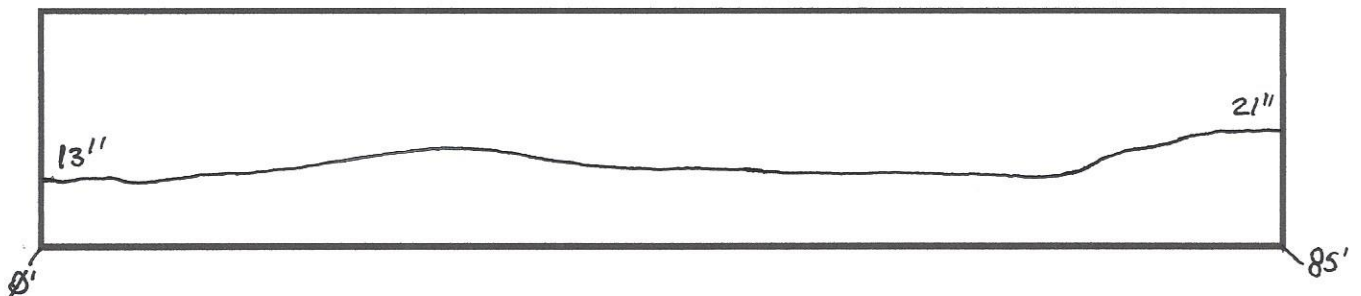
General Condition of Pipe: Pipes are in Good Condition with no major deficiencies. The South pipe is CMP with a diameter of 48" running from East to West and has a length of 85'. The sediment level inside the south pipe is 11" at running from East to West and has a length of 85'. The sediment level at the entrance to the North pipe is 13" and 21" at the exit.

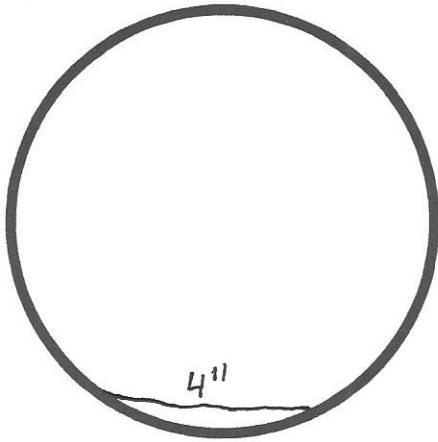
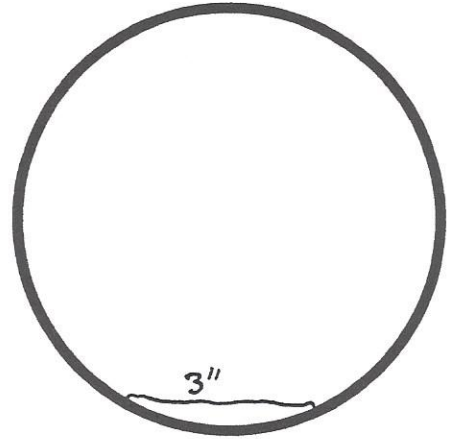
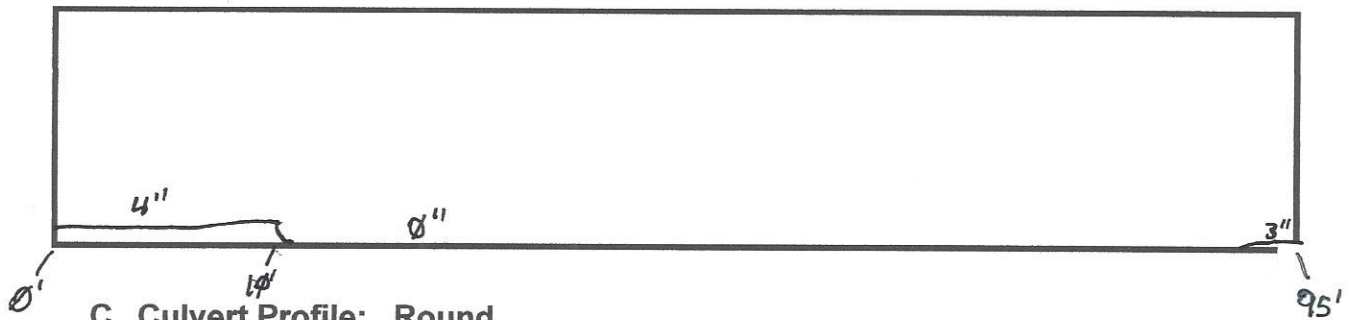
General Condition of Pipe: Pipes were found to be in good condition with no major deficiencies. South pipe is CMP, 52" in diameter and 90' in length. South pipe has minimal marine growth and has a sediment level of 3" consistent throughout the pipe, no deficiencies were noted. North pipe is CMP with a diameter of 52" in diameter and 90' in length. North pipe has minimal marine growth and has a sediment level of 4" dropping to 0" at 10' in the pipe. Sediment level rise to 3" at the outfall of the pipe, no deficiencies were noted.

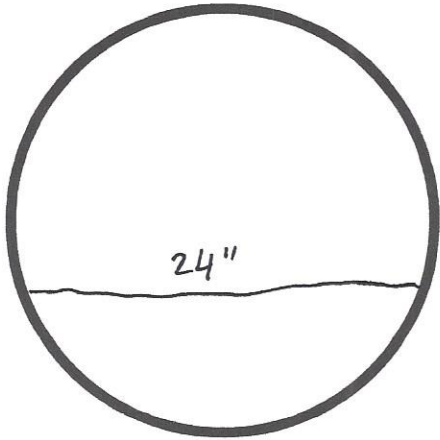
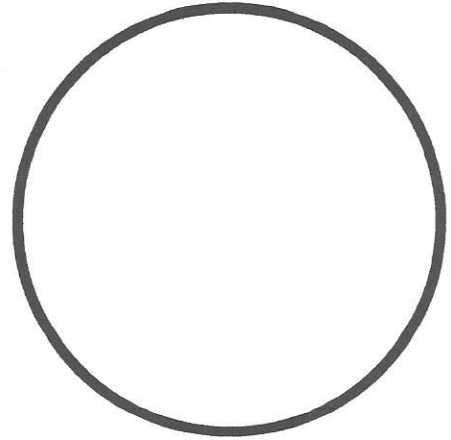
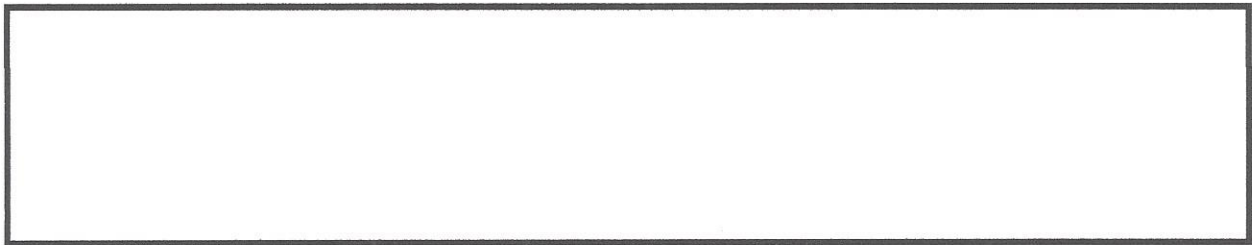
General Condition of Pipe: Entrance to Pipe has 24" of sediment. Diver was  
unable to enter the pipe due to mangroves blocking the entrance.

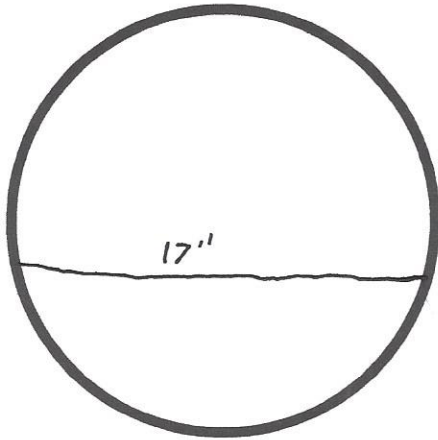
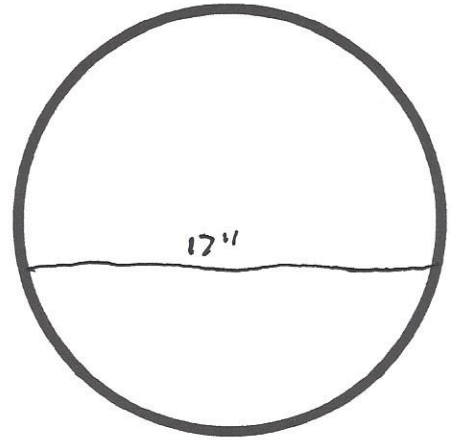
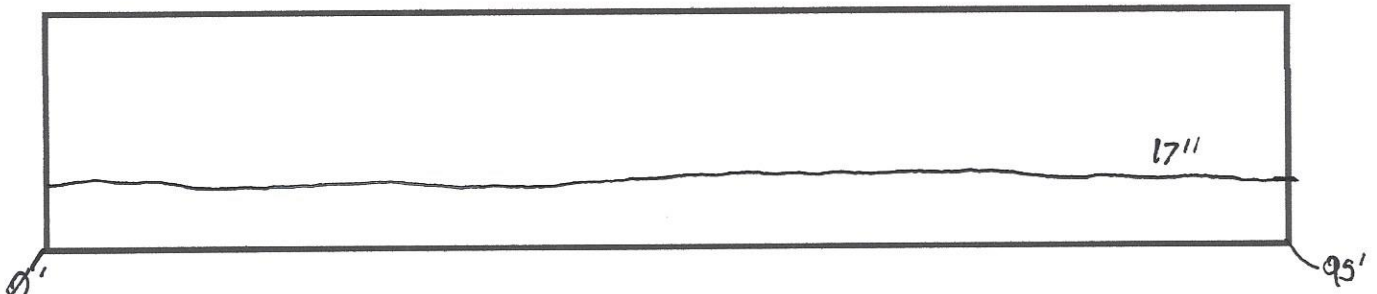
General Condition of Pipe: Location # was found to be a double bore pipe. The  
west Pipe and East pipe were found to be very similar in that they both Have a  
diameter of 72", a length of 95', a sediment level of 17", and are both CMP.
