## APPENDIX E

### SHENANDOAH PIPING REPORT

## **Pond Interconnection and Estuary Culvert Inspection Report**

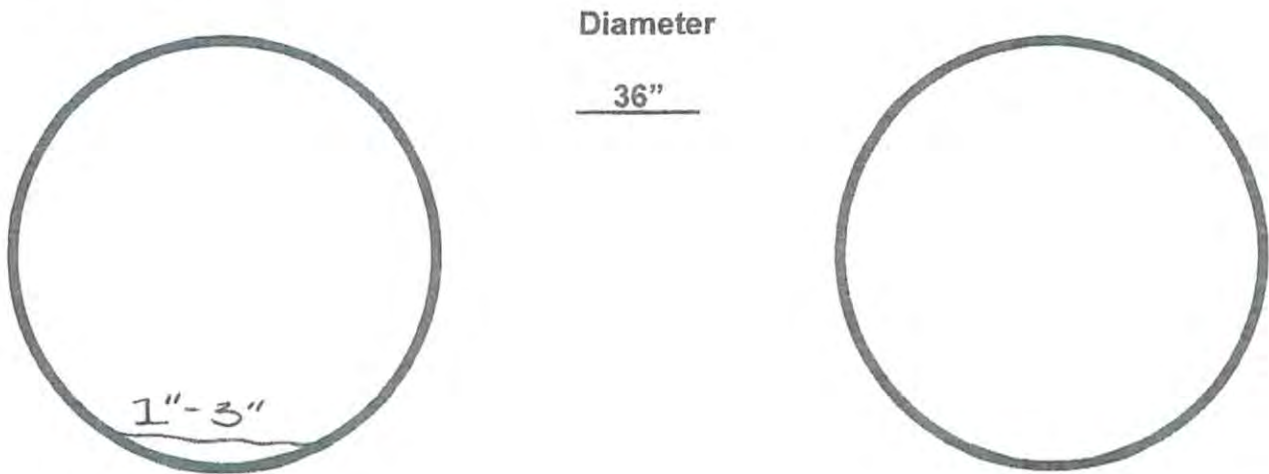
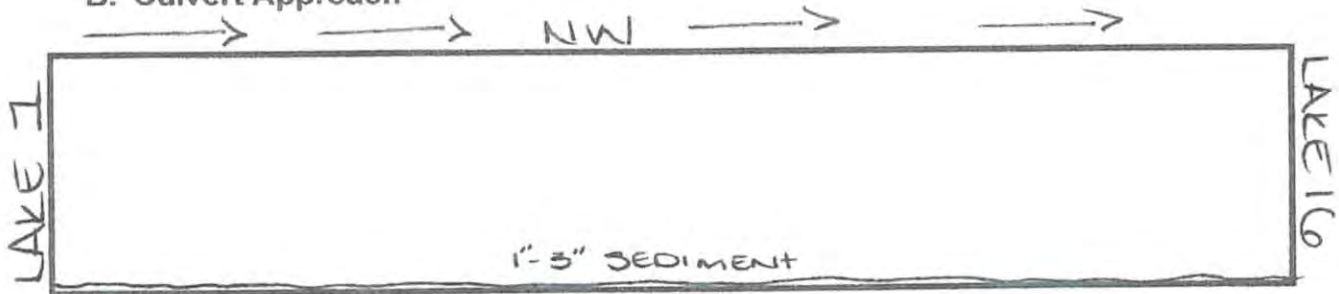
General Condition of Pipe: Dive team noted 1 to 3 inches of sediment throughout the pipe. Overall condition is good with no debris or obstructions.

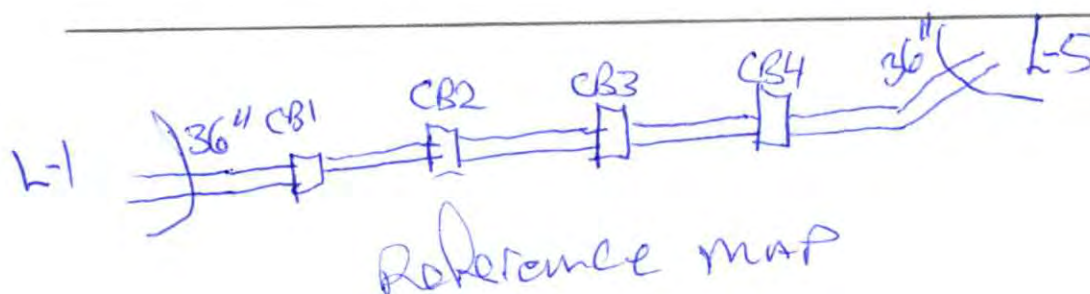
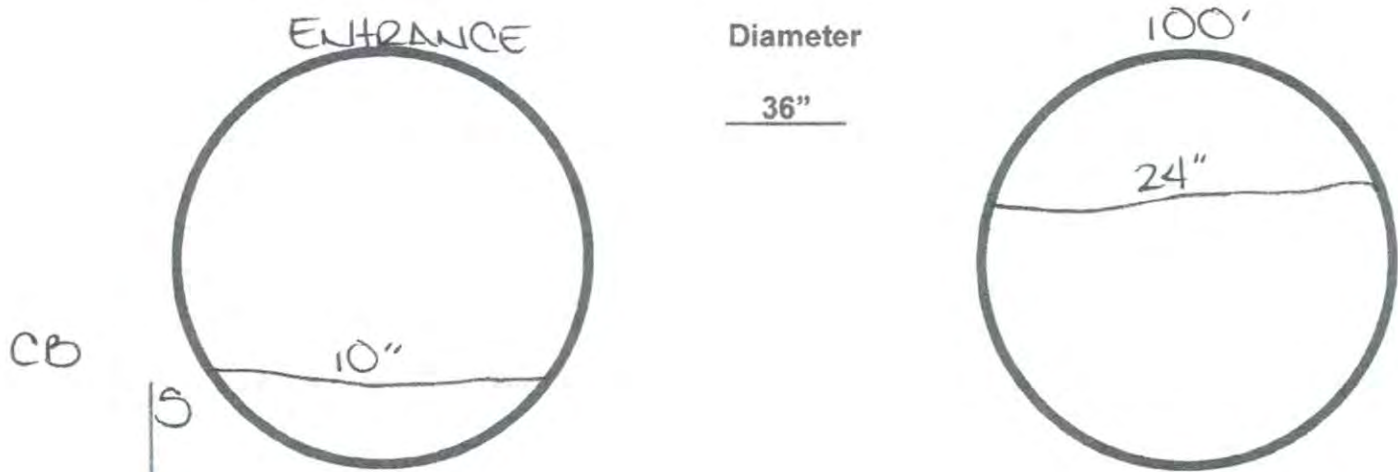
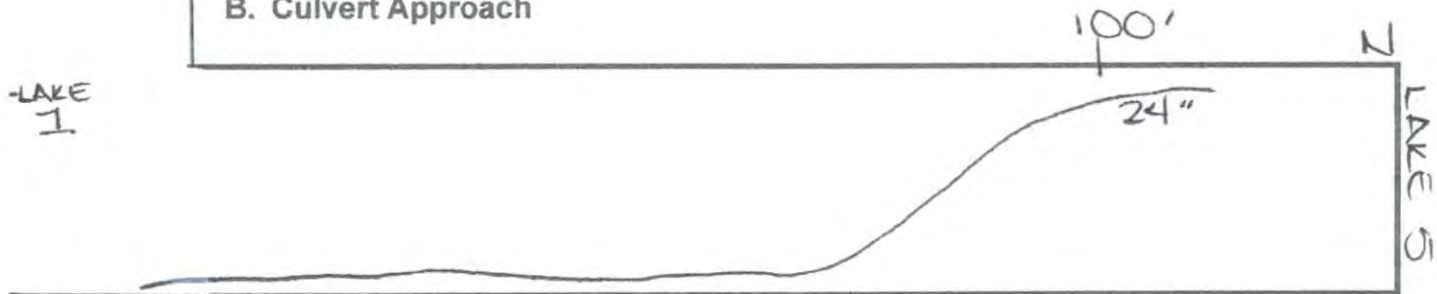
General Condition of Pipe: Dive team noted 10" of sediment at the entrance of the pipe. Slight sediment increases at catch basin 2. Catch basin 2 is in overall good condition. Sediment decreased to 2" to 8" after catch basin 2. At 100' into the pipe the sediment rose to 24". Dive is unable to further inspect the pipe due to clog at 100'.

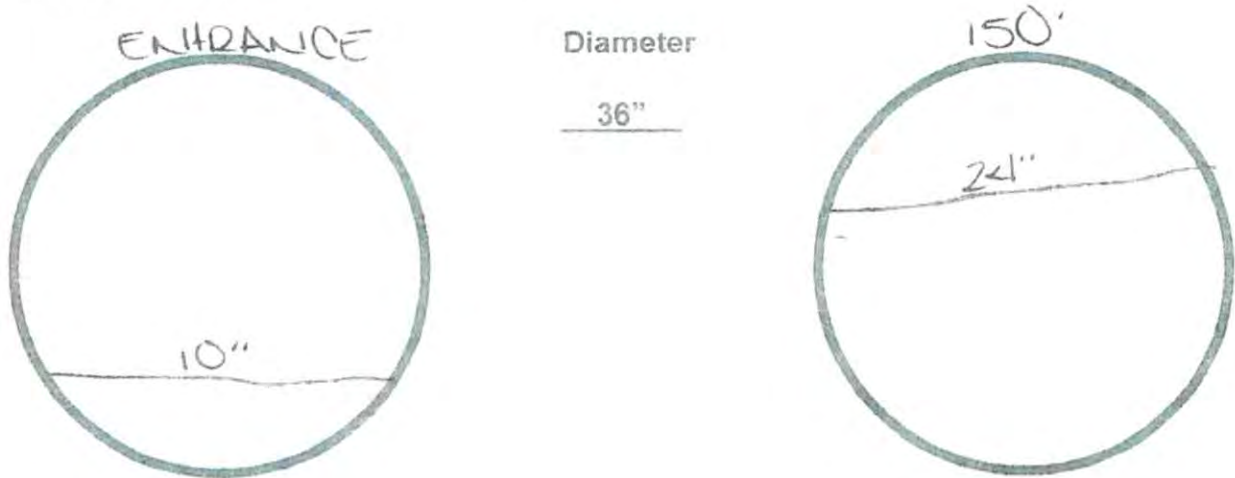
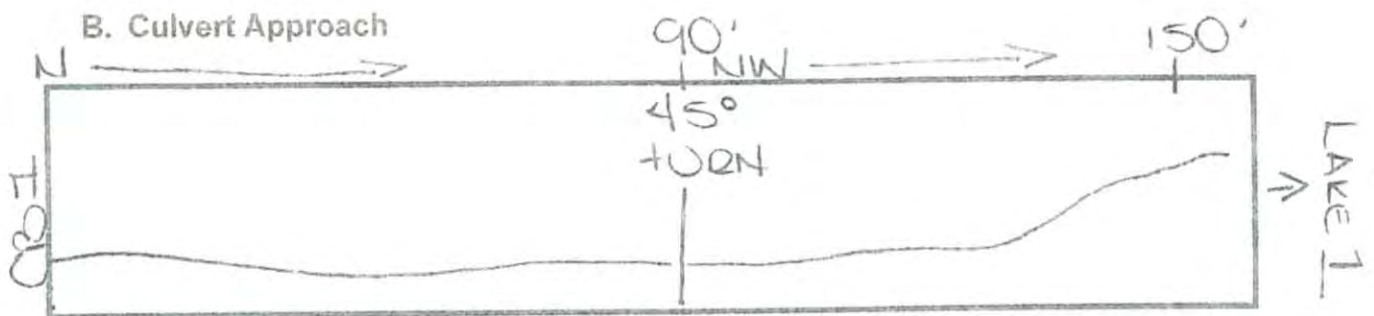
General Condition of Pipe: Dive team noted 10" of sediment at the entrance of the pipe. At 90' the pipe turns 45 degrees towards the North West. At 150' the sediment level rose to 2' diver unable to continue inspection due to the sediment levels.

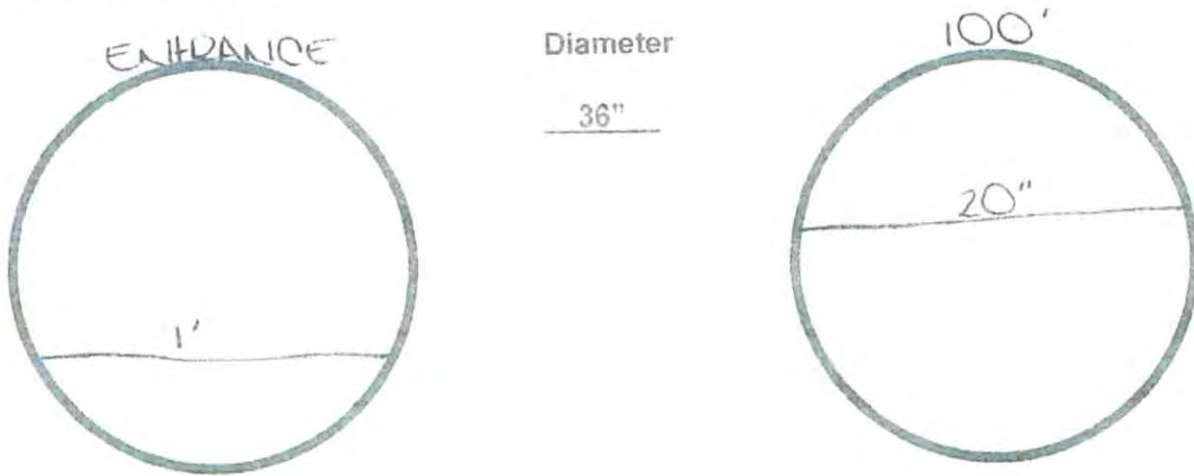
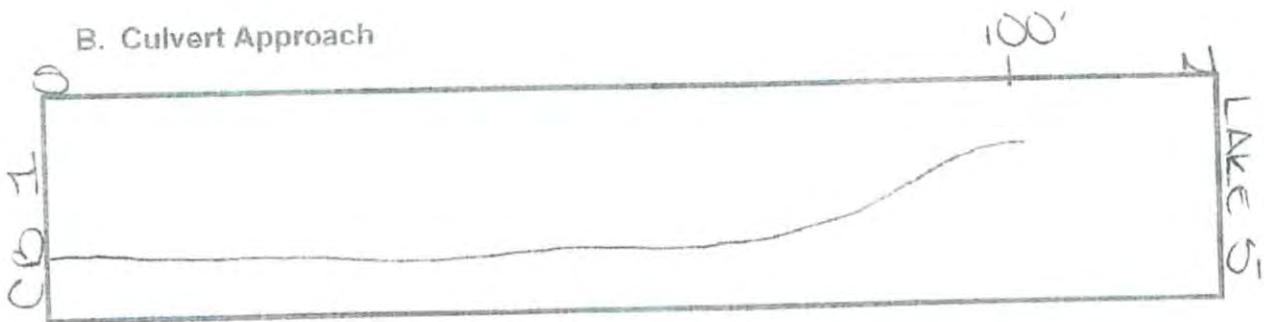
General Condition of Pipe: Dive team noted 1' of sediment at the entrance of the pipe. Slight sediment increases at CB2, CB2 in good condition. Sediment decreased after CB 2 to 8". Sediment increased to 20" at 100'. Diver unable to continue the inspection from this end. Overall condition of the pipe is good. Good water flow through the pipe.

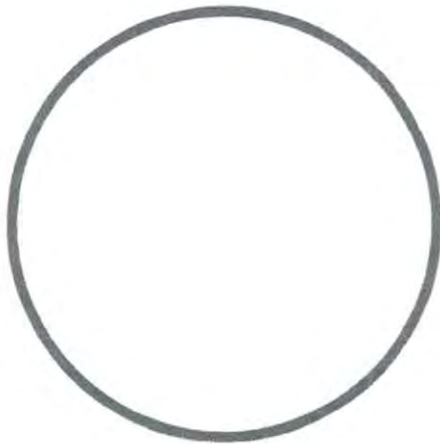
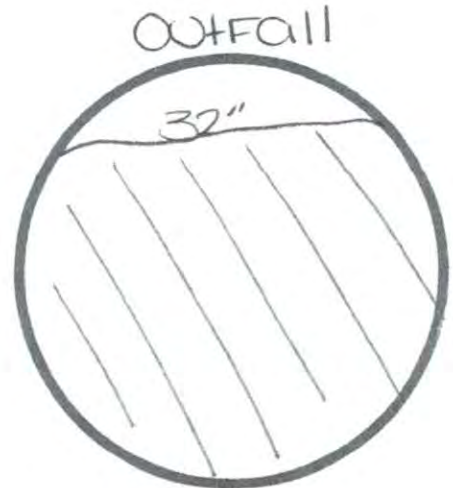
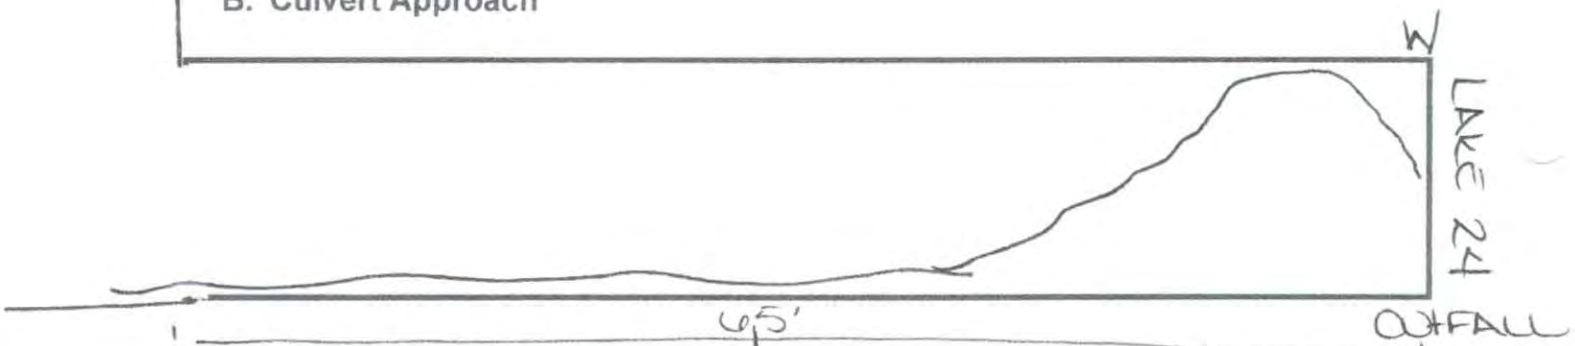
General Condition of Pipe: Dive team noted that the Pipe is clogged at the outfall in lake 24. Diver was able to make it to the outfall but was unable to exit. Lake 24 outfall pipe flows east to CS #6 at Mangrove estuary.

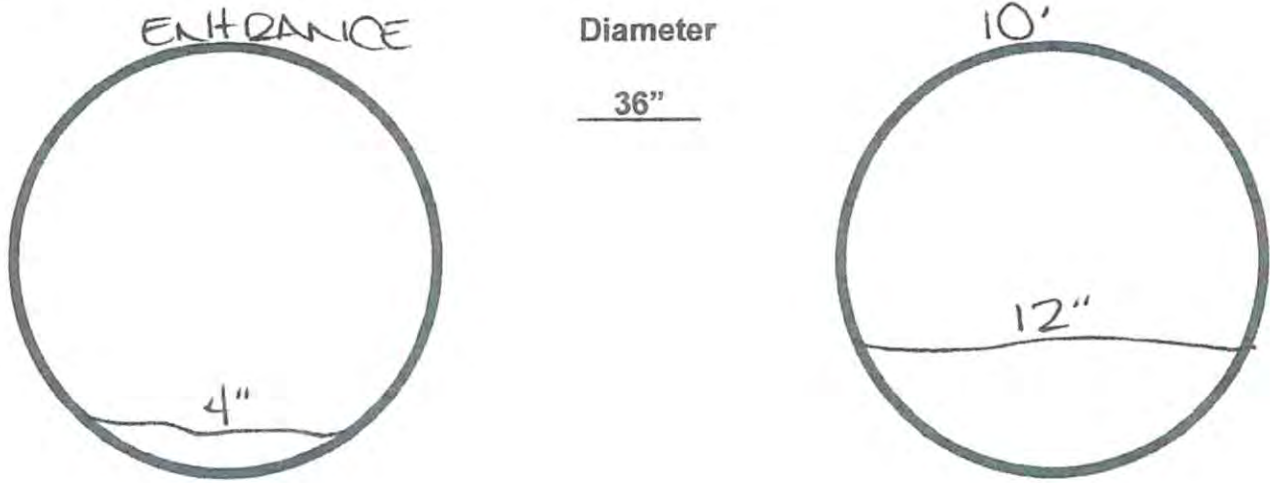
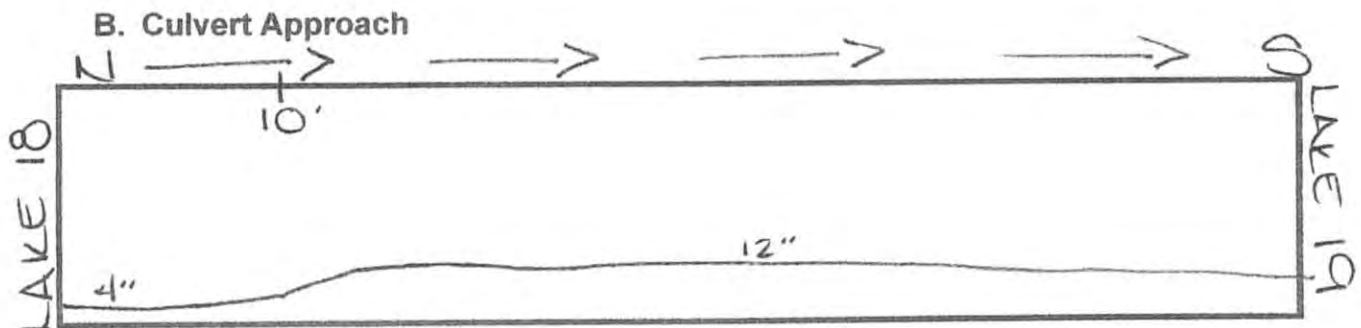
General Condition of Pipe: Dive team noted 4" of sediment at the entry of the  
pipe. Sediment level increases to 12" 10' into the pipe. Overall condition of the  
pipe is good.

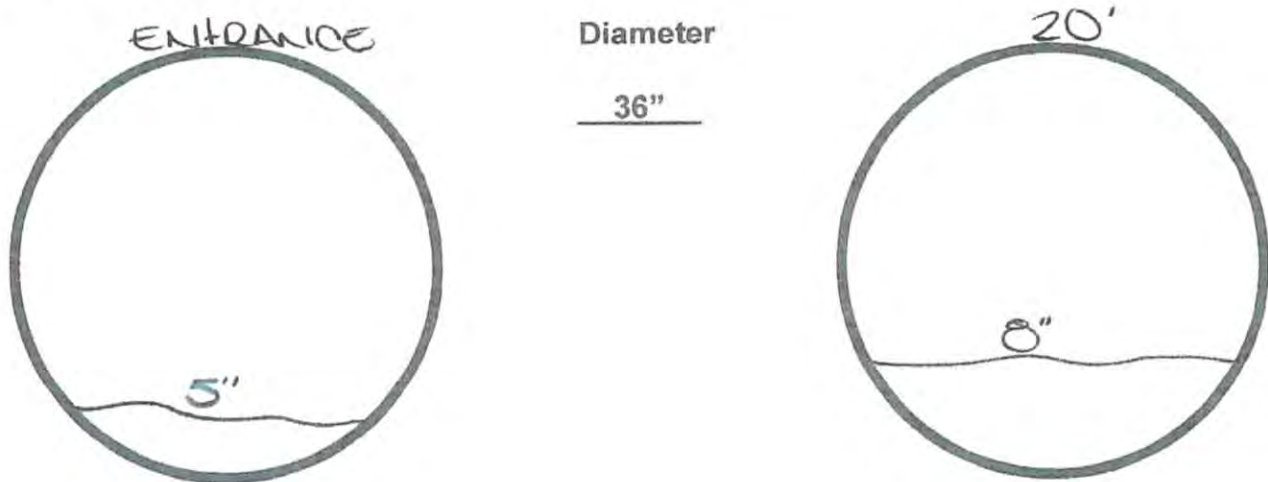
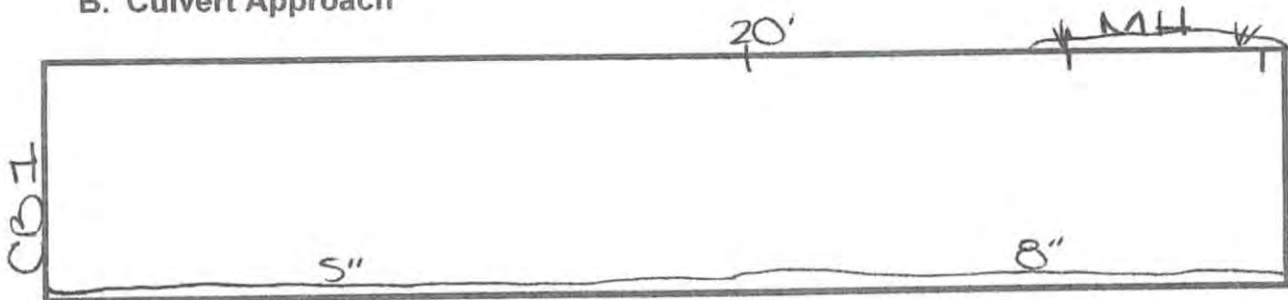
General Condition of Pipe: Dive team noted 5" of sediment at the entrance of the pipe. Sediment increasing at approximately 20' into pipe to 8" – 10". Diver arrived at a manhole that was not accessible from the top side due to overgrowth.

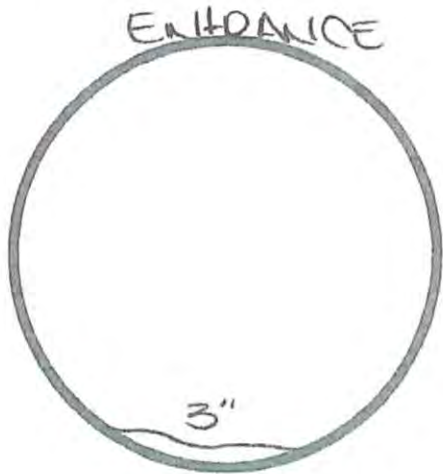
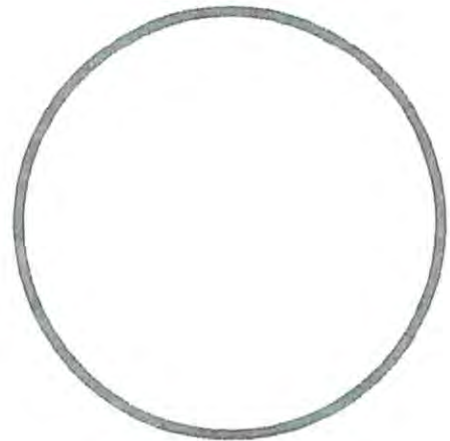
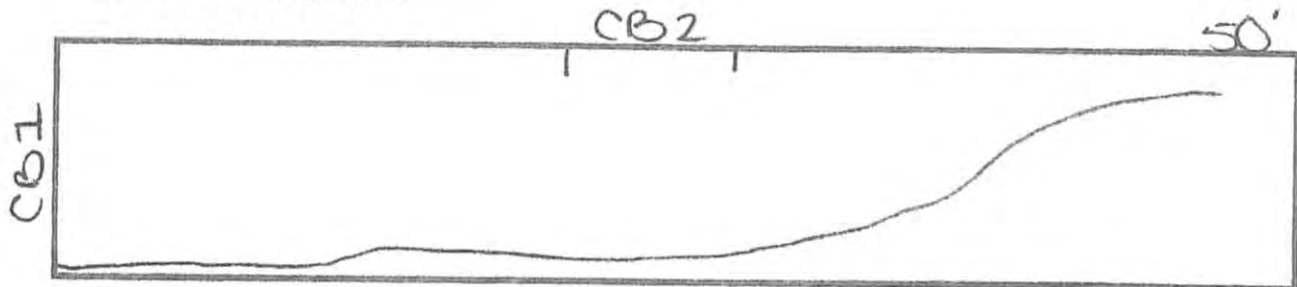
General Condition of Pipe: Dive team noted 3" of sediment at the entrance of the pipe. Catch Basin 2 is in overall good condition. Sediment increased to 8" – 10 " after CB 2 and continues to increase. Diver unable to continue inspection at the 50' mark due to sediment. The sediment throughout the pipe is a mixture of sand and shell.

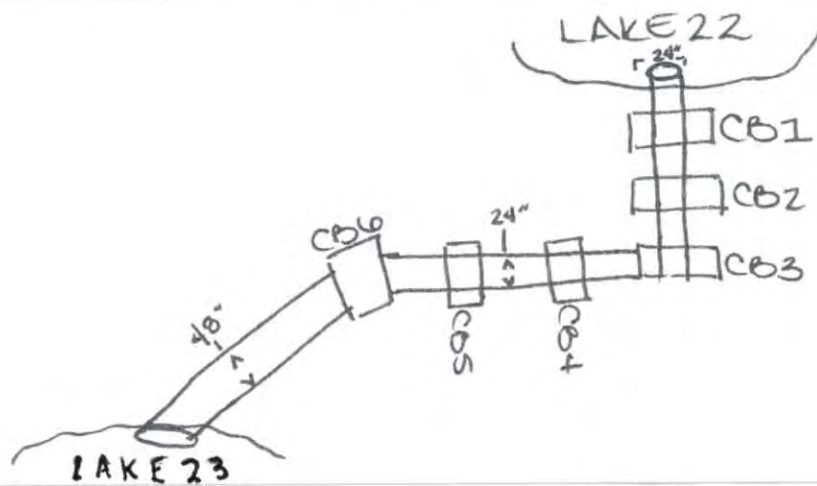
General Condition of Pipe: Diver noted 4" of sediment throughout the length of the pipe. Overall condition of the pipe is good with no damage or obstructions.

Comments: Diver noted that Lake 22 connects to Lake 23 through a series of  
6 catch basins. The outfall in Lake 22 is a 24" pipe that runs through the first 5  
catch basins. Dive was unable to inspect due to size.

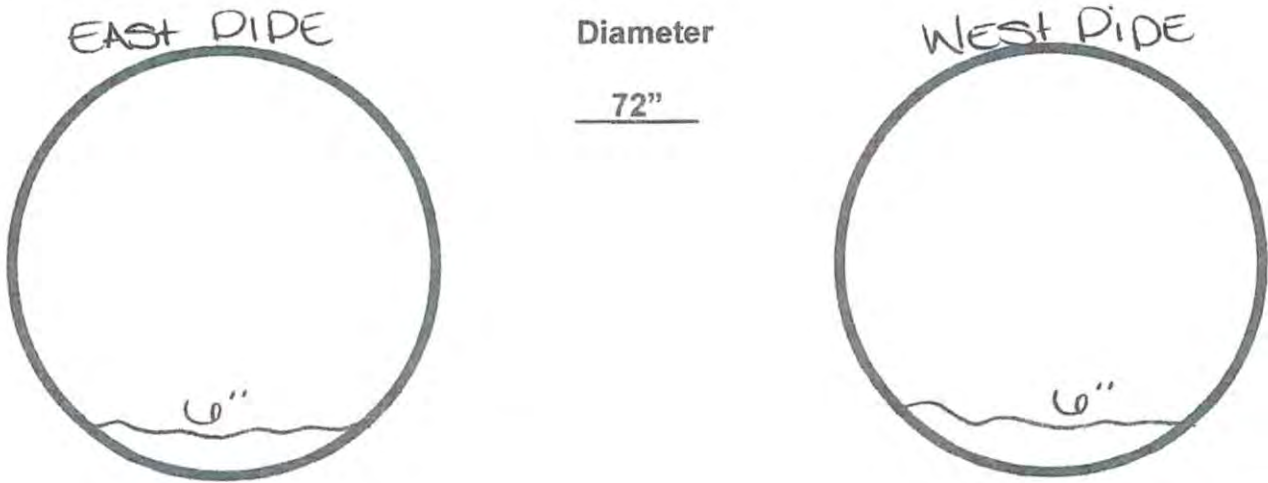
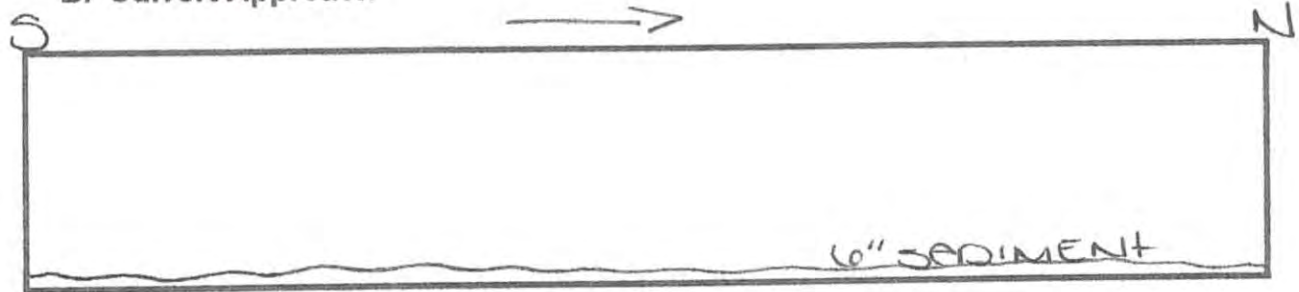
General Condition of Pipe: Dive team noted 6" of sediment throughout the length of both pipes. Overall condition of the pipes is good with no damage, or obstructions.

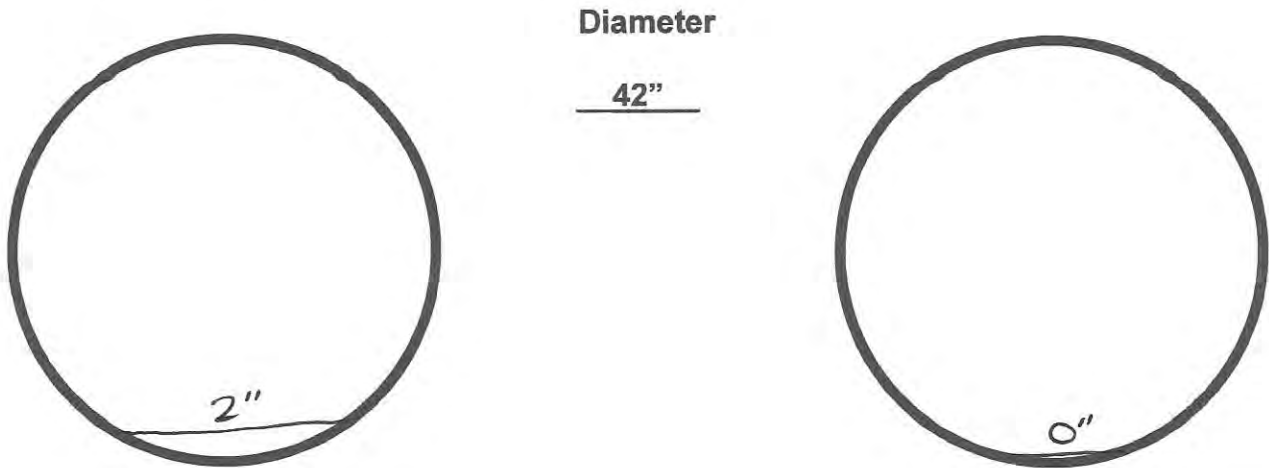
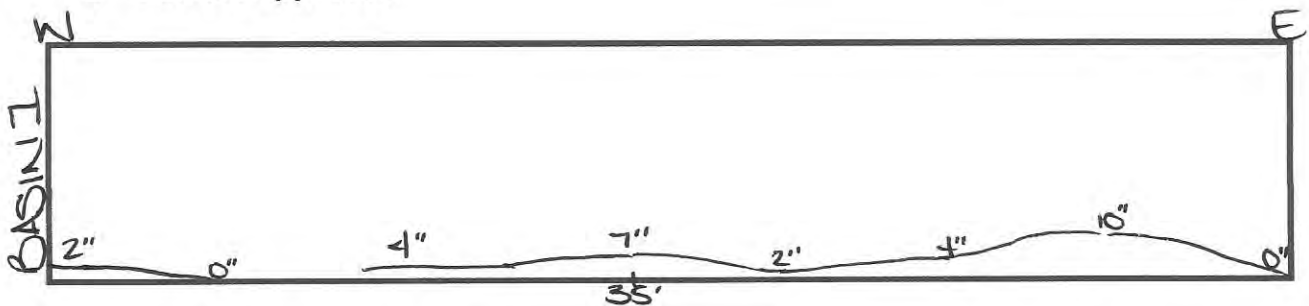
General Condition of Pipe: The mouth of pipe to basin 1 is 69' running South-West. Sediment buildup at the mouth is 2" then drops to 0" with no marine growth. Pipe Transitions from CMP to RCP at basin 1. Basin 1 is an RCP pipe with 1" of sediment with no marine growth. Basin 1 to MH2 is 100' running North-West. Sediment in structure at MH2 is 4" deep. Sediment increases to 7" deep at 35'. MH2 to MH3 is a 122' RCP pipe that runs North-West with a diameter of 42" and a sediment level of 2". Sediment level at MH3 structure is 6" deep. MH3 to basin 4 is a 133' long RCP pipe running South-East, and has a diameter of 42" with no 0" of sediment. At 73' Sediment increases to 4", Pipe has no Marine Growth. Basin 4 has a Sediment level of 10". Basin 4 to Basin 5 runs South-East for 157'. The RCP from basin 4 to basin 5 is 42" in diameter with a sediment level of 11" with no marine growth. Basin 5 has a sediment level of 12". Basin 5 to basin 6 South-East for 101', it is an RCP pipe with a diameter of 42", it has a sediment level of 4" and no marine growth. Basin 6 to Basin 7 is an RCP pipe that runs for 273' South-East, it is 42" in diameter with a sediment level of 13" and no marine growth. Basin 7 has a sediment level of 4" with two pipes connecting. The pipe to the left of diver runs North-East and is an RCP with a sediment level of 0".

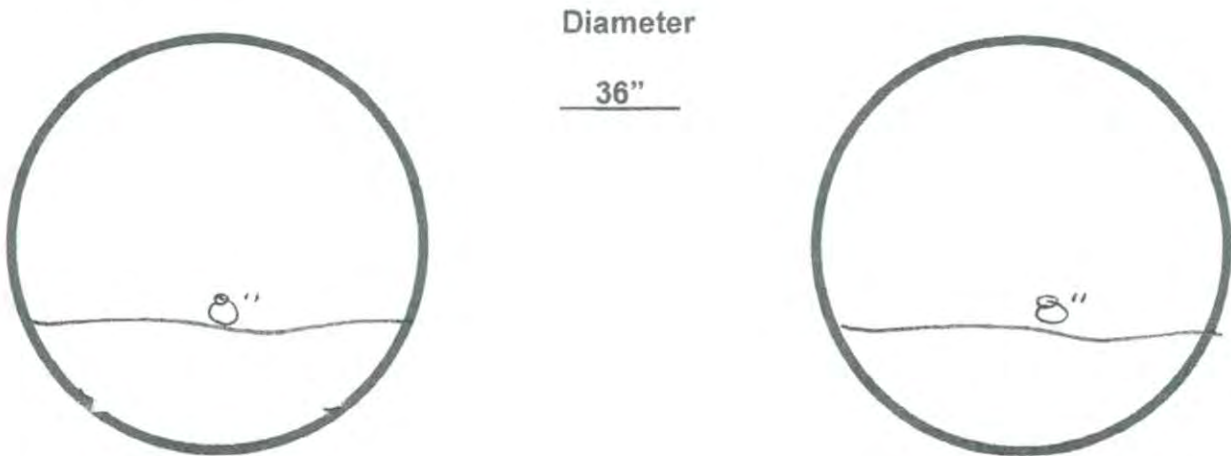
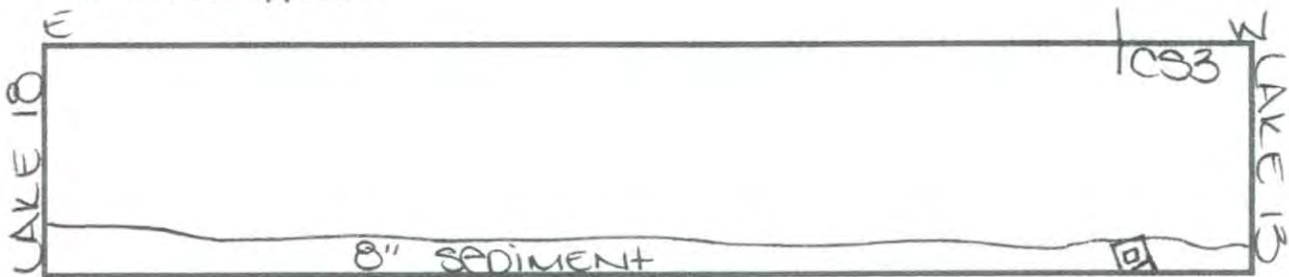
General Condition of Pipe: Dive team noted 8" of sediment throughout the length of the pipe. Sediment consisting of mud and shells. Also noted a cement block at the control station 3. Overall condition of the pipe appears to be good.

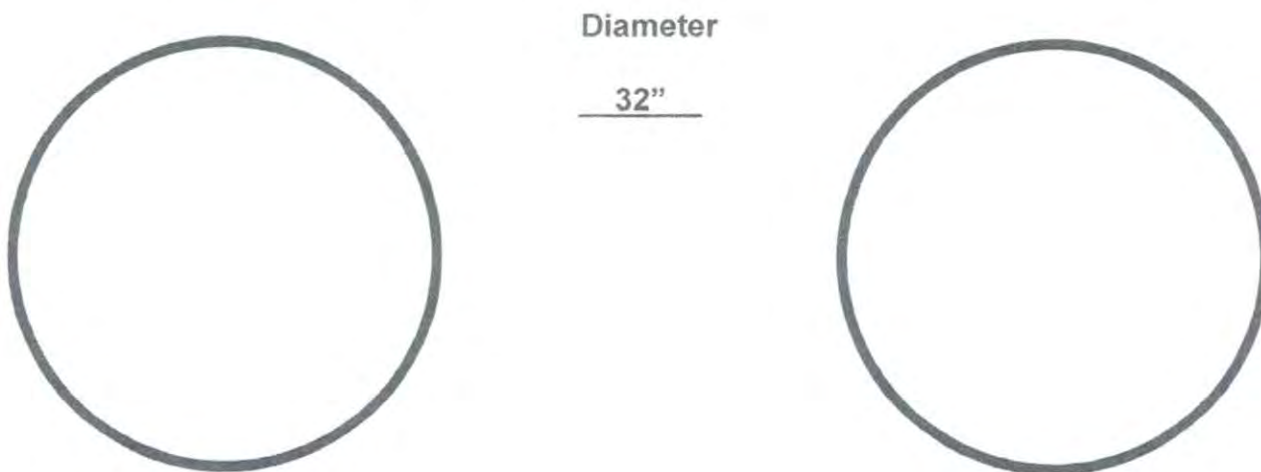
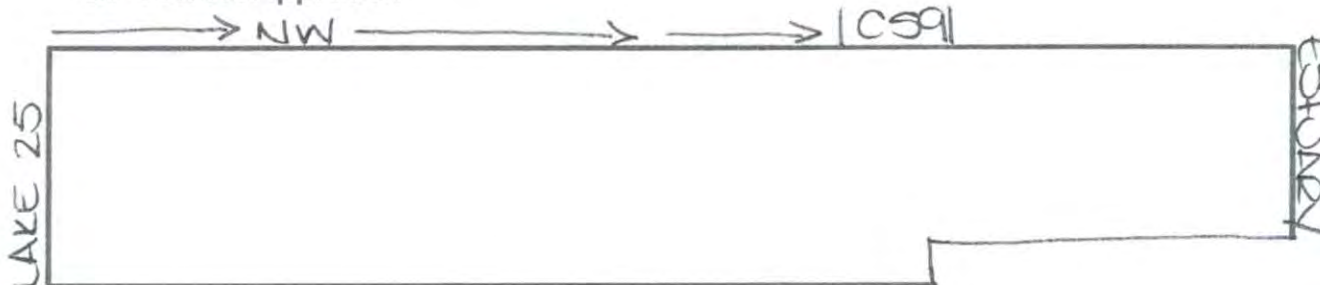
General Condition of Pipe: Dive team noted very little to no sediment throughout the length of the pipe. Overall condition of the pipe is good with a strong flow of water.

Comments: Dive team dove this pipe up to CS #9. From CS#9 to Estuary was a dry pipe.

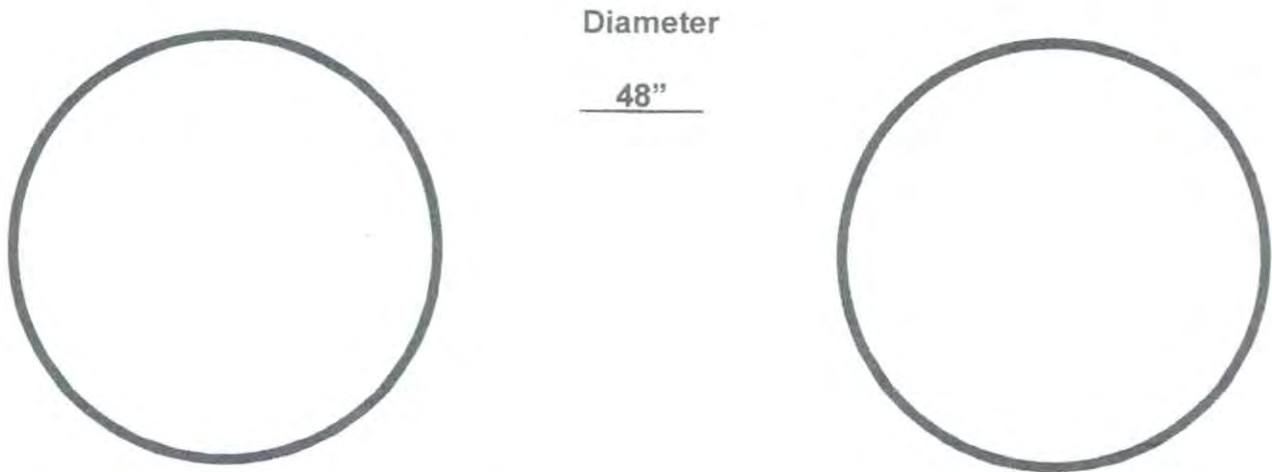
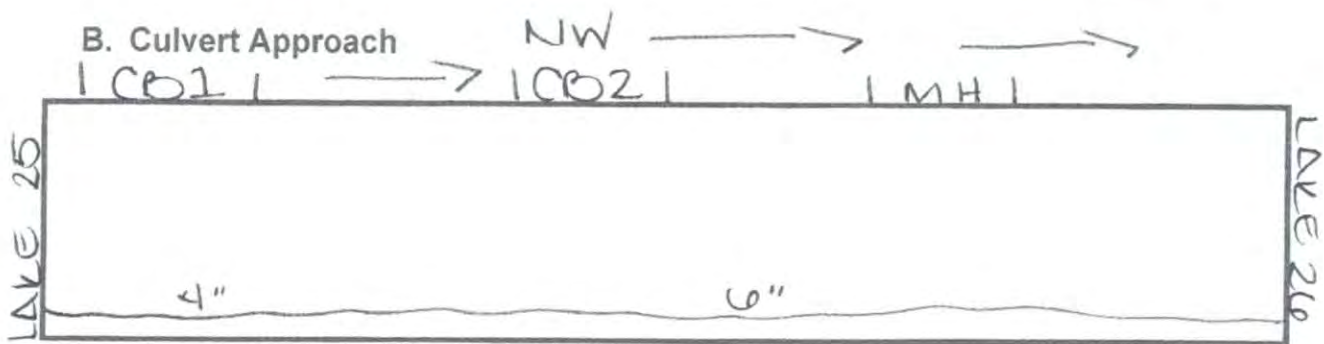
General Condition of Pipe: Dive team noted 6" of sediment throughout the pipe.

Overall condition of the pipe is good. Dive team reported a man hole between  
lakes 25 and 26.

Comments: Dive team noted that the pipe started as CMP and transitioned  
into RCP at the 45 degree turn.

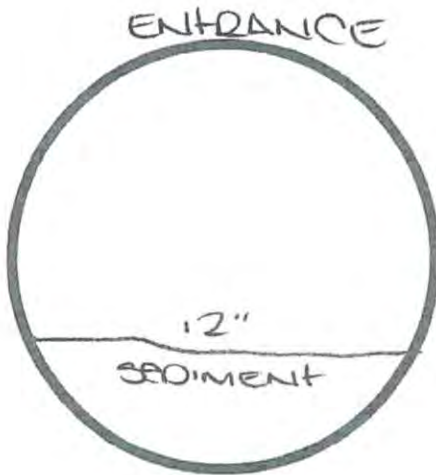
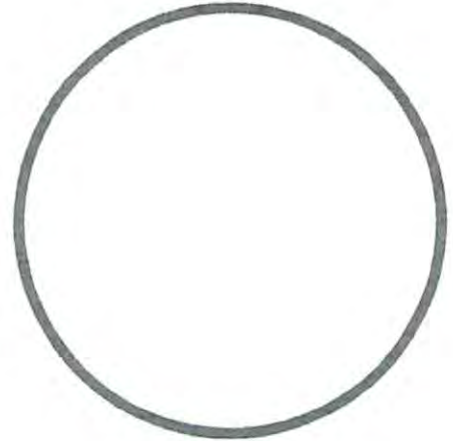
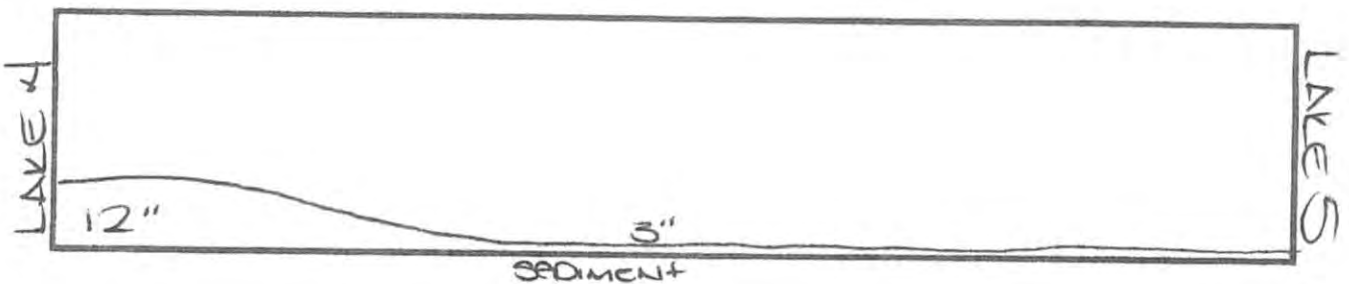
General Condition of Pipe: Dive team noted 1' of sediment at the pipe entrance.

Sediment decreased to 3". Overall condition of the pipe is good.

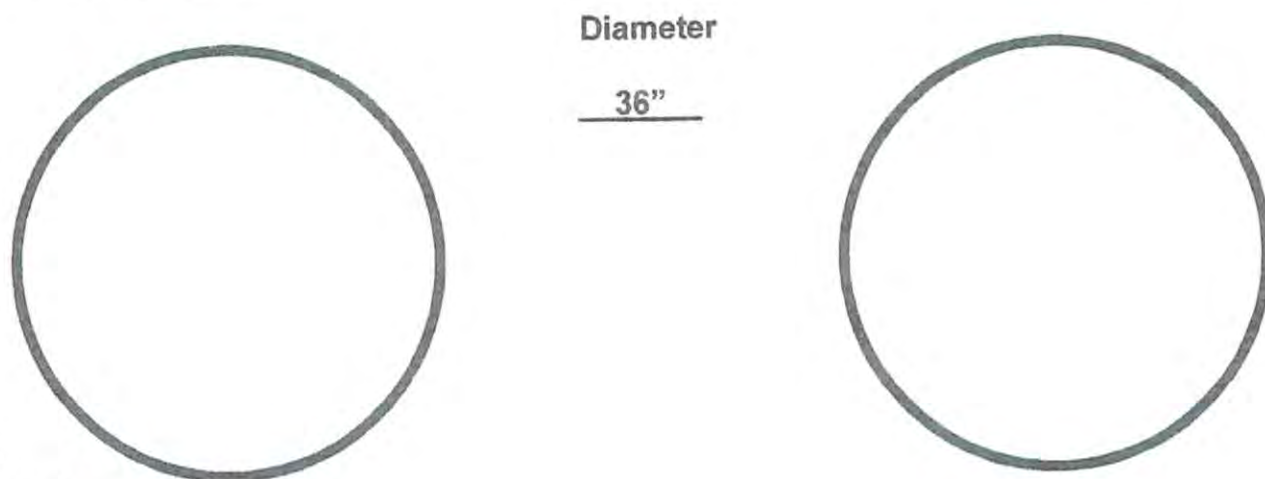
General Condition of Pipe: Dive team noted little to no sediment throughout the length of the pipe. Overall condition of the pipe is ok, with joints and concrete in ok condition. Good and steady flow of water through pipe. Dive team noted a manhole at 190' into the pipe.

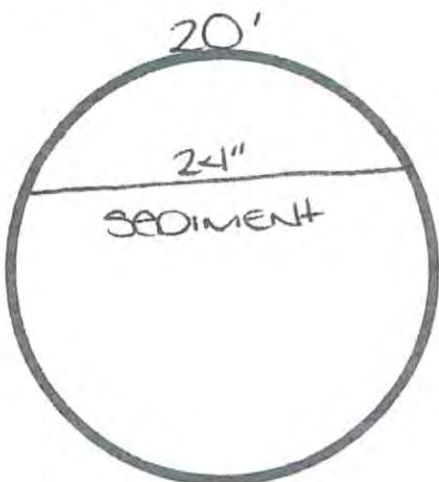
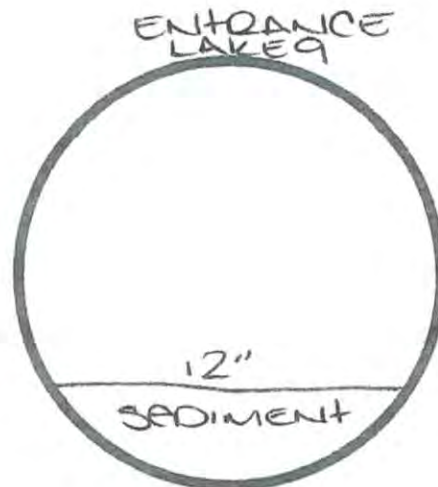
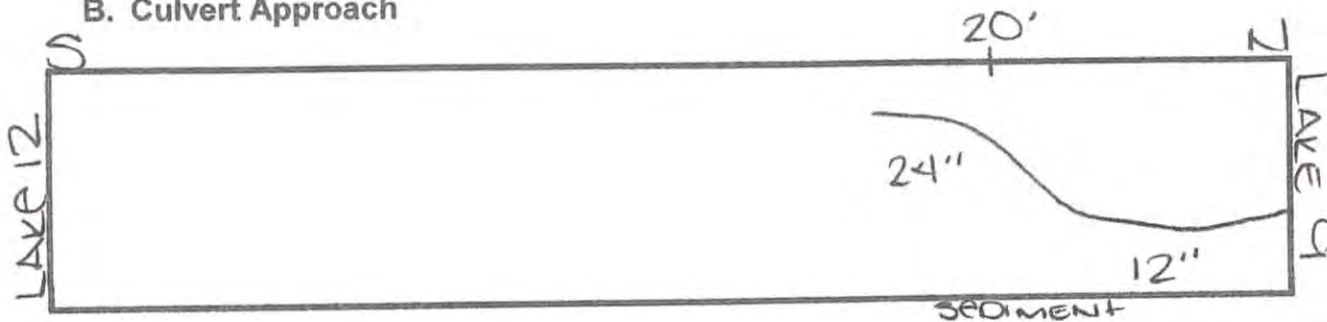
General Condition of Pipe: 12" of sediment at entrance of pipe. Sediment is a mixture of sand and shells. Dive team could not determine the condition of the pipe due to 24" of sediment blocking further access at 20' deep.

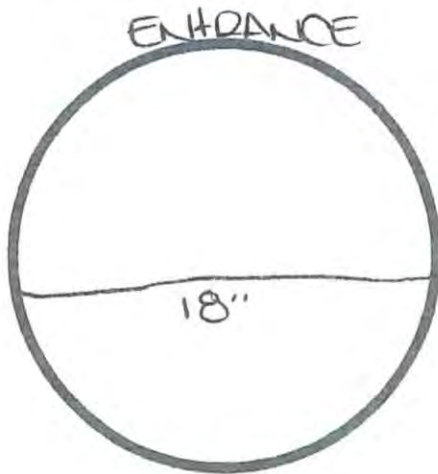
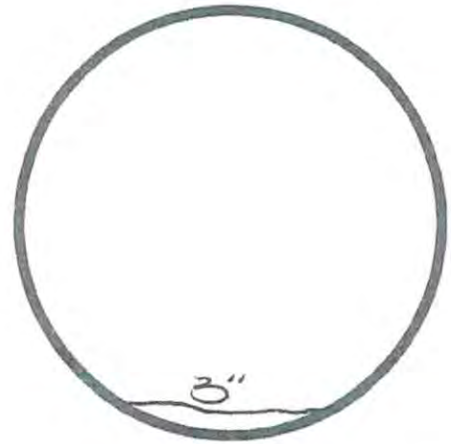
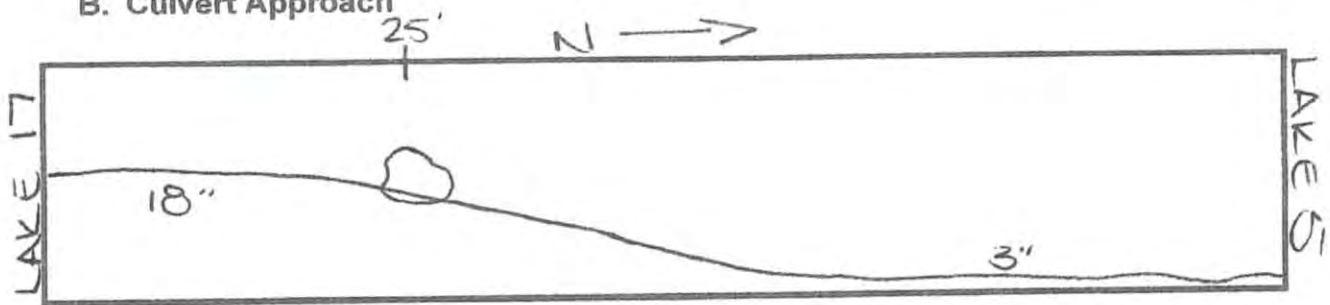
General Condition of Pipe: Dive team noted 18" of sediment at the entrance of the  
Pipe. Sediment consisting of sand and shells. Obstruction at 25' into the pipe,  
large boulder. 3" of sediment throughout the length of the pipe. Overall condition  
of the pipe is good.

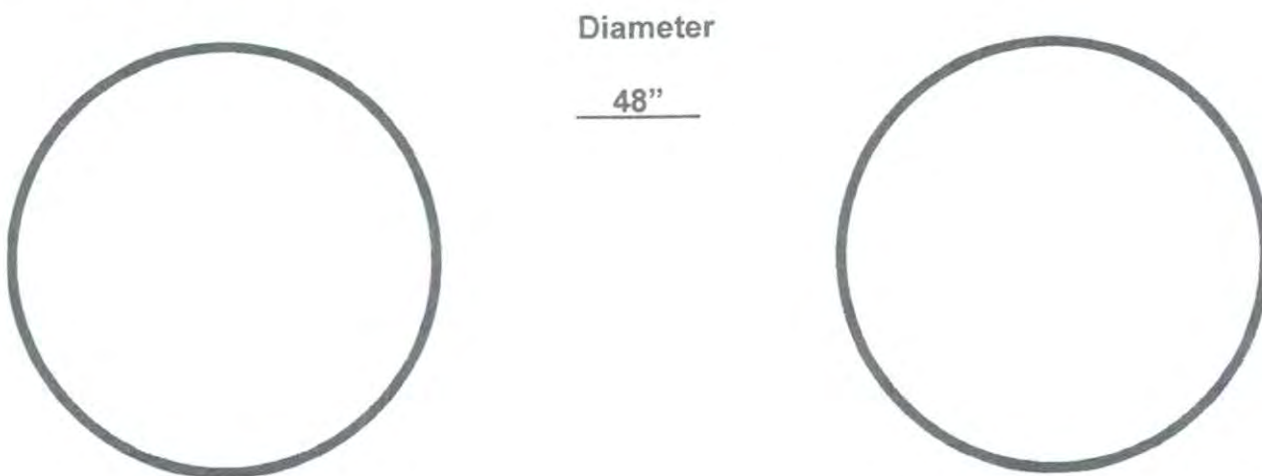
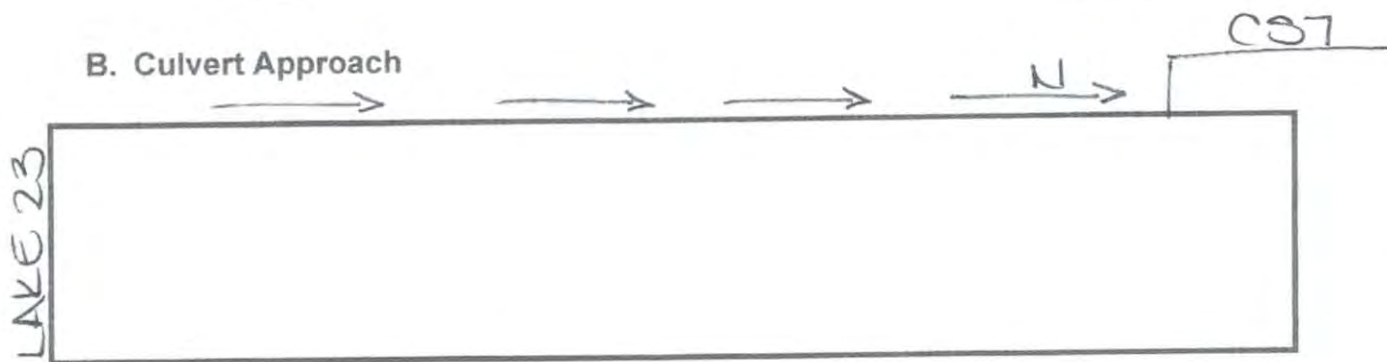
General Condition of Pipe: Dive team noted very little to no sediment throughout the length of the pipe. Overall condition of the pipe is good. Strong flow of water.

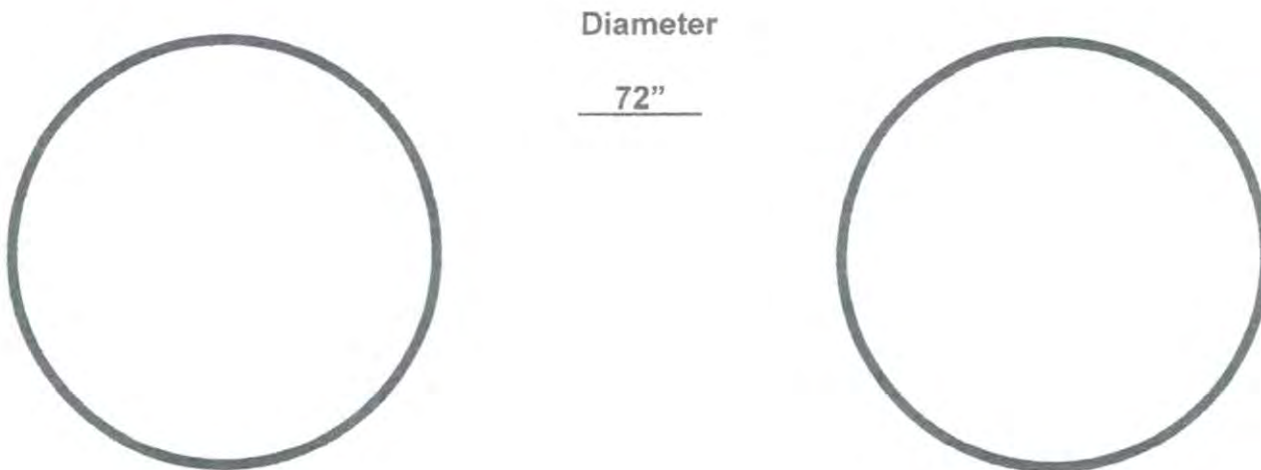
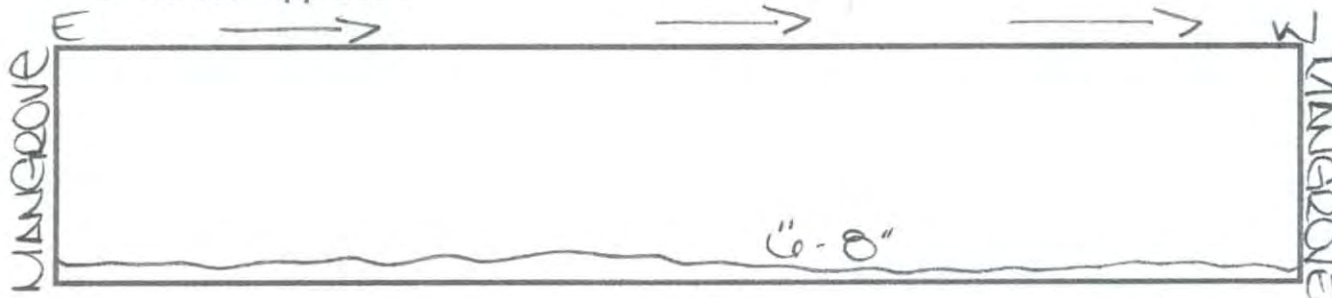
General Condition of Pipe: Dive team noted 6 – 8" of sediment throughout the length of the pipe. Overall condition of the pipe is good. With no obstructions.

Comments: Very low visibility inside of the pipe.

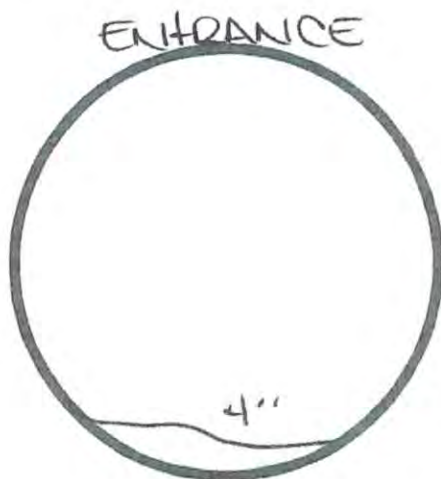
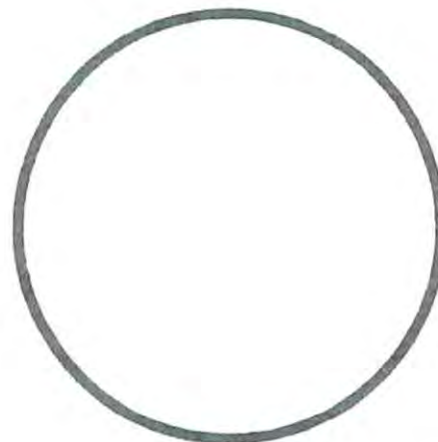
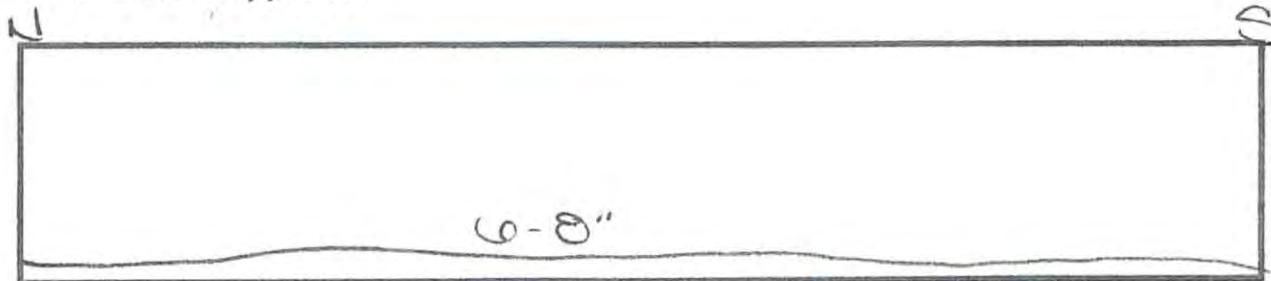
General Condition of Pipe: Dive team noted 4" of sediment at the entrance of the  
pipe. Also noted tree branches and roots in the pipe. Sediment consists of sand  
and leaves. Sediment is 6" to 8" throughout the length of the pipe.

Comments: Very low visibility inside of the pipe.

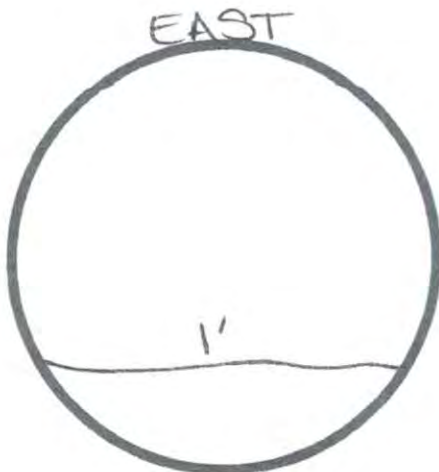
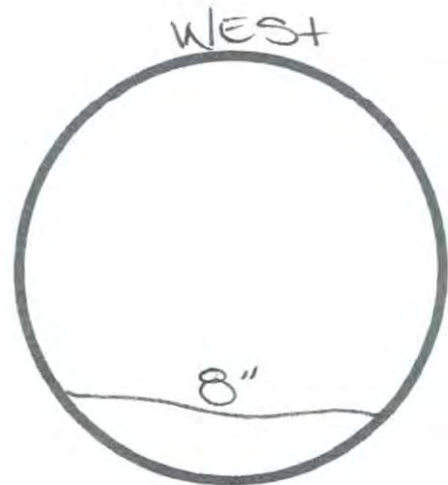
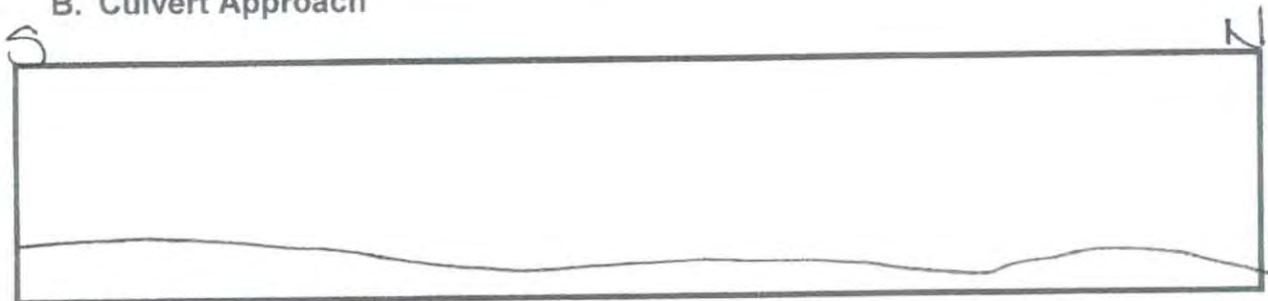
General Condition of Pipe: Dive team noted approximately 12" of sediment at the entrance. Over all condition of pipe is good. Sediment between 8 and 12" throughout pipe.

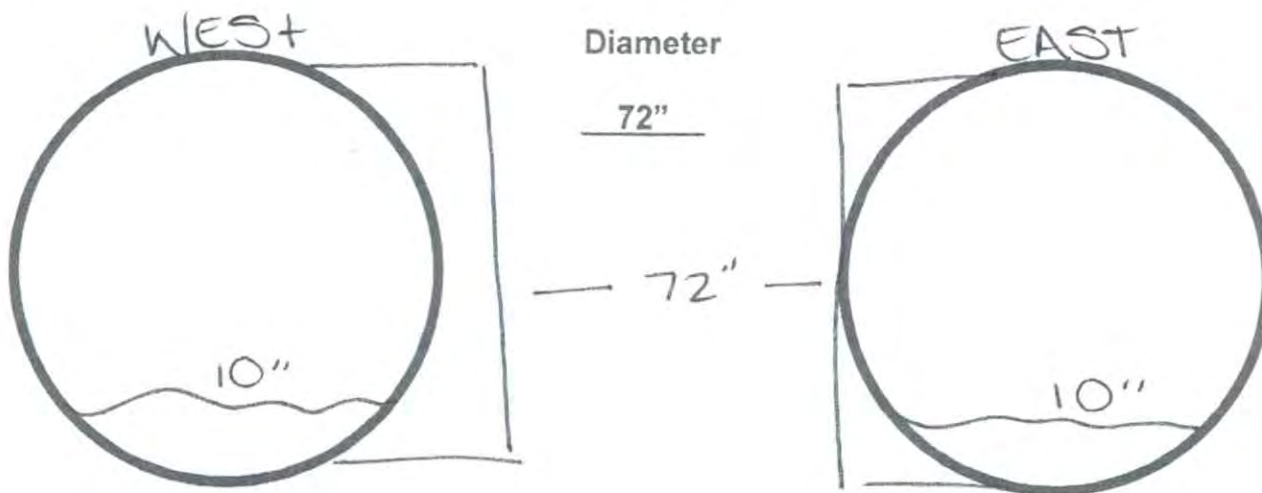
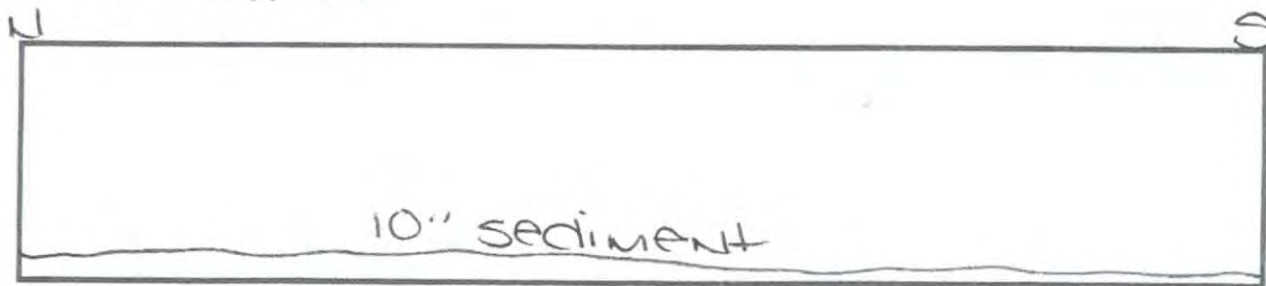
General Condition of Pipe: Dive team noted 10 inches of sediment throughout both East and West pipes. Overall condition is good with no debris or obstructions.
