## APPENDIX E

### SHENANDOAH PIPING REPORT

## **Pond Interconnection and Estuary Culvert Inspection Report**

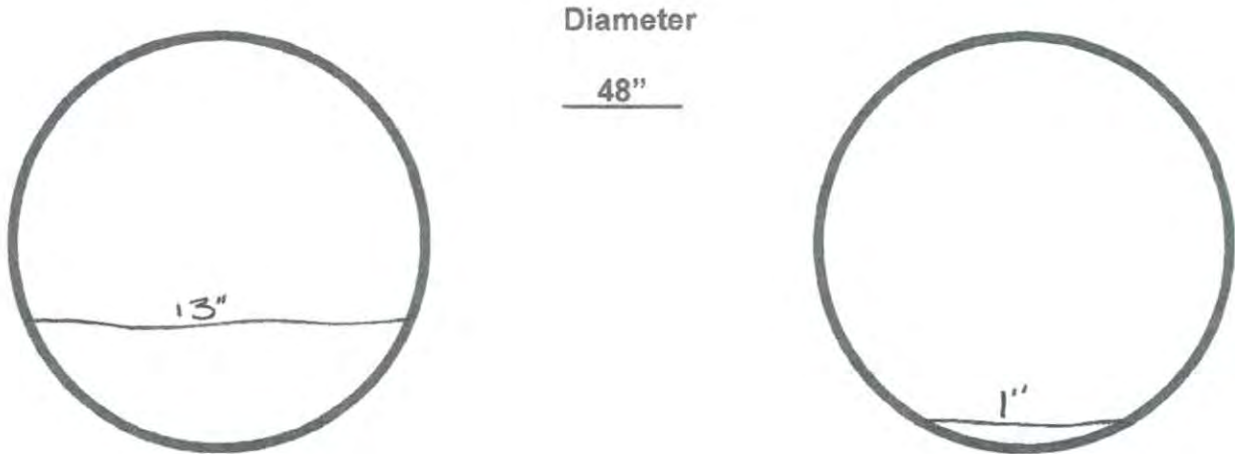
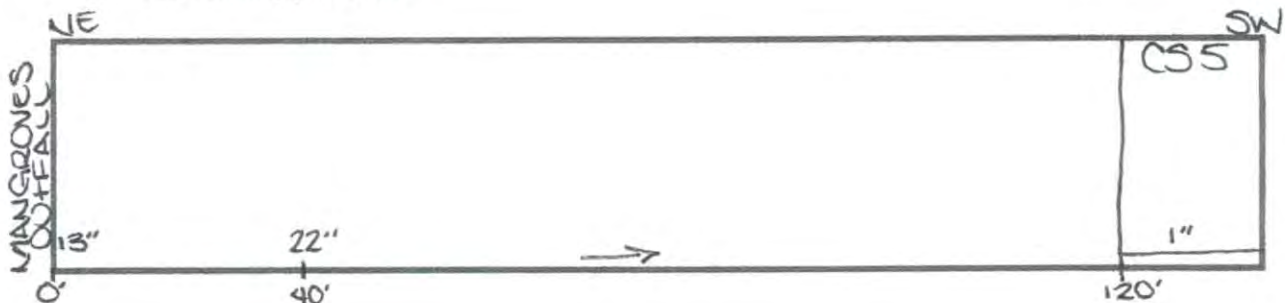
General Condition of Pipe: Diver noted the sediment levels increased heading toward CS5 then decreased. Diver also noted heavy marine growth along the sides.

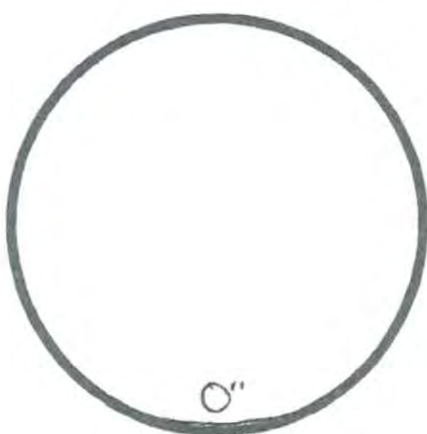
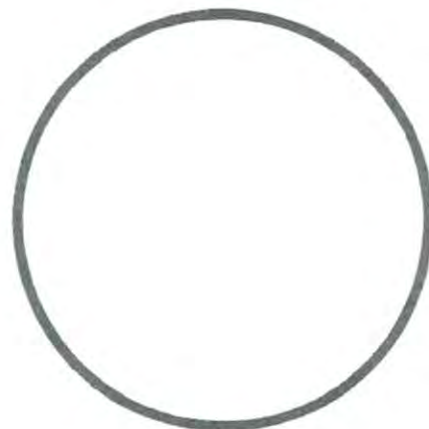
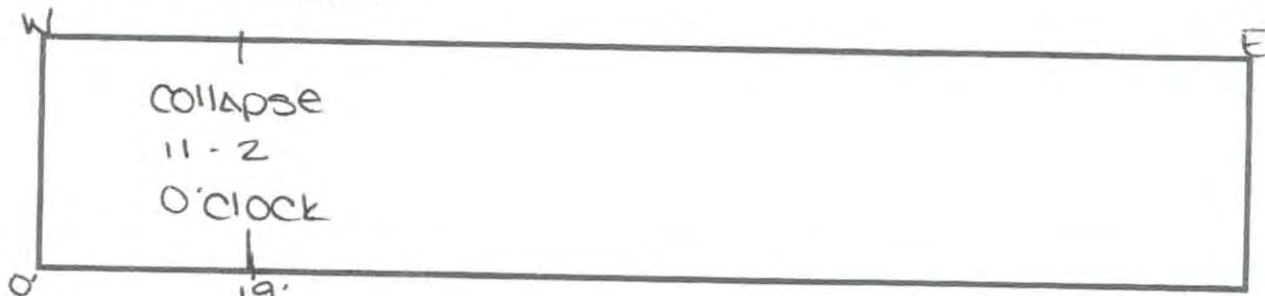
General Condition of Pipe: Diver noted moderate growth on the sides of the pipe.

Comments: Diver was unable to continue inspection past 19' due to pipe  
collapse.

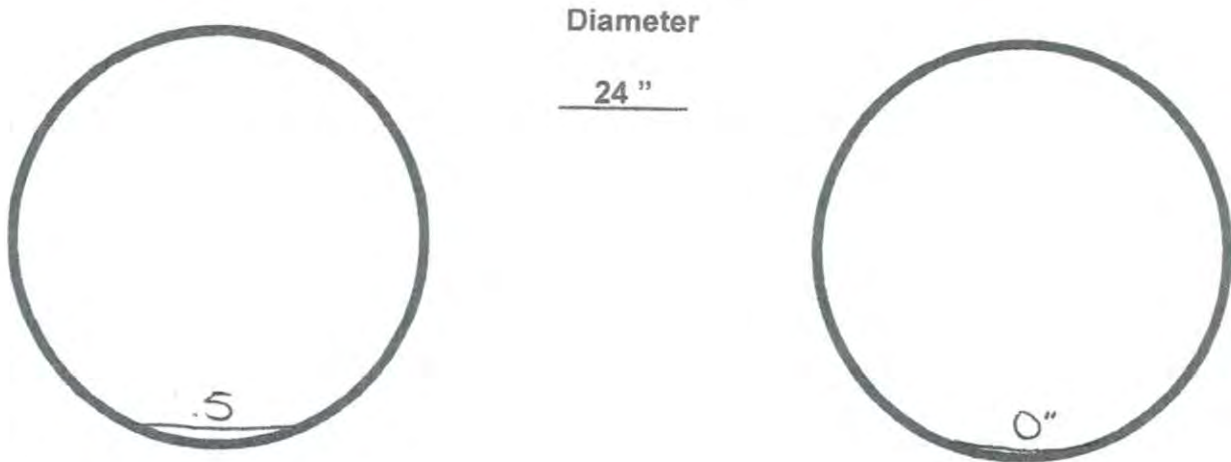
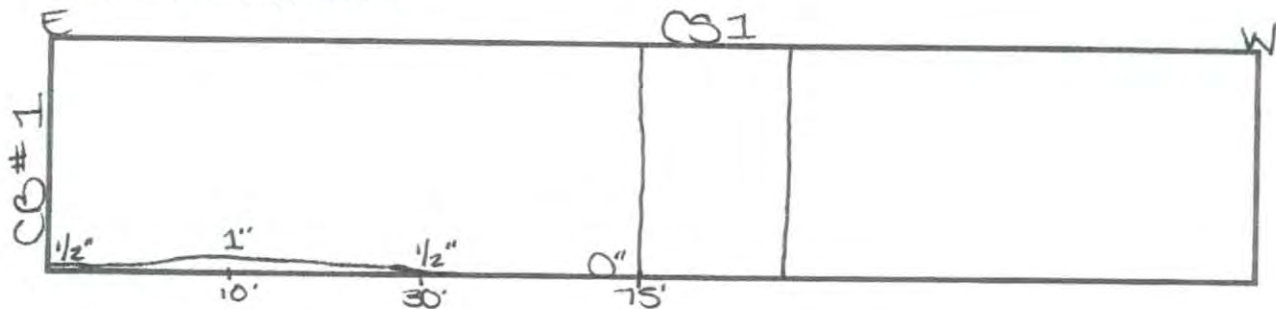
General Condition of Pipe: Diver noted minor cracking at the mud work at the mouth of the pipe in CB1. Also noted moderate growth.

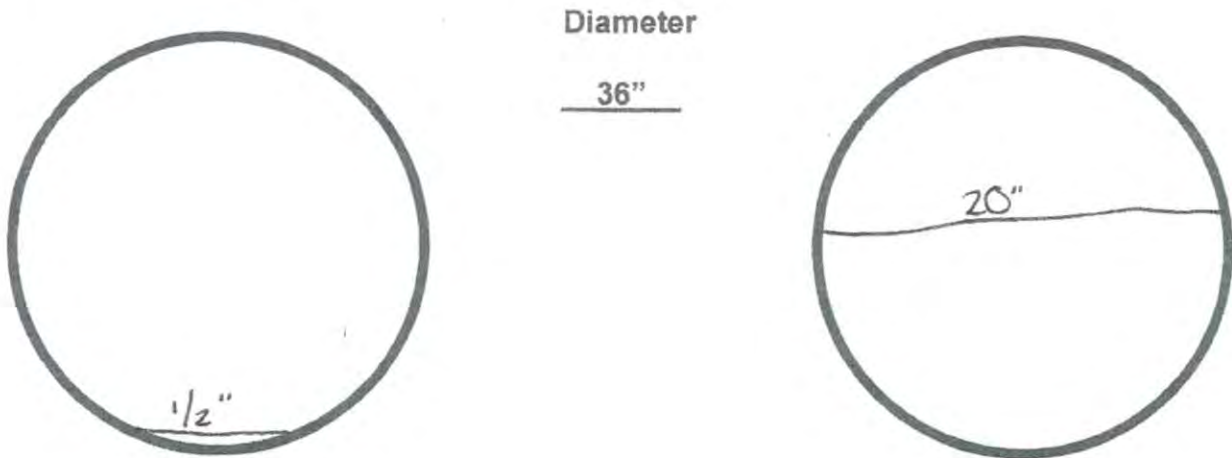
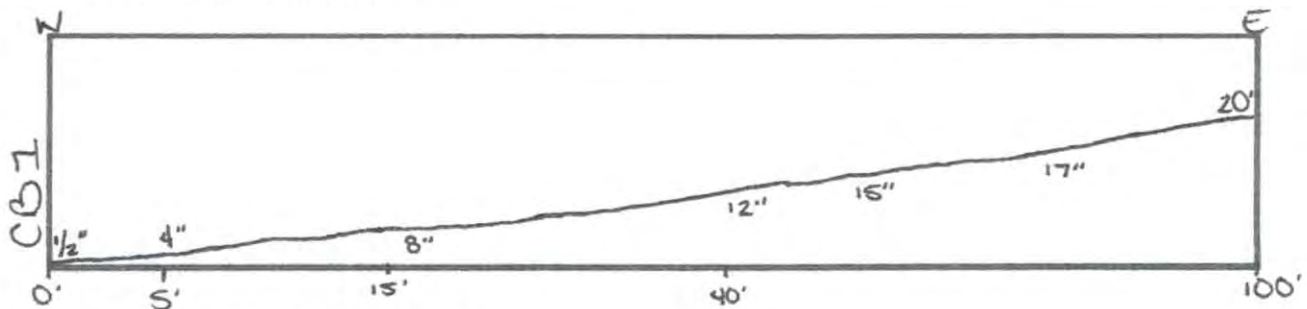
General Condition of Pipe: Diver noted that the sediment rose from 1/2" to 20"  
throughout the length of the pipe. Also noted minor marine growth along the  
sides of the pipe.

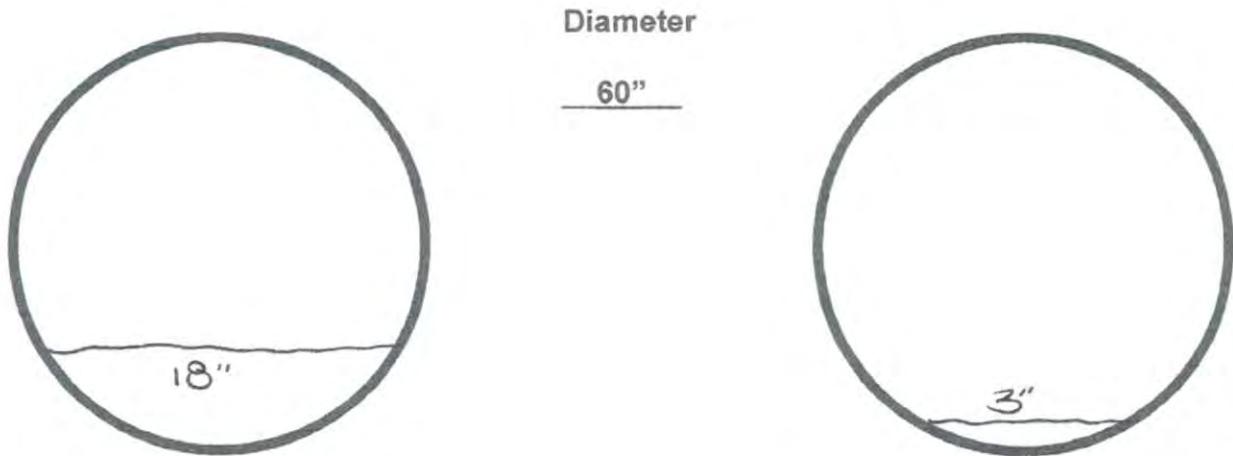
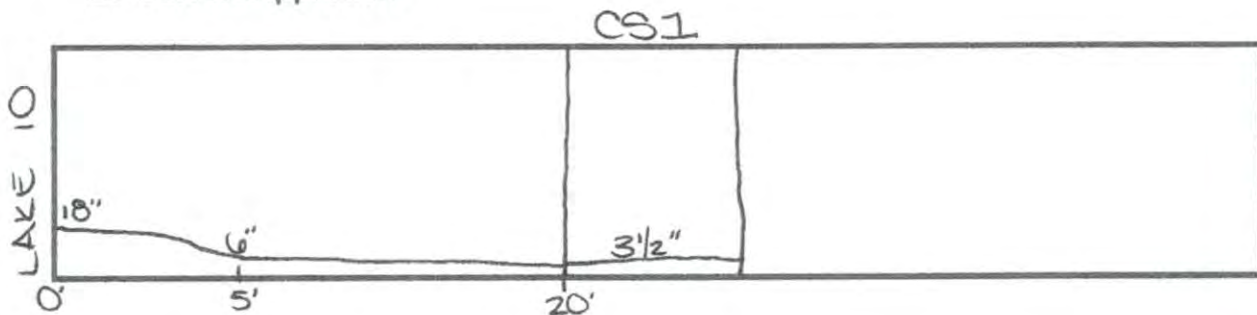
General Condition of Pipe: Diver noted a rebar trash rack at Lake 10 outfall, heavy corrosion on the trash rack along with heavy marine growth and mild corrosion. Control structure 1 has some rebar exposed. Diver also noted the sediment levels decreased throughout the pipe.

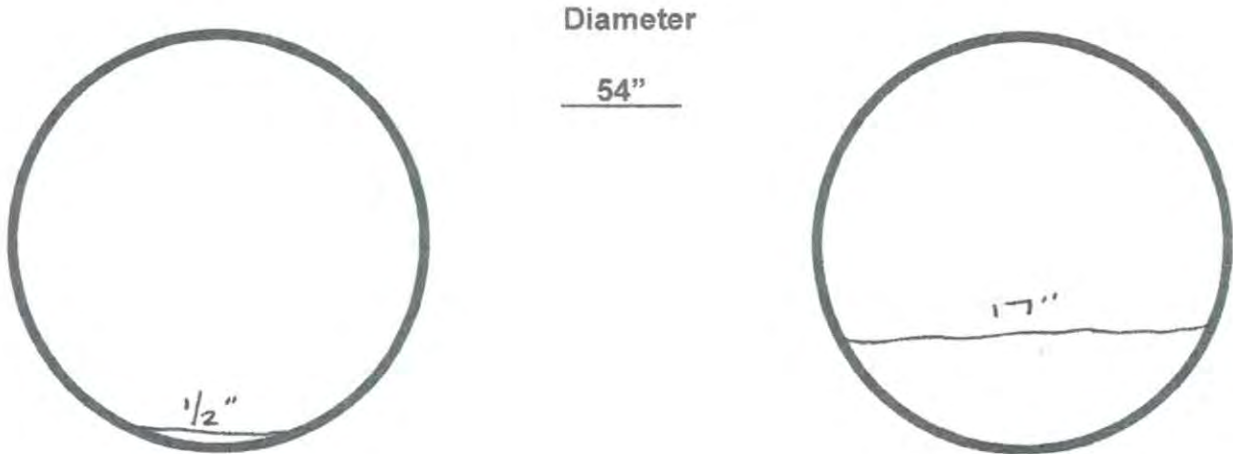
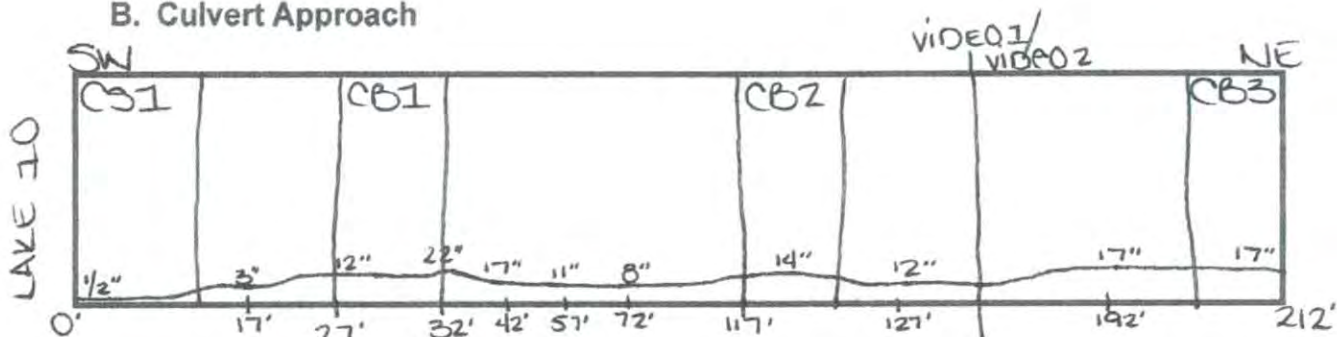
General Condition of Pipe: Control structure 1 has cracking around the pipe on  
the structure wall. Diver noted ½" to 22" of sediment and moderate growth  
throughout the pipe. Also noted mild cracking on the walls of catch basin 1.

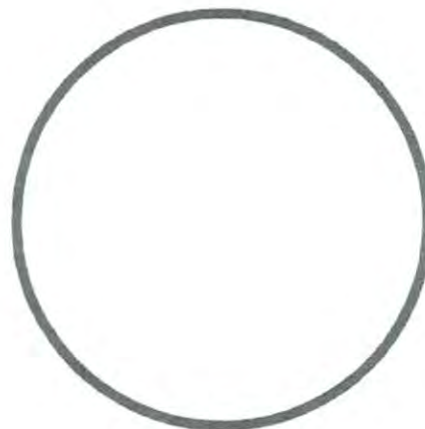
General Condition of Pipe: Dive team noted that the outfall has a homemade control structure. The control structure is not flush against the mouth of the pipe, and is not secured to the pipe. Diver also noted a 4" gap at the 6 O'clock position.

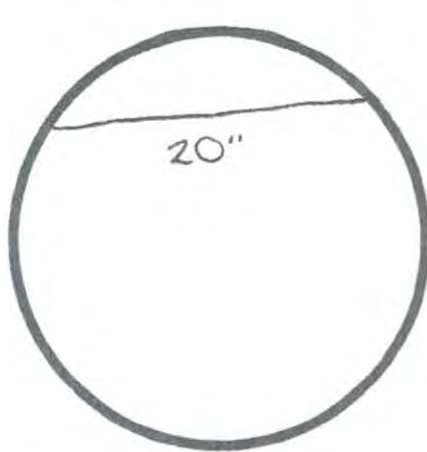
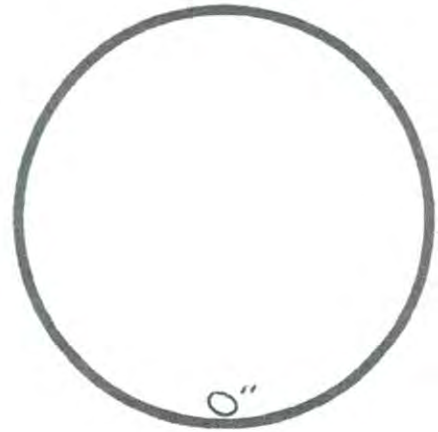
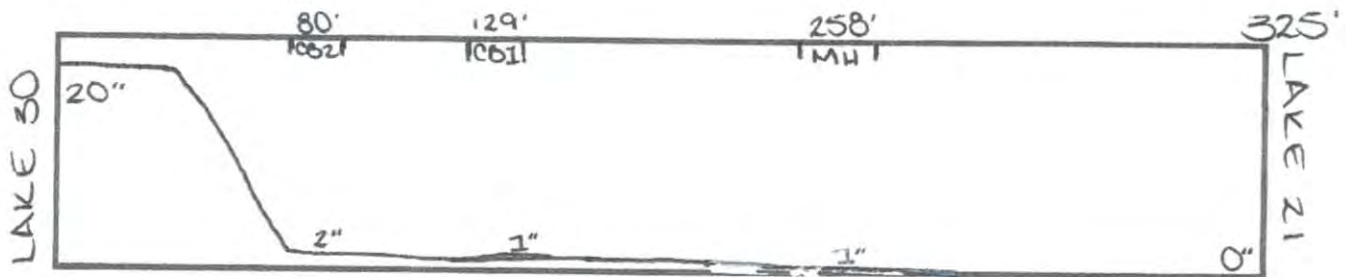
Comments: Diver noted that the pipe is CMP from Lake 30 to CB1 then turns  
into plastic out to Lake 21.

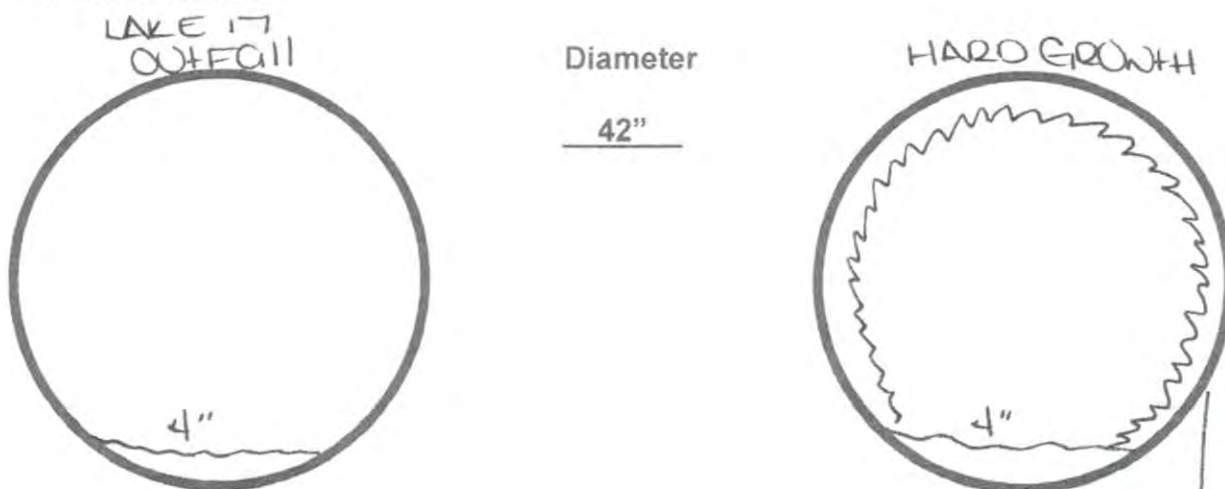
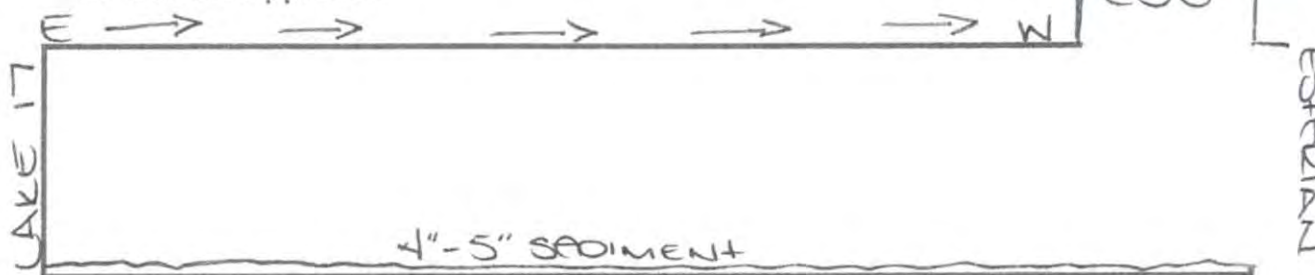
General Condition of Pipe: Dive team noted 4" to 5" of sediment throughout the length of the pipe. Dive team also noted excessive hard growth throughout the pipe that becomes substantial in the last 50' of the pipe. Other than the hard growth the overall condition of the pipe is good.

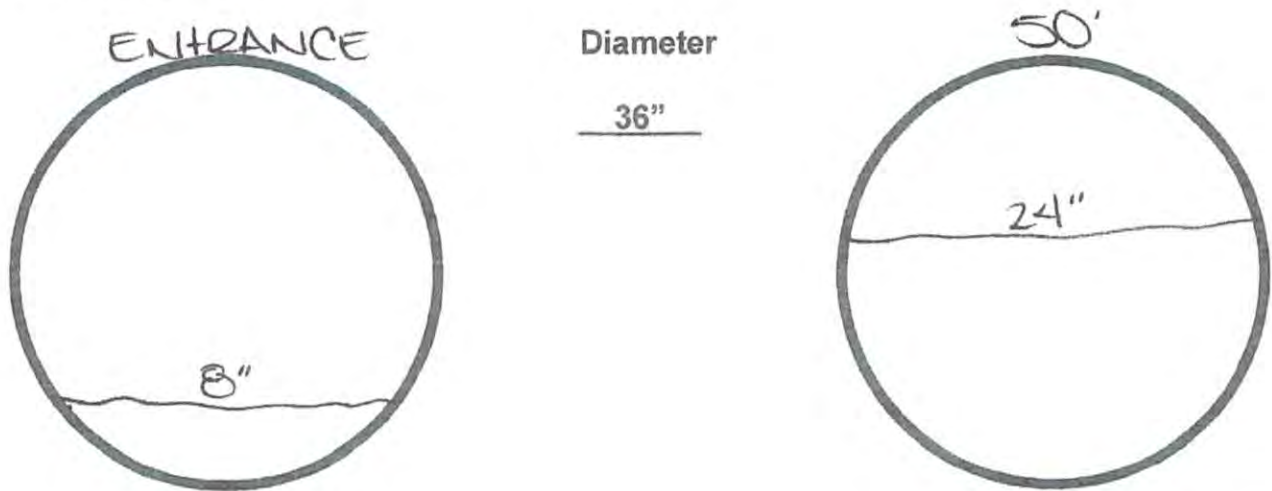
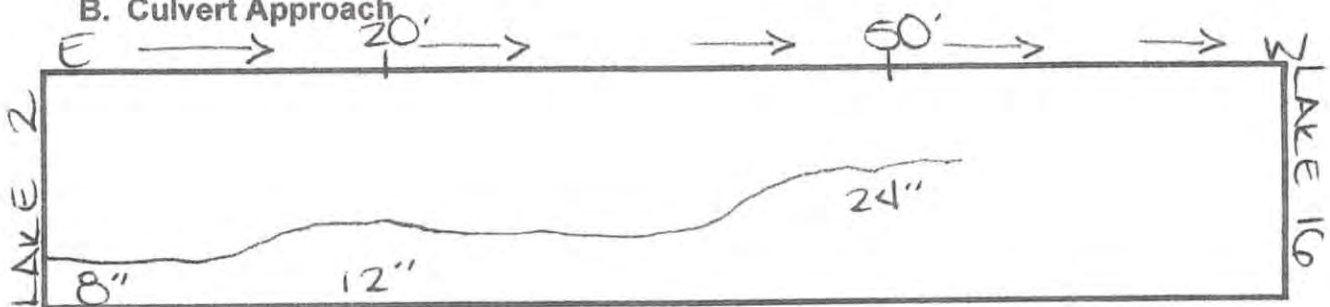
General Condition of Pipe: Dive team noted that the sediment is 8" at the pipe entrance and rises to 1' at the 20' mark. Pipe has very little water flow due to sediment increase at 50". Diver unable to continue past the 50' mark.

Comments: Inspection ended at 50' due to sediment levels.

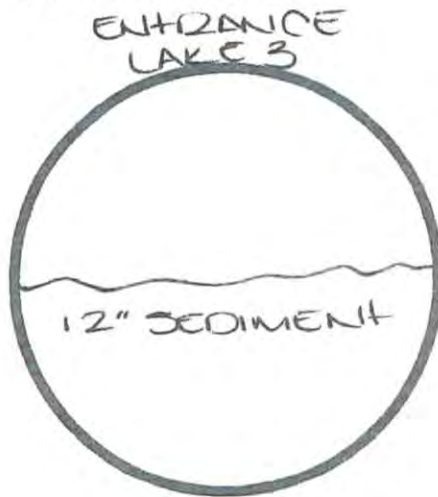
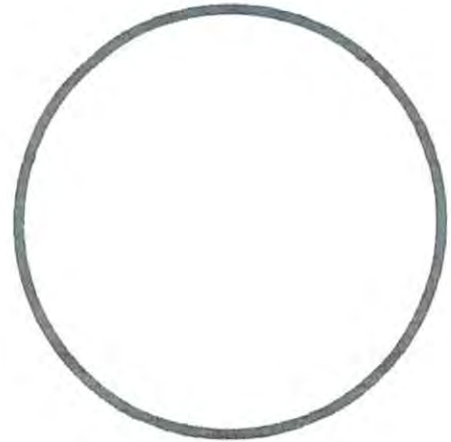
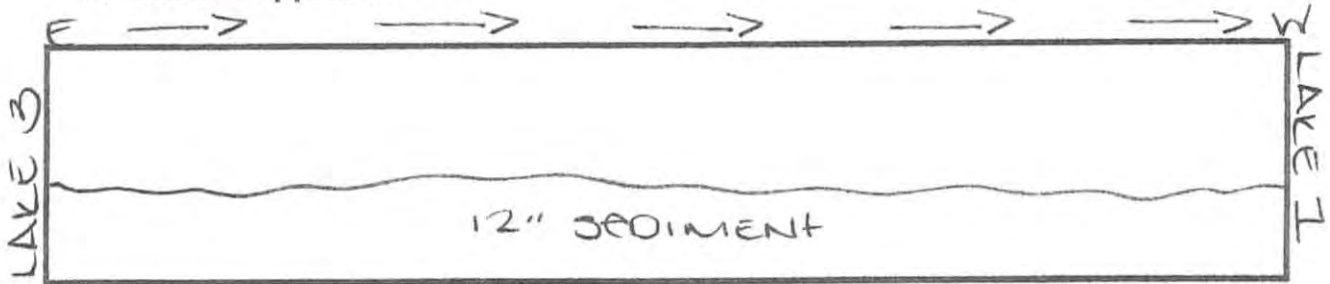
General Condition of Pipe: Dive team noted 12" of sediment.

Comments: Diver unable to inspect pipe due to sediment level.

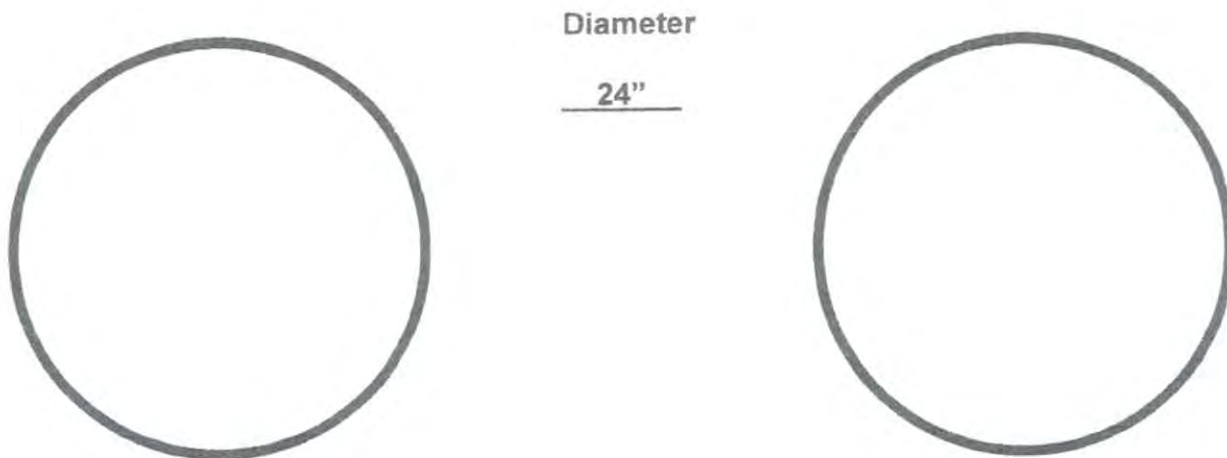
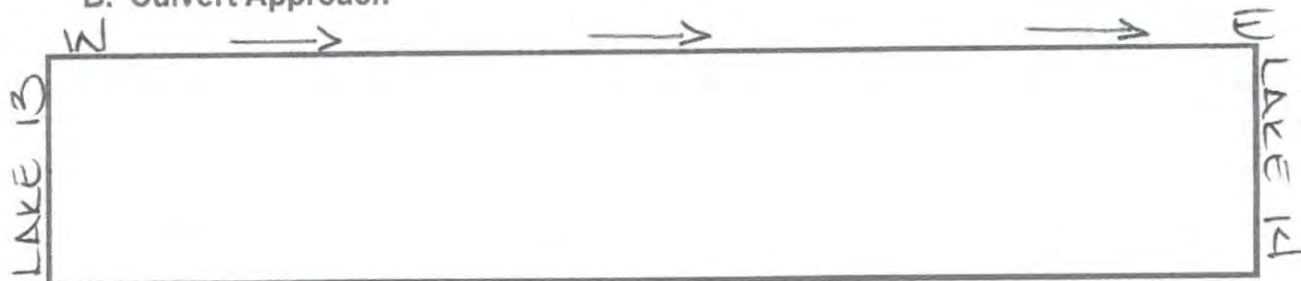
General Condition of Pipe: Dive team noted a steady stream of water coming out of the outfall.

Comments: Dive team was unable to penetrate the pipe due to the size.

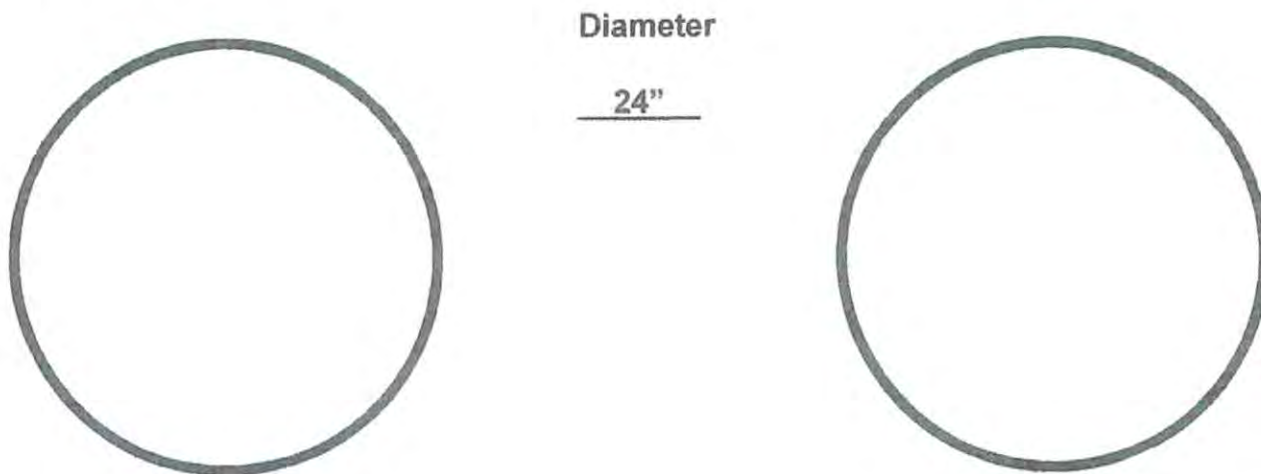
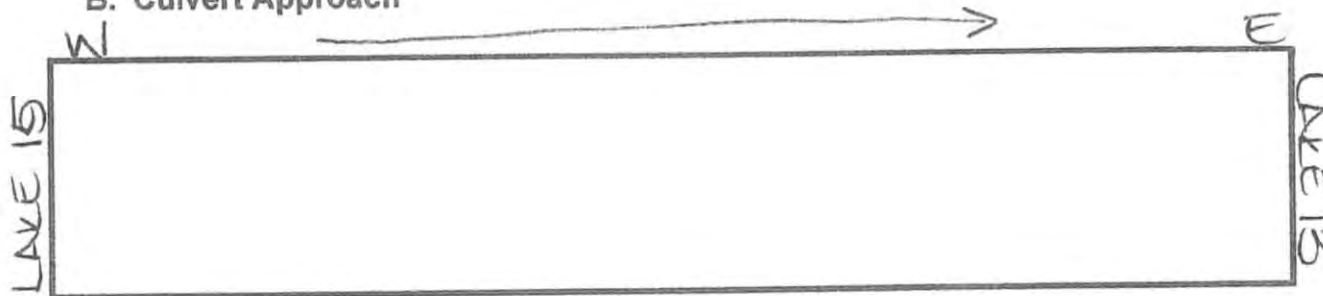
General Condition of Pipe: Dive team noted a steady stream of water coming out of the outfall.

Comments: Dive team was unable to penetrate the pipe due to the size.

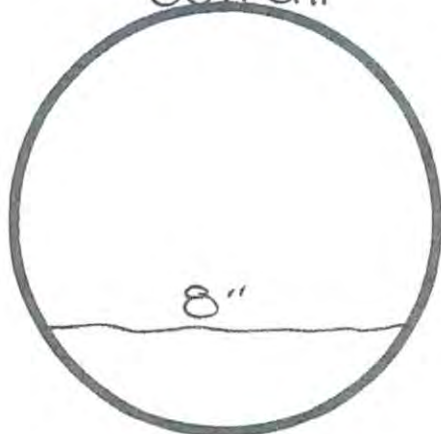
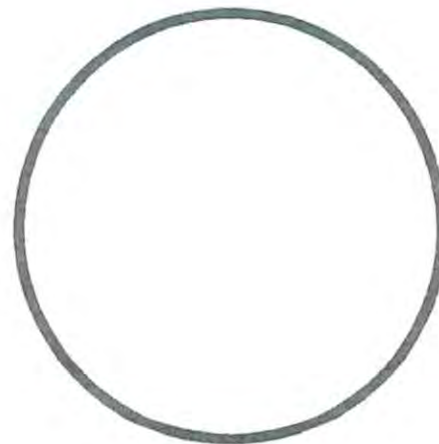
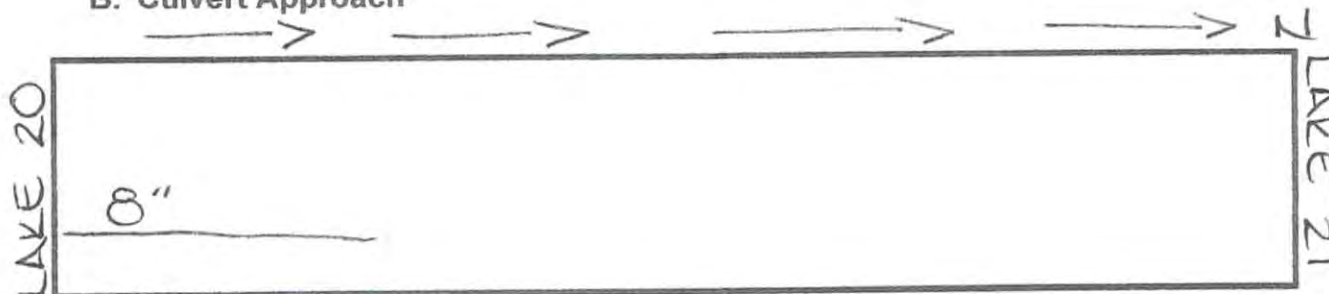
LAKE 20  
OUTFALL

General Condition of Pipe: Dive team noted 8" of sediment at the entrance of the pipe. Also noted a strong water flow at the outfall.

Comments: Dive team unable to penetrate the pipe due to size and sediment.

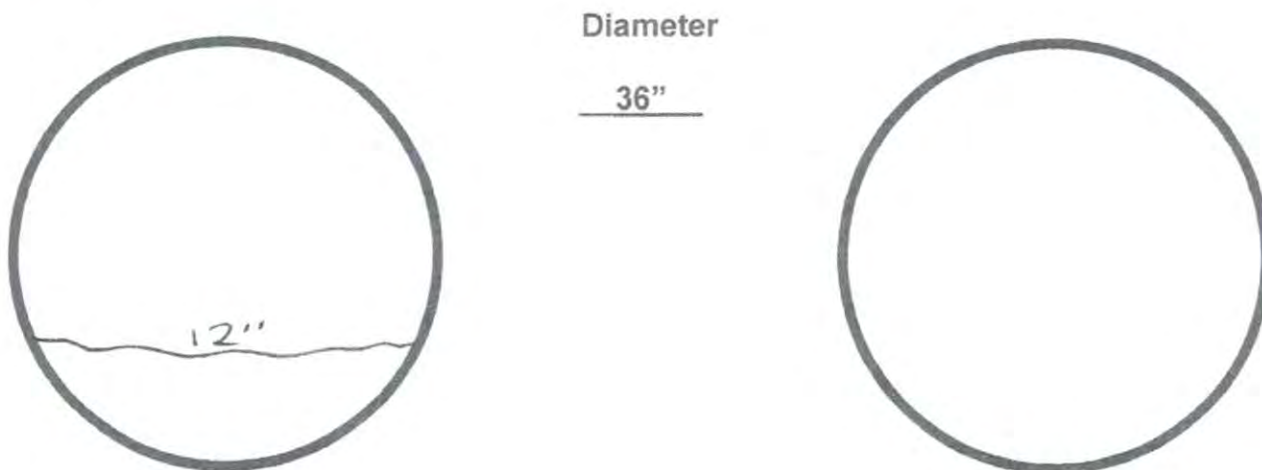
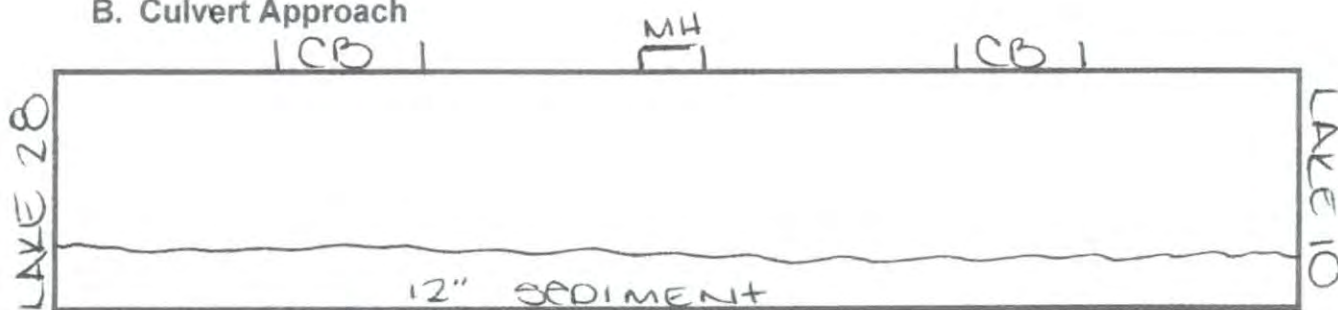
General Condition of Pipe: Dive team noted 12" of sediment throughout the  
length of the pipe. Overall condition of the pipe is good. No damage or  
obstructions with good water flow.

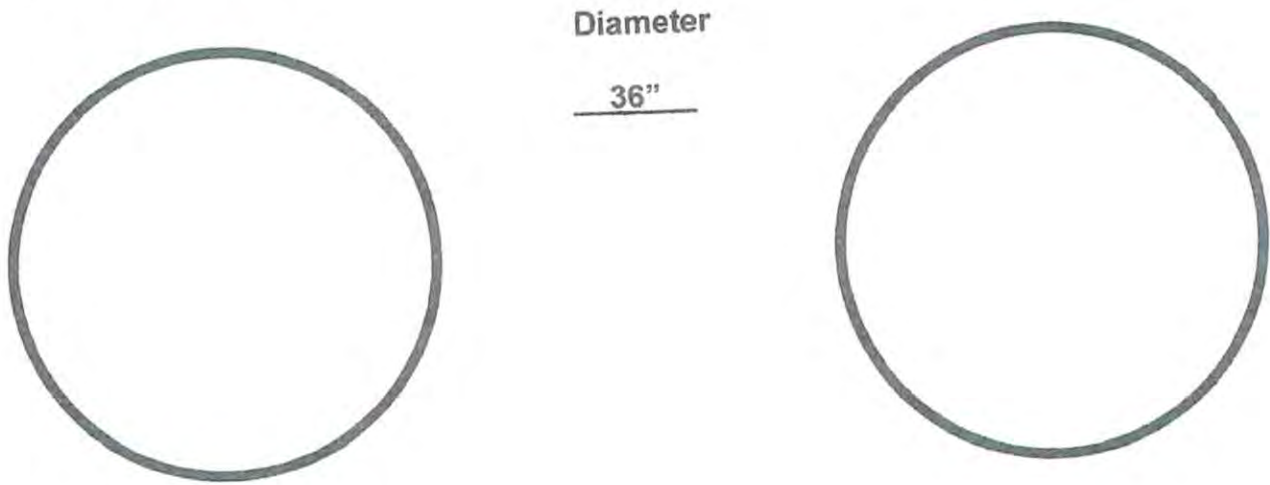
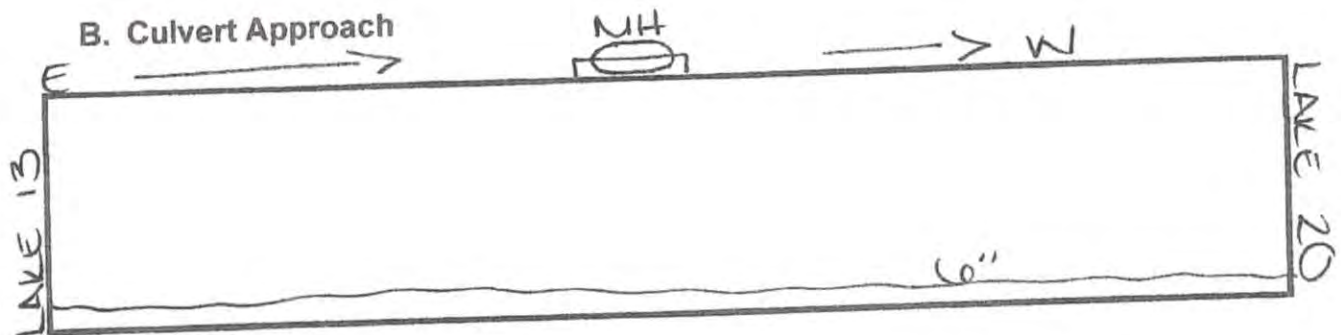
General Condition of Pipe: Dive team noted 4" to 6" of sediment throughout the  
length of the pipe. Overall condition of the pipe is good with no damage or  
obstructions.

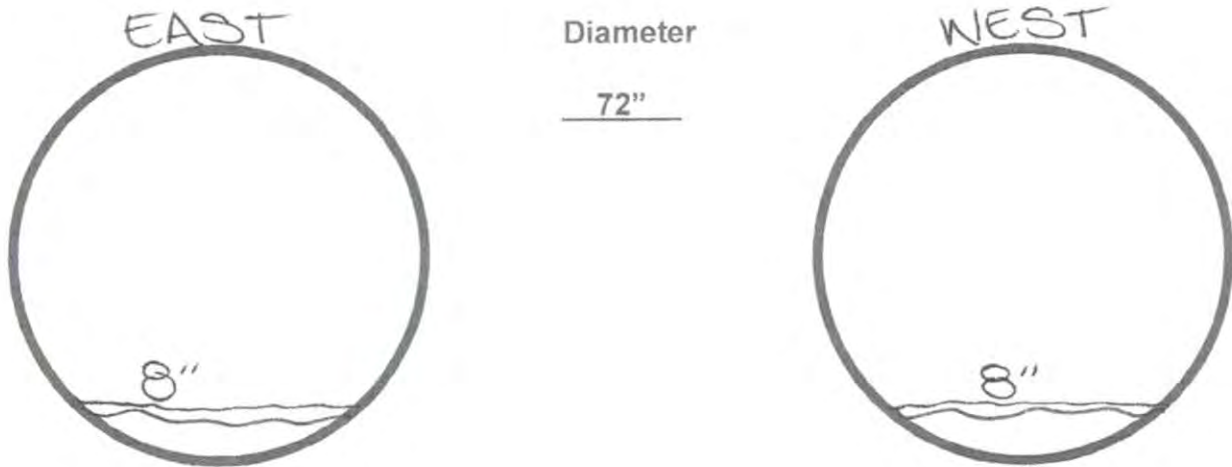
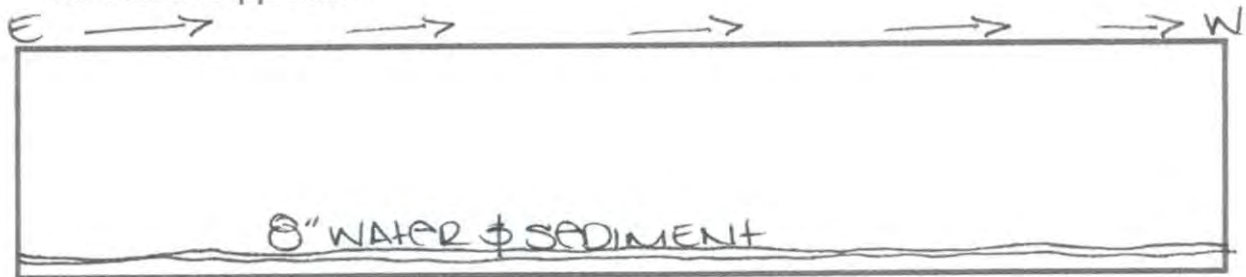
General Condition of Pipe: Dive team noted that the Pipe has only 8" of water in both the east and west pipes with 8" of sediment at the entrance. Both pipes are in overall good condition with no obstructions.

Comments: No video due to the pipe being dry.

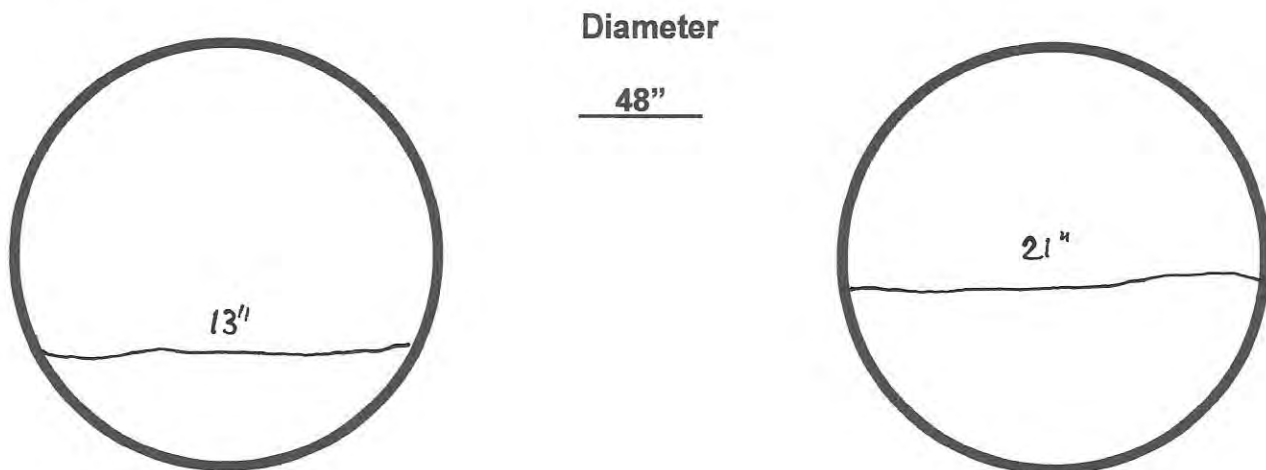
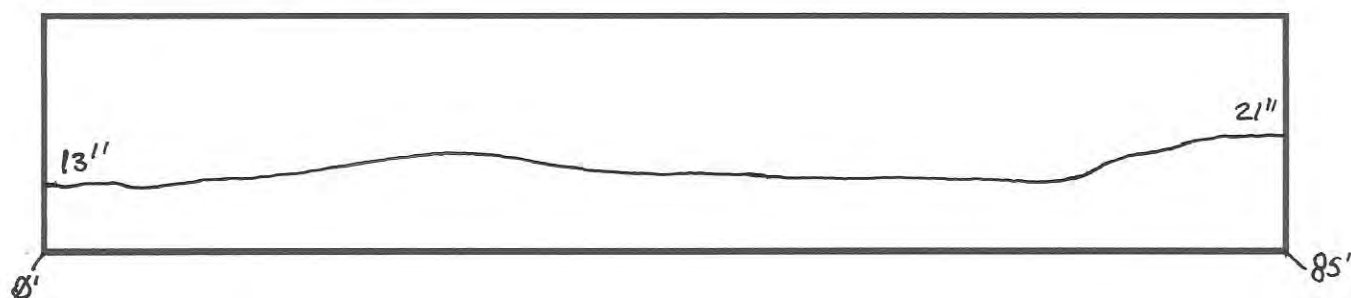
General Condition of Pipe: Pipes are in Good Condition with no major deficiencies. The South pipe is CMP with a diameter of 48" running from East to West and has a length of 85'. The sediment level inside the south pipe is 11" at running from East to West and has a length of 85'. The sediment level at the entrance to the North pipe is 13" and 21" at the exit.

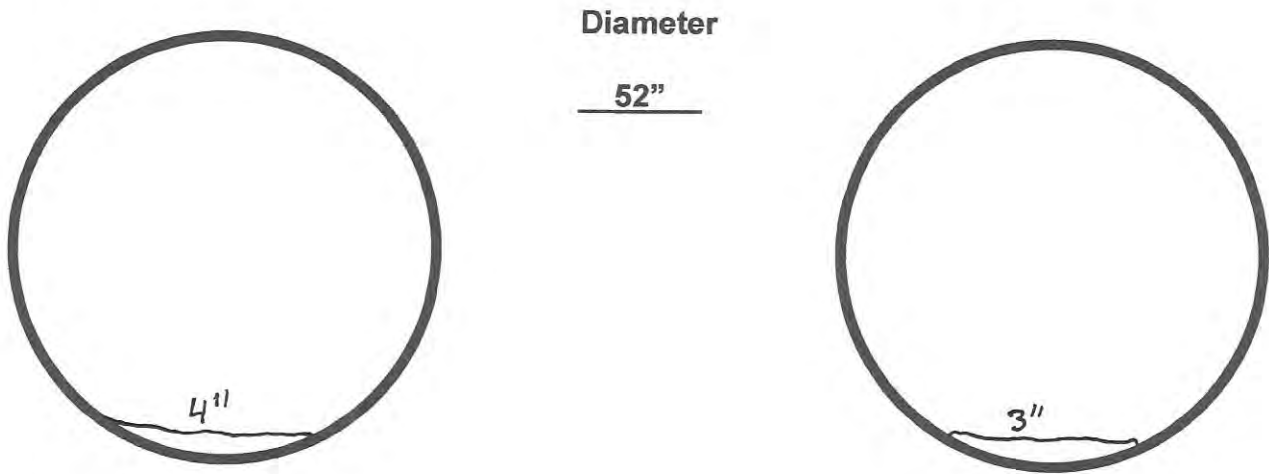
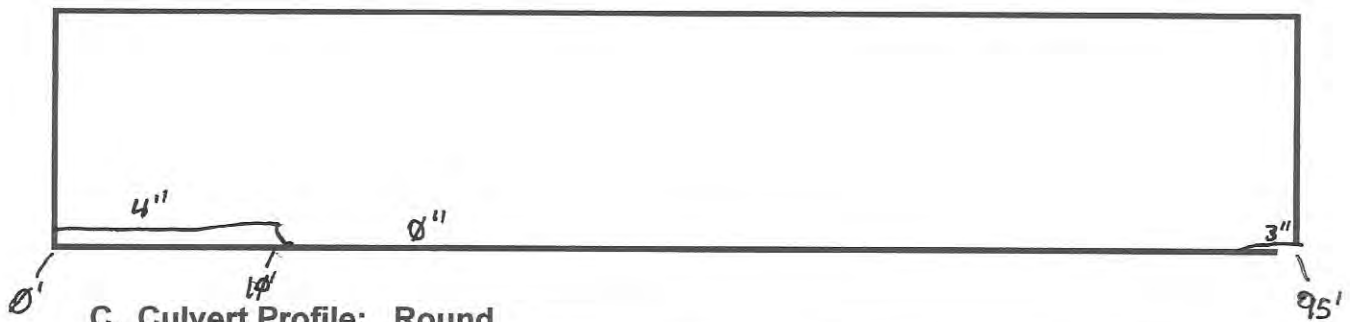
General Condition of Pipe: Pipes were found to be in good condition with no major deficiencies. South pipe is CMP, 52" in diameter and 90' in length. South pipe has minimal marine growth and has a sediment level of 3" consistent throughout the pipe, no deficiencies were noted. North pipe is CMP with a diameter of 52" in diameter and 90' in length. North pipe has minimal marine growth and has a sediment level of 4" dropping to 0" at 10' in the pipe. Sediment level rise to 3" at the outfall of the pipe, no deficiencies were noted.

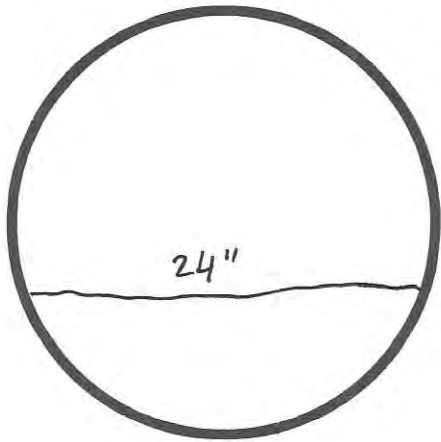
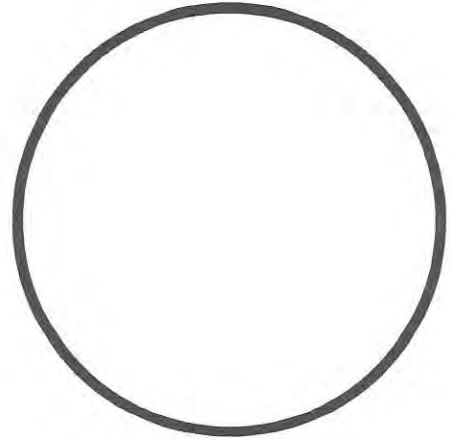
General Condition of Pipe: Entrance to Pipe has 24" of sediment. Diver was  
unable to enter the pipe due to mangroves blocking the entrance.

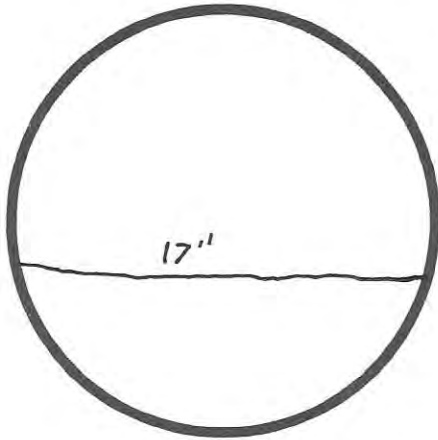
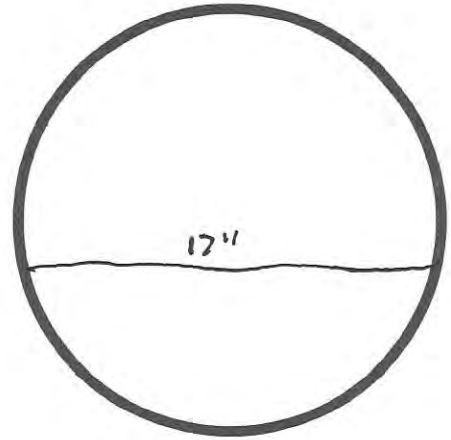
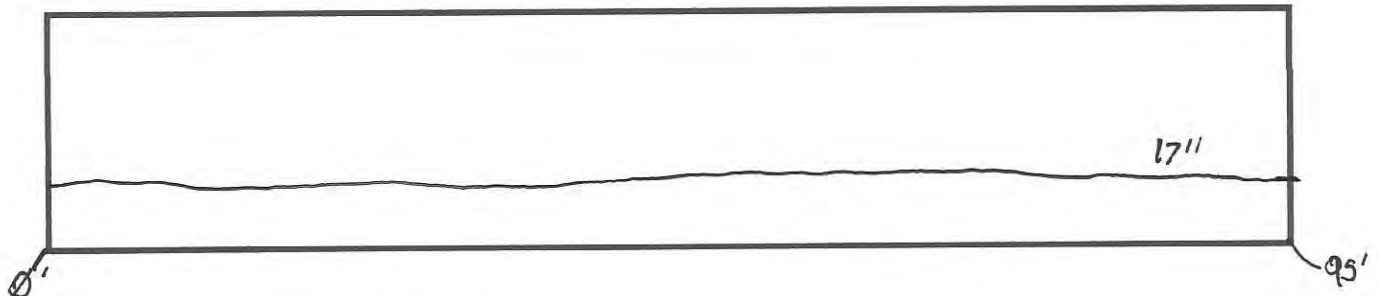
General Condition of Pipe: Location # was found to be a double bore pipe. The  
west Pipe and East pipe were found to be very similar in that they both Have a  
diameter of 72", a length of 95', a sediment level of 17", and are both CMP.
