# GRAND HARBOR COMMUNITY ASSOCIATION

## Property Condition Assessment Report of Findings

KHA No: 147699000

JANUARY 27, 2020

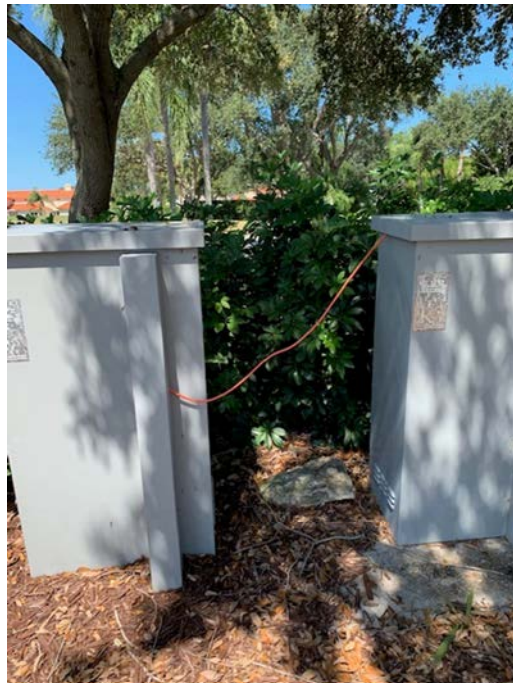
Photo 6.3 - Exposed wire coming from the electrical box near Saint David's.

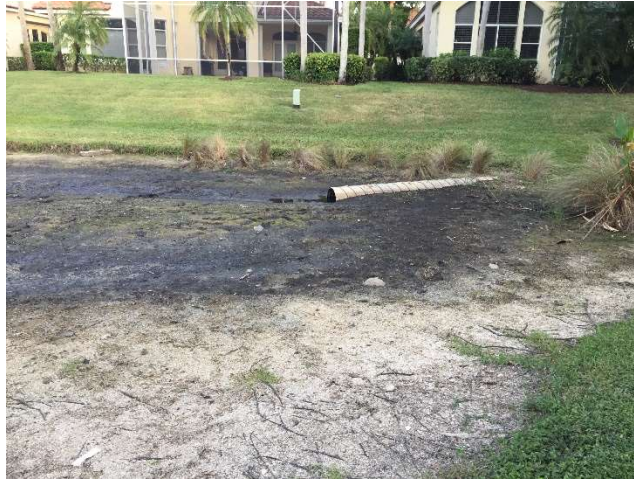
Severe siltation was observed in most ponds. This siltation causes the ponds to have less storage volume which can cause flooding conditions for the homes in its surrounding area. Some of these areas are experiencing enough siltation and have for a sustained period of time that vegetation has started to grow. It is recommended that all areas experiencing siltation be desilted immediately to the pond's permitted design conditions by excavating the first 100 linear feet outside of the interconnecting pipes. The technique described above for the pond banks uses silt/sand to fill the geotubes and restore back to permitted conditions. According to Newland Erosion Control, the silt used for this can be taken from the areas experiencing siltation.

See the images below demonstrating the siltation and erosion below. The siltation and erosion of this pond specifically is so severe that the banks and available water volume is significantly reduced when the water levels are at the permitted control elevations. These images were taken when the water level was above the control elevation but well below the modified water level.

*Photo 8.3 – Siltation in Pond #16*

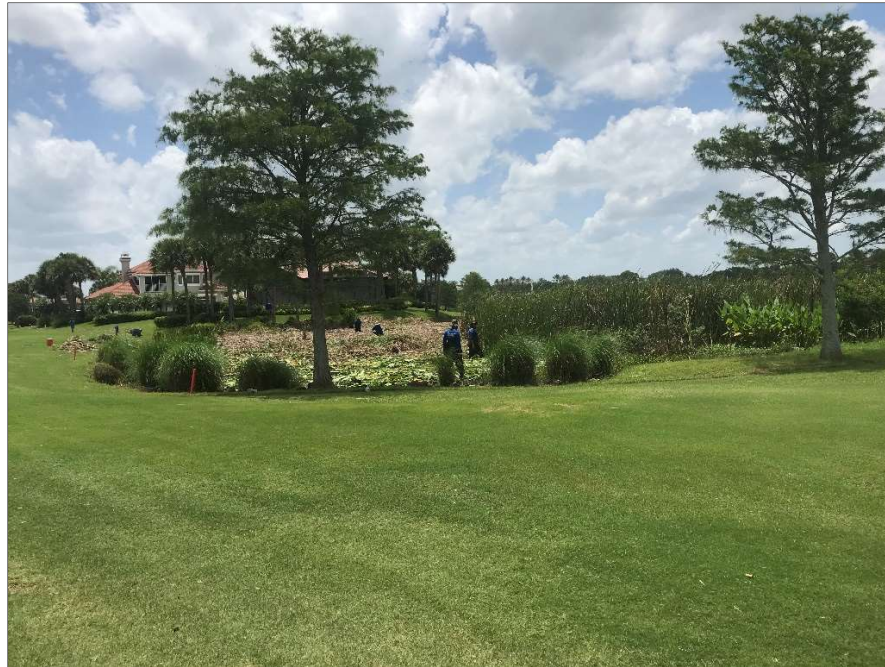
*Photo 8.9 – Maintenance crew removing cattail from littoral zone*

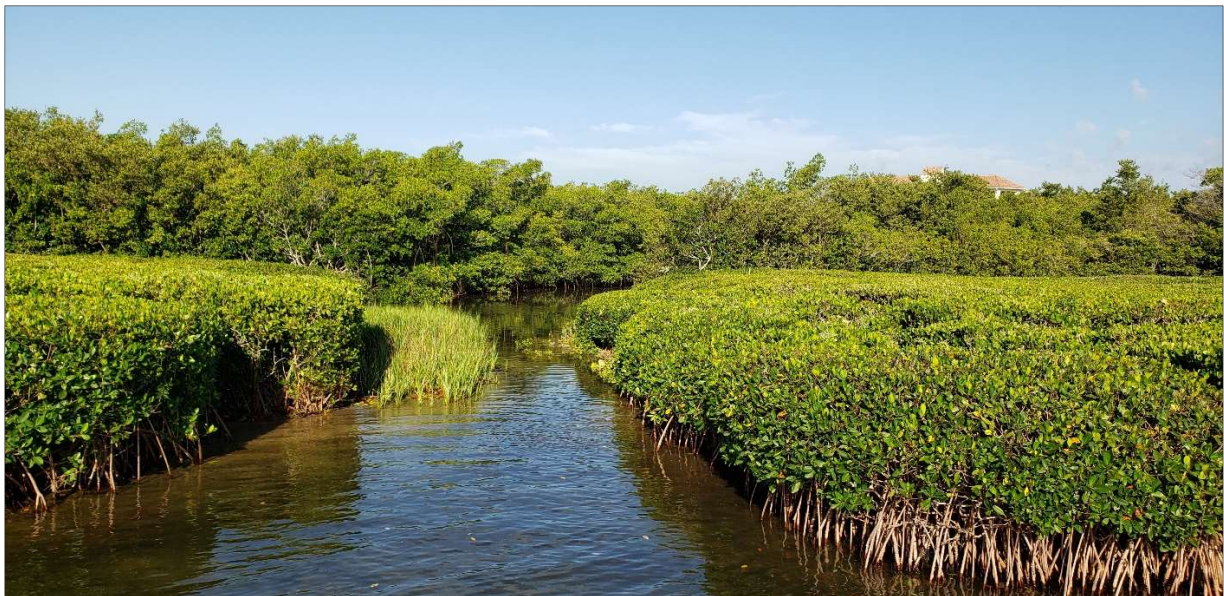
Two of the four permitted flushing channels were observed to be blocked due to excessive sediment accretion. Similar to the estuarine wetlands, it is our recommendation that these channels be restored to their permitted conditions. Consultation with FDEP and SJRWMD is also recommended to determine whether any additional permits are required for the work to be done. The dredging of the flushing channel should be authorized as maintenance of the existing permit to restore the channel to the original permitted configuration. FDEP and SJRWMD will require information regarding the proposed dredging method, and how spoil material and turbid water will be managed to prevent water quality degradation. In addition, only one navigation barrier exists in one of the flushing channels. Consultation with FDEP is recommended regarding the placement of additional navigation barriers seaward of the existing golf cart crossings. Consultation with Indian River Mosquito Control District is recommended to maintain adequate mosquito control regarding maintenance of the estuary and flushing channels. Refer to Appendix G for more information on the flushing channels and watercourses.

*Photo 15.8 – Blocked flushing channel at high tide, with red mangrove and smooth cordgrass*

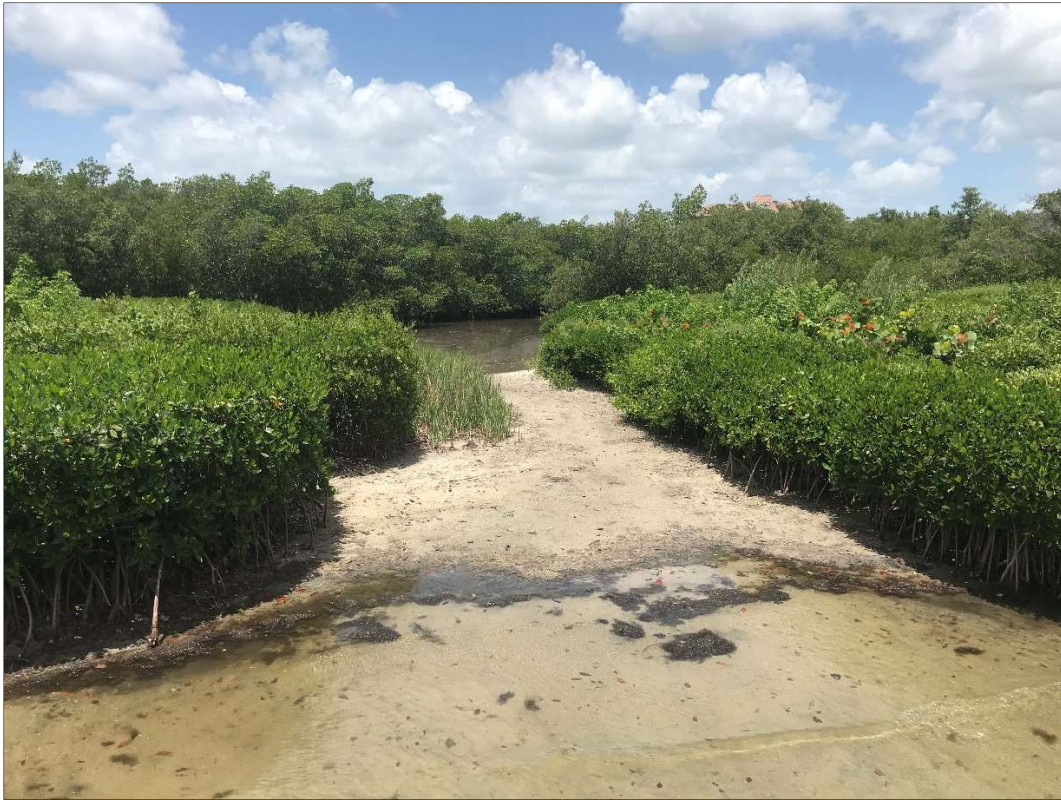
*Photo 15.9 – Blocked flushing channel at low tide, with red mangrove and smooth cordgrass*

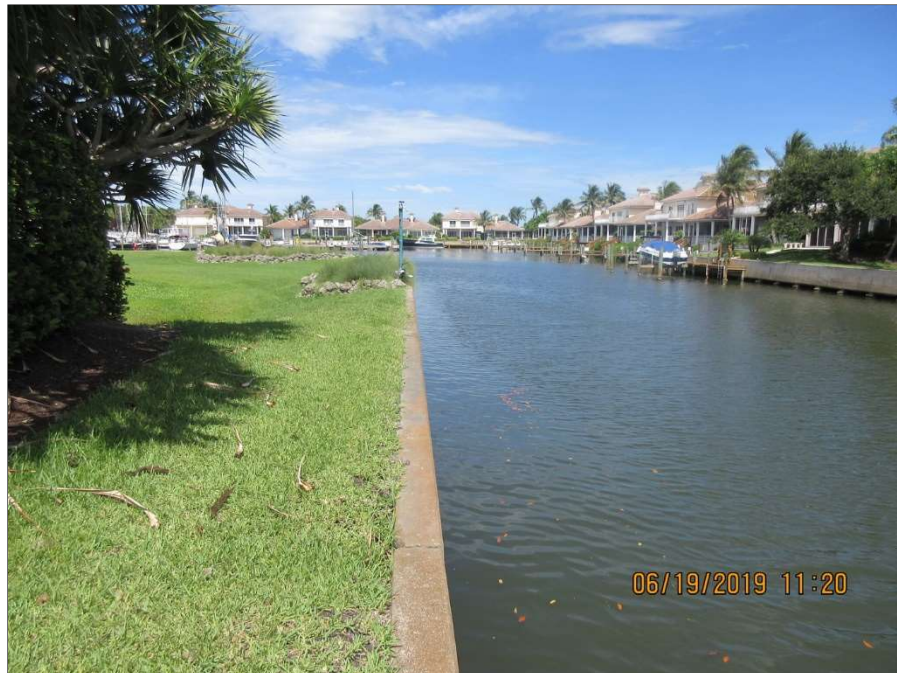
Photo 18.4 – Overview of Retaining wall Span #1

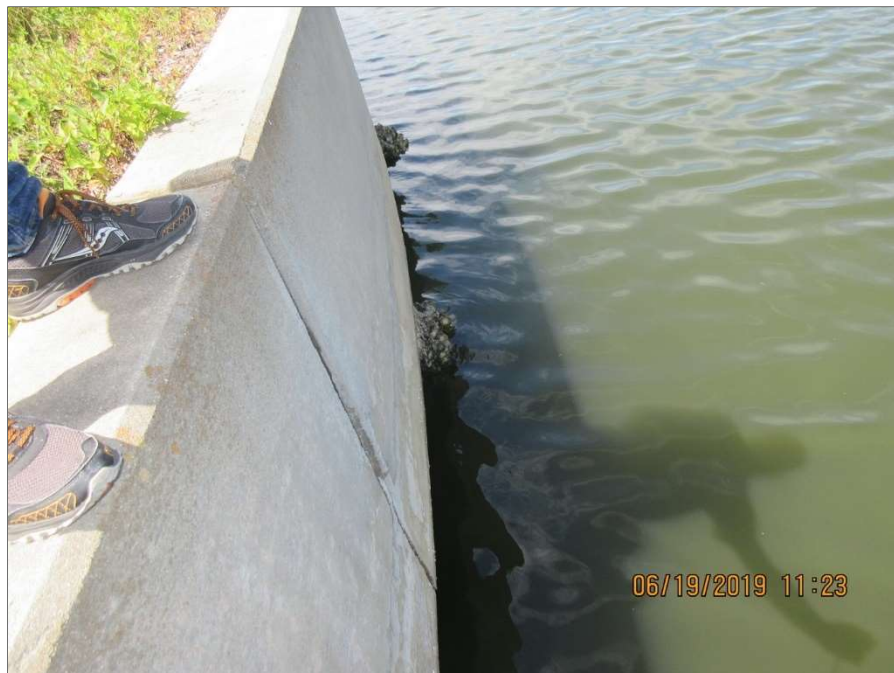
*Photo 18.6 –Overview of the water-side edge of Retaining wall Span #1*

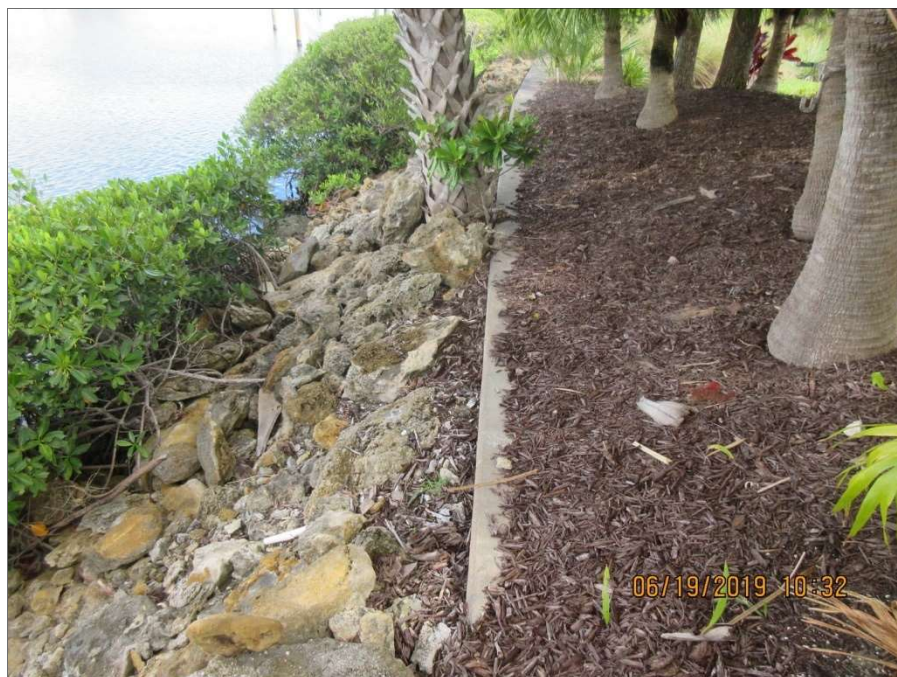
*Photo 18.9—Rock revetment covered the water-side; landscaping covered the land-side of Retaining wall Span #2*

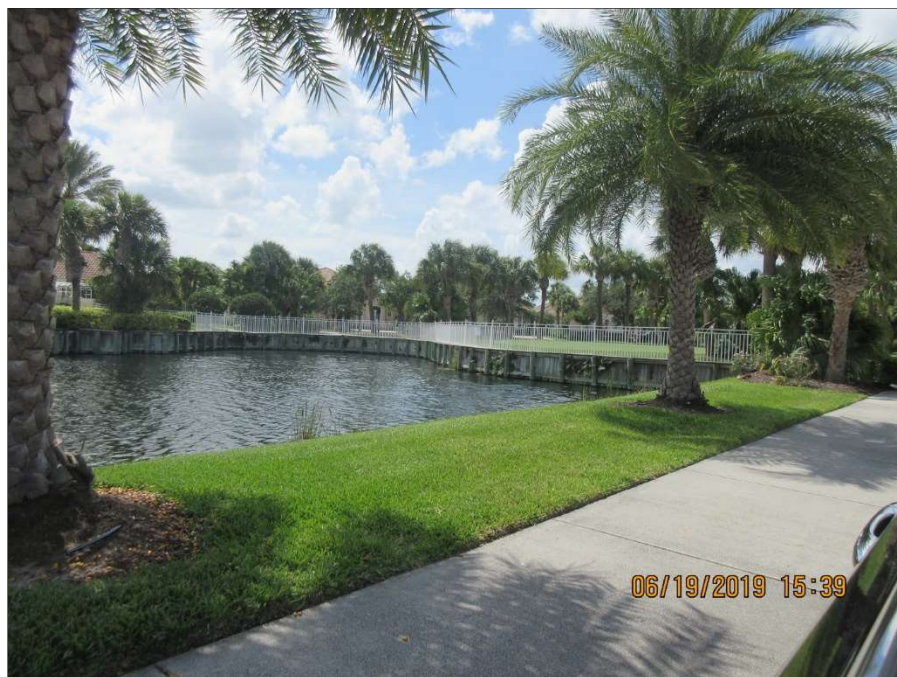
Photo 18.11 – Overview of wood retaining wall

Regarding the metal sheet pile retaining wall #3, with timber covering and cap, we recommend replacing the timber top surface board. The timber boards are missing at some locations and no longer properly connected at other locations. Due to continued exposure to the environmental elements, as well as long term submergence, the majority of the boards are splintered, cracked and rotted. The extent of the decay and deterioration observed in the timber boards deems them beyond repair. Because timber boards covered most of the metal sheet piles, the condition of the sheet piles is unknown. However, portions that were exposed did not exhibit any deficiencies. During replacement of the timber façade, we recommend a thorough inspection of the condition of the existing metal sheet piles.

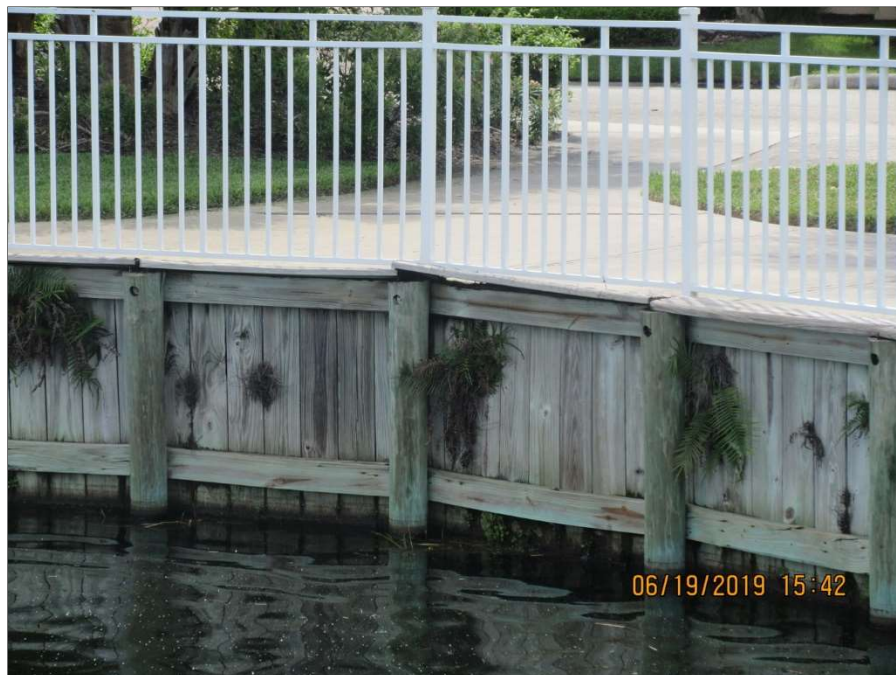
Photo 18.12 – Vegetation growing on retaining wall #3

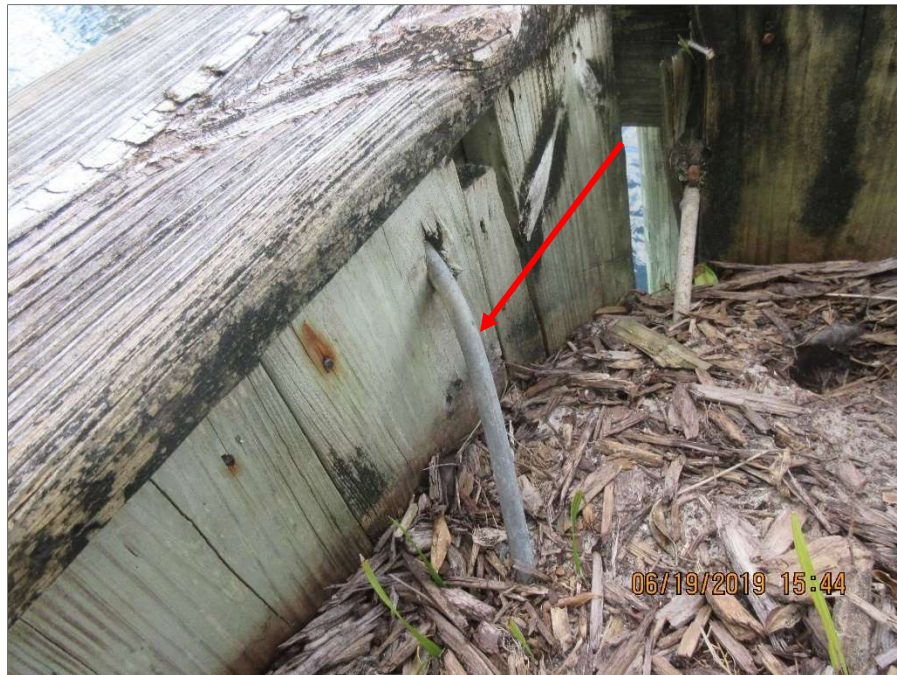
*Photo 18.14 – Bent tie back rod at Wall #3*

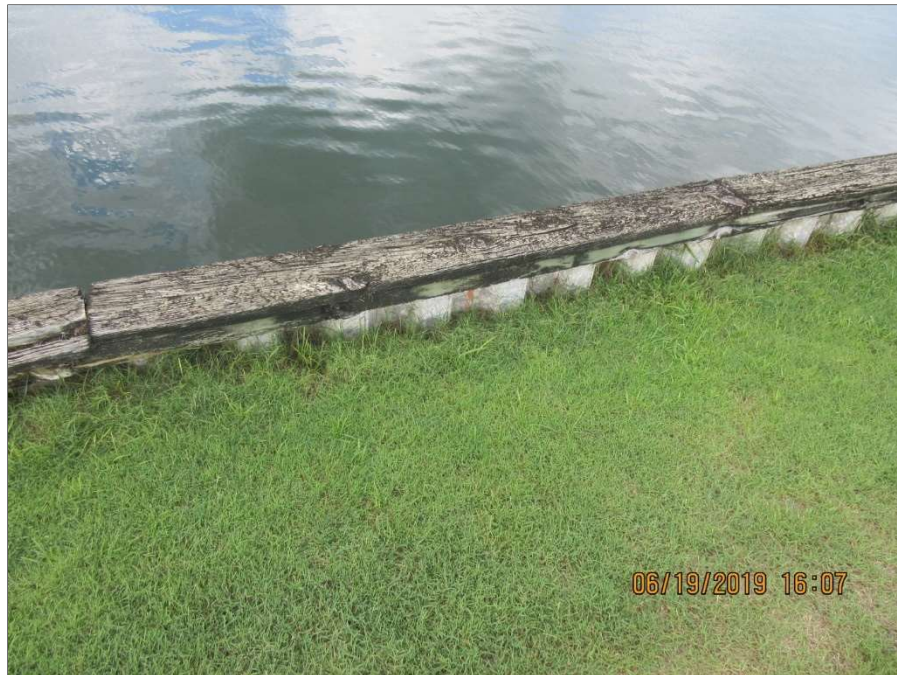
*Photo 18.18 –Exposed portion of landside of Retaining wall Span #4*

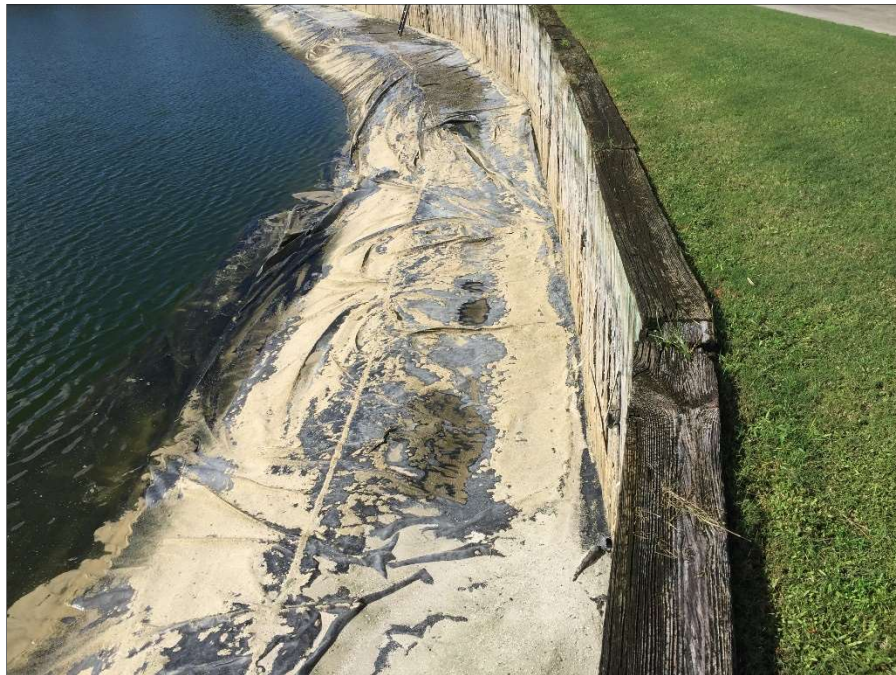
*Photo 18.21 – Pond liner in the recycled water reservoir with Retaining wall Span #4*

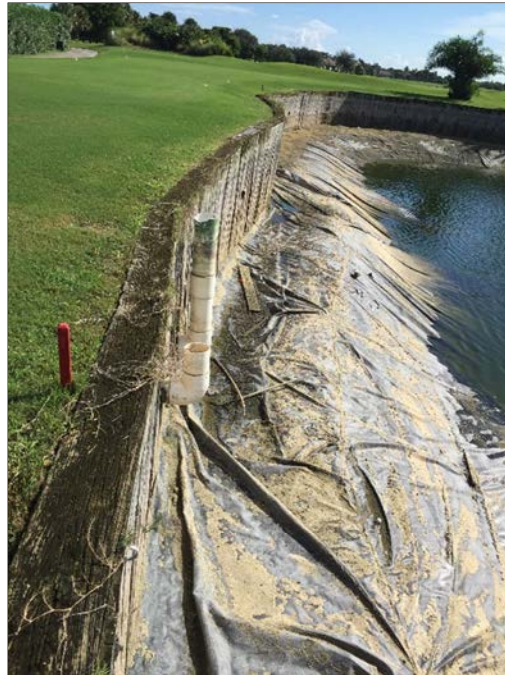
*Photo 18.22 – Pond liner in the recycled water reservoir with Retaining wall Span #4*

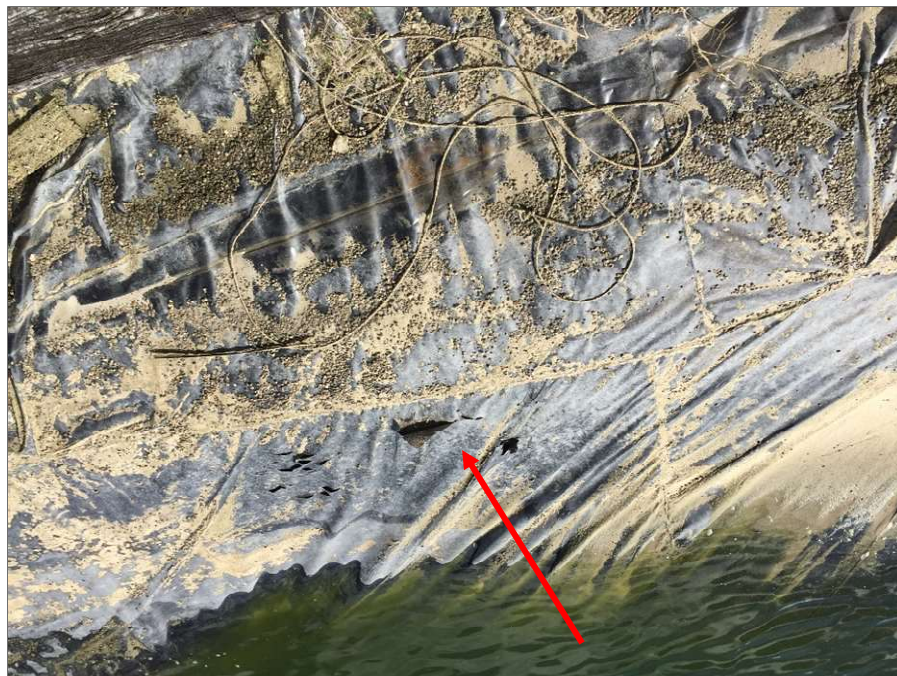
*Photo 18.23 – Pond liner in the recycled water reservoir with tears.*

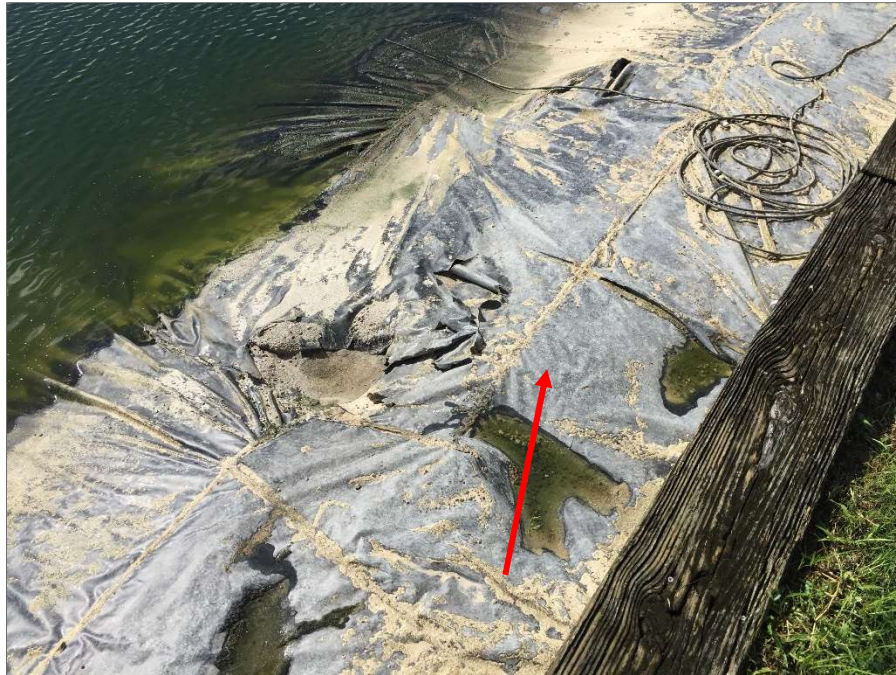
*Photo 18.24 – Pond liner in the recycled water reservoir with tears.*

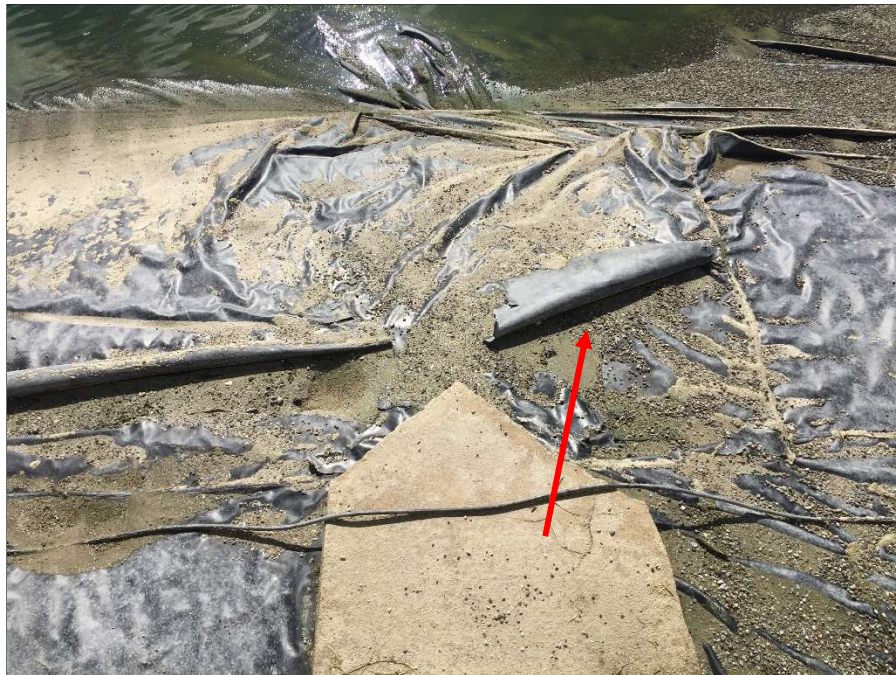
*Photo 18.25 – Pond liner in the recycled water reservoir with tears*

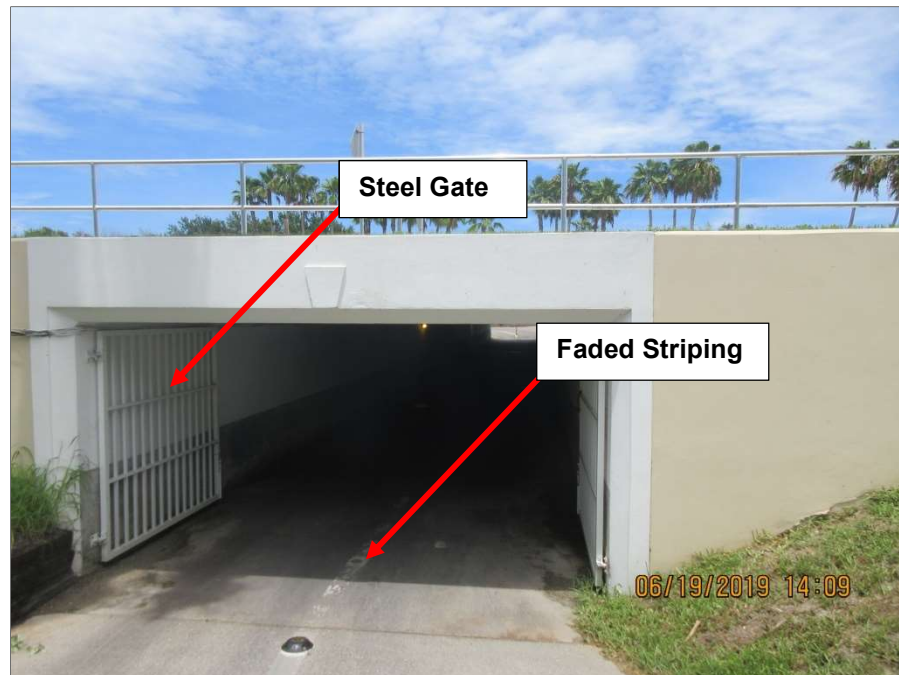
- Approximately 169 feet in length
- Tunnel #1 included a steel pedestrian gate at the west entry
- Paint delamination was observed on the ceiling
- Transverse cracks with evidence of water intrusion, including rust stains and efflorescence, were observed on the ceiling at multiple locations
- Evidence of ponding (poor drainage) was observed at the perimeter walls of the tunnel
- Cracks spanning the full height of the tunnel walls and a transverse crack on the slab on grade
- Striping is deteriorated and faded

Photo 19.1 –Steel Gate at entry of Tunnel #1. Note faded striping.

In regard to the cast in place concrete tunnels (#1 through #4), we recommend sealing the overhead concrete cracks and leaks with a polyurethane chemical grout, and routing and sealing the cracks on slab on grade and tunnel walls of all four tunnels. We also recommend correcting the poor drainage deficiency to allow water to properly run off the surface. The localized concrete spalling should be repaired by chipping around the damaged area, cleaning the reinforcing steel, and applying a quick set grout. The patch can then be painted to match the existing paint on the tunnels. Additionally, it is recommended that the impact damages to the finish be corrected and re-painted at the entry of tunnel #4.

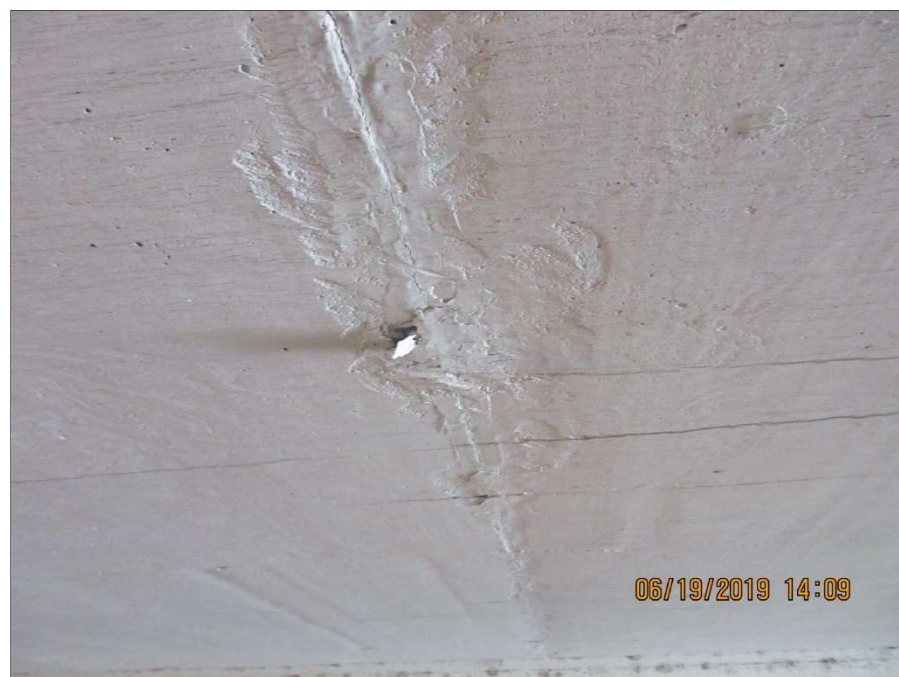
Photo 19.2 –Paint delamination of the ceiling of Tunnel #1

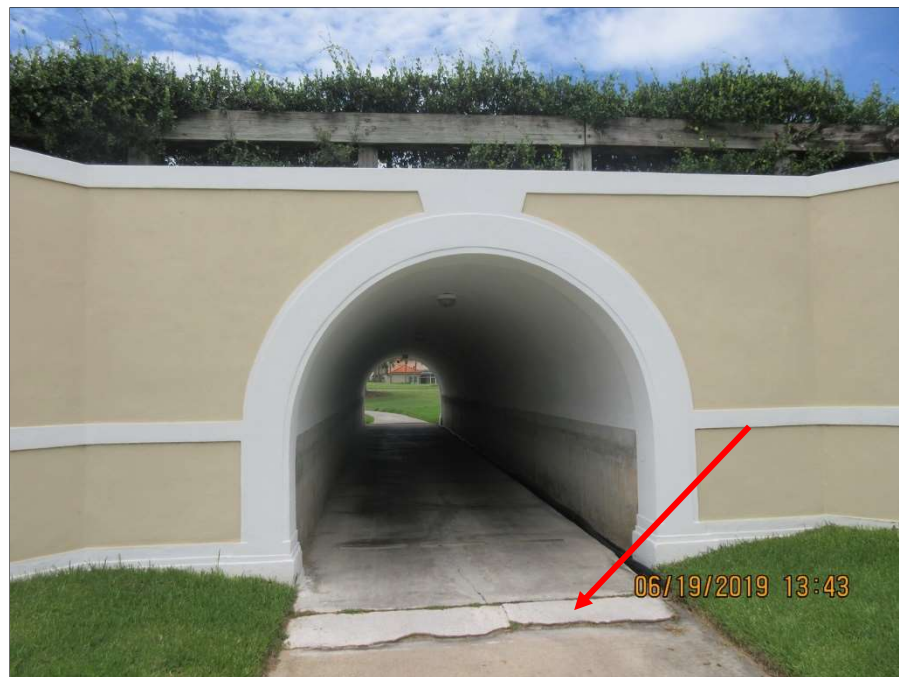
- Approximately 73 feet in length
- Evidence of slab modifications. Additional topping slab observed above the original elevation of the pedestrian pathway
- Cracks in the concrete topping-slab throughout
- Localized concrete spall was observed at one location

Photo 19.8 – Post-modified topping slab at Tunnel #2

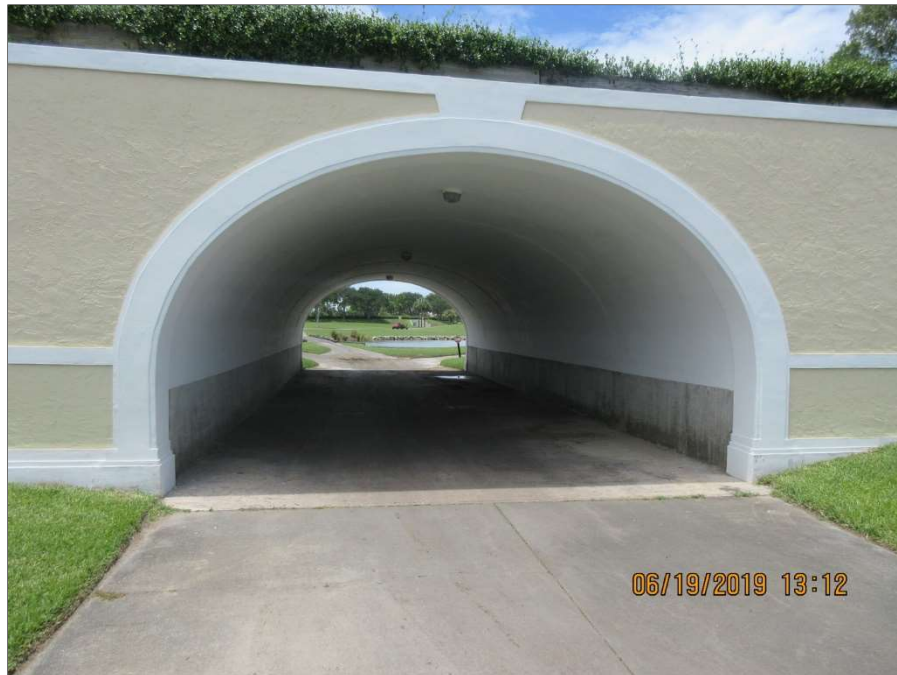
Photo 19.11 – Overview of Tunnel #3

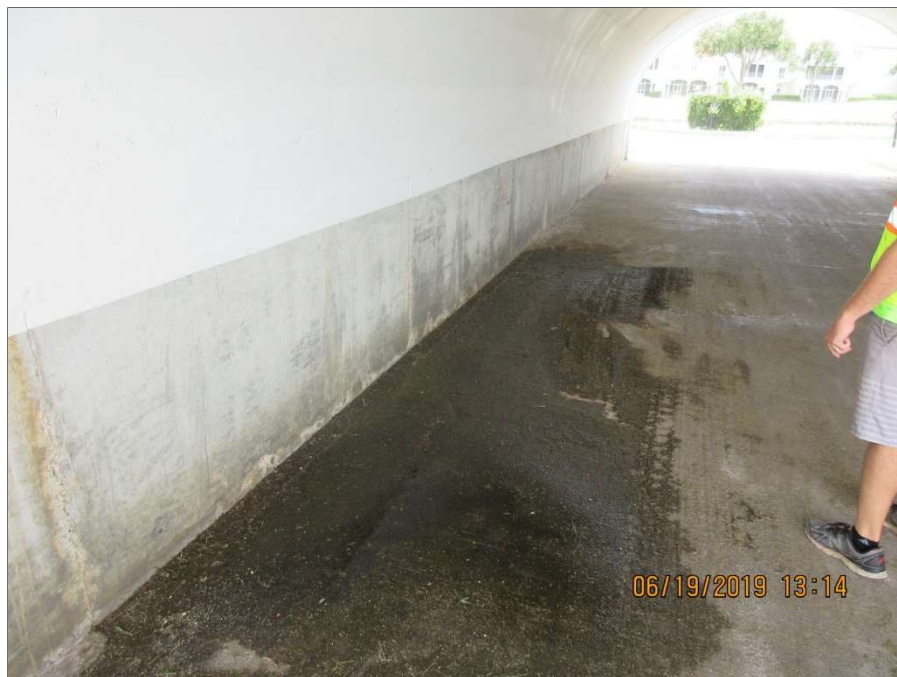
- Approximately 63 feet in length
- Cracks on the concrete slab on grade throughout
- Localized concrete spall with exposed reinforcing
- Evidence of ponding (poor drainage) was observed at the perimeter walls of the tunnel

*Photo 19.14 – Evidence of ponding/poor drainage at Tunnel #3*

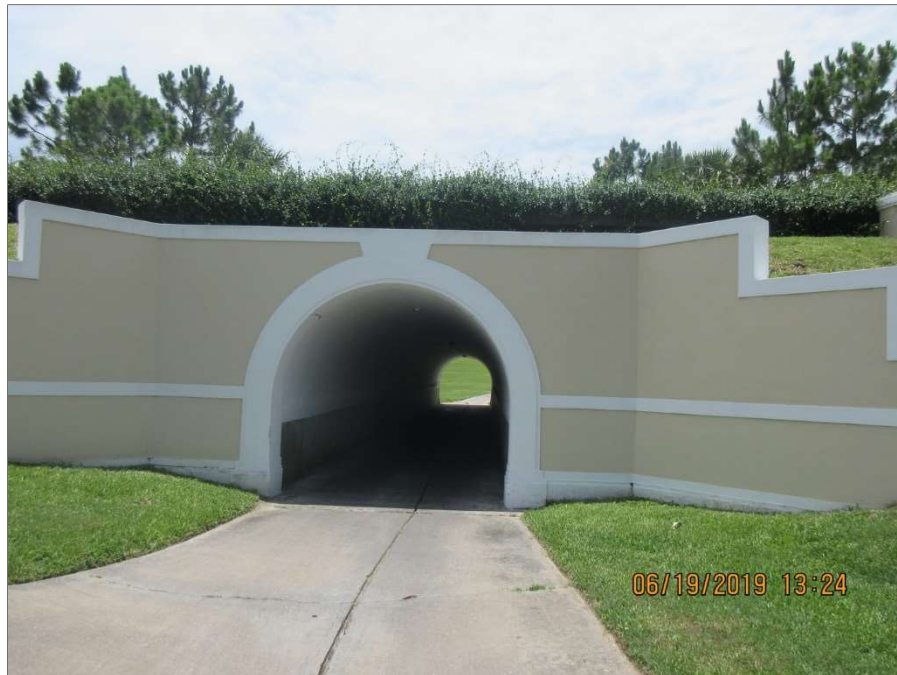
*Photo 19.15 – Overview of Tunnel #4*

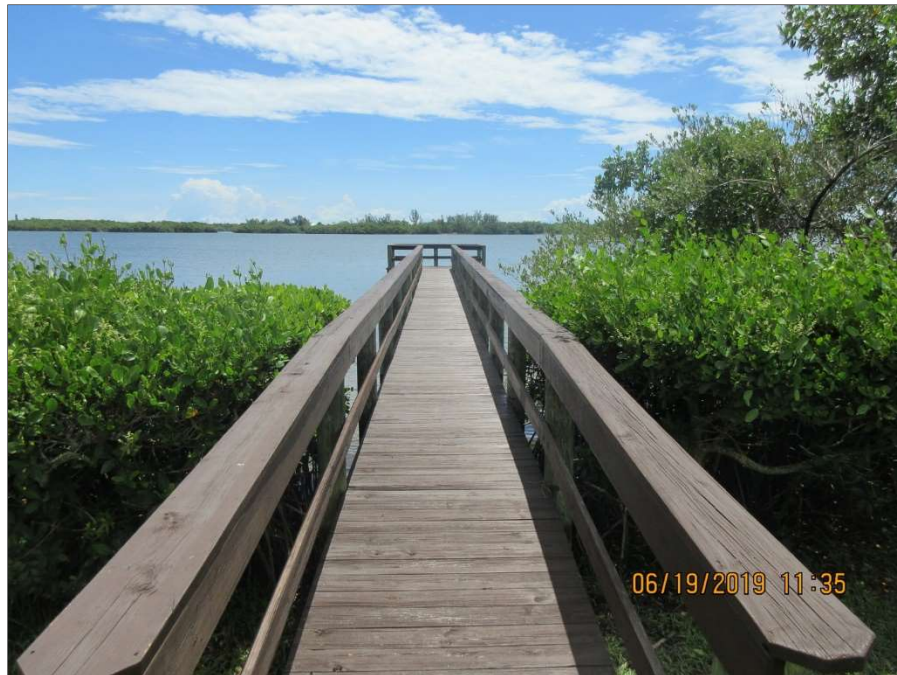
*Photo 20.1 –Overview of River Village Pier*

It is recommended that on the River Village Pier, the cross bracing throughout be removed and replaced with new anchor attachments. The cross bracing is missing, damaged or rotting and no longer providing the intended structural capacity.

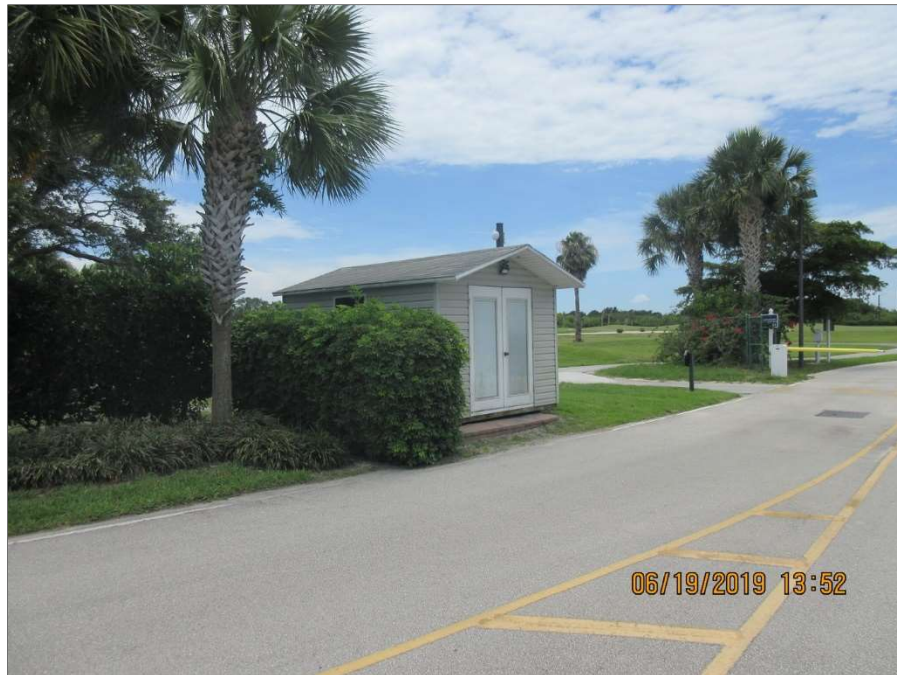
Photo 20.5 – Overview of Via Marbella Guard Shack

At the guard shack, we recommend it being removed and replaced.

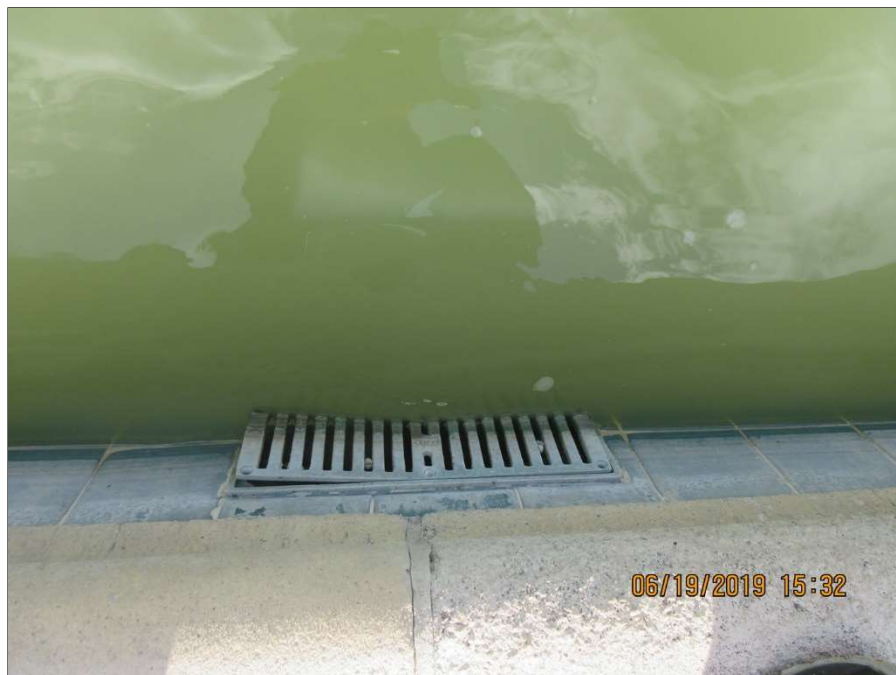
- Shrinkage cracks observed on the perimeter coping
- Bent skimmer plate
- Finish delamination on the walking surface surrounding the fountain
- Fountain lighting not working

Photo 20.12 – Bent skimmer in fountain
