# GRAND HARBOR COMMUNITY ASSOCIATION

## Property Condition Assessment Report of Findings

KHA No: 147699000

JANUARY 27, 2020

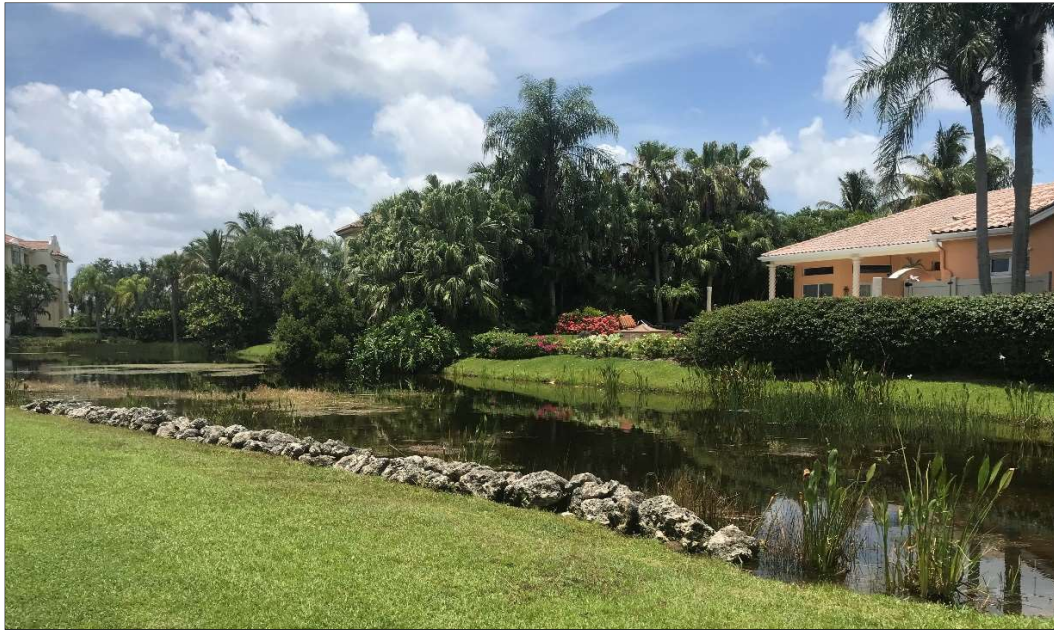
The FDEP and SJRWMD permits require 30% of the lake area (22.1 acres) to be vegetated littoral shelf, with at least 80% coverage of desirable wetland species. However, based on field reconnaissance, the area of littoral shelf that currently meets the vegetation requirement is approximately 8.9 acres. In addition, the species composition and distribution present in the existing littoral shelf does not match the permitted plans. Exotic and noxious species, including cattail, Brazilian pepper, and Mexican primrose willow, were observed in around the littoral zones. It is our recommendation that the littoral zones be restored to permitted conditions. Consultation with SJRWMD and FDEP is recommended if any modifications to the permits are sought. Upon consultation with FDEP and/or SJRWMD, additional planting of littoral zone vegetation may be required to maintain permit compliance. Removal of exotic and noxious vegetation from the littoral zones is recommended.

*Photo 8.7 – Littoral zone with sparse coverage of arrowhead*

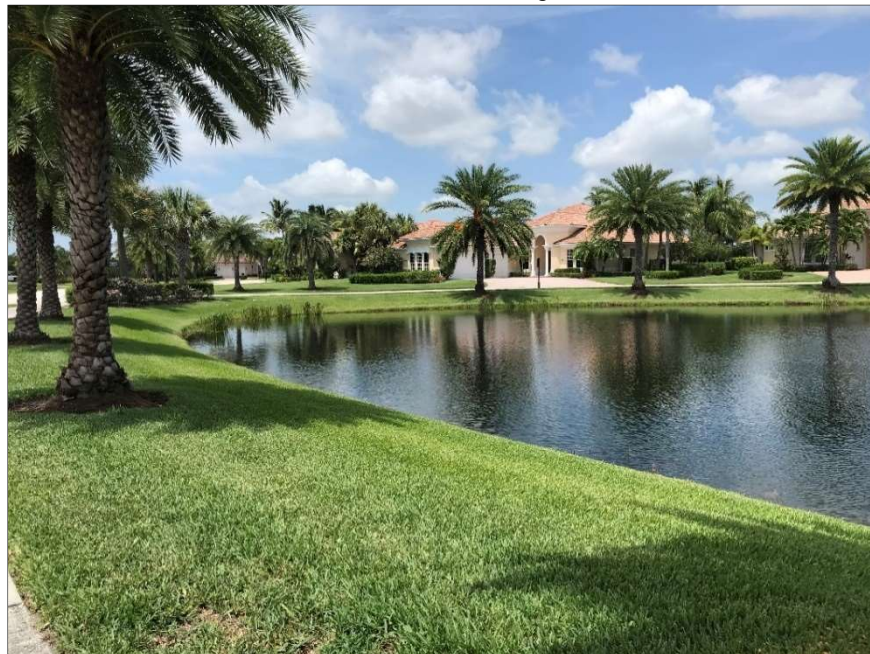
*Photo 8.12 – Littoral zone with minimal coverage of arrowhead*

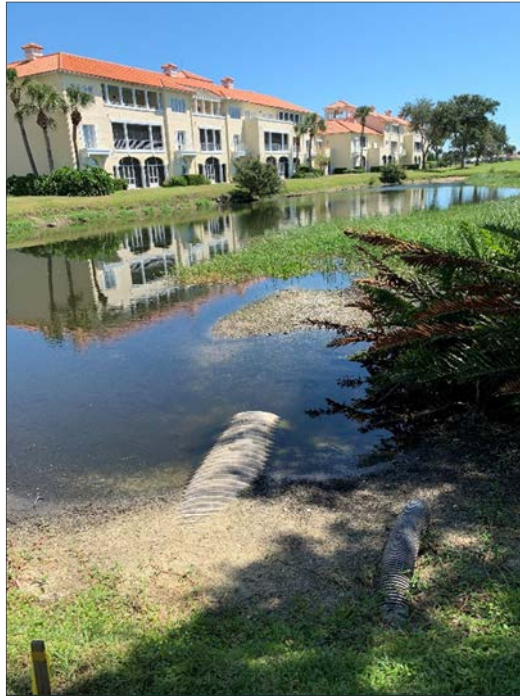
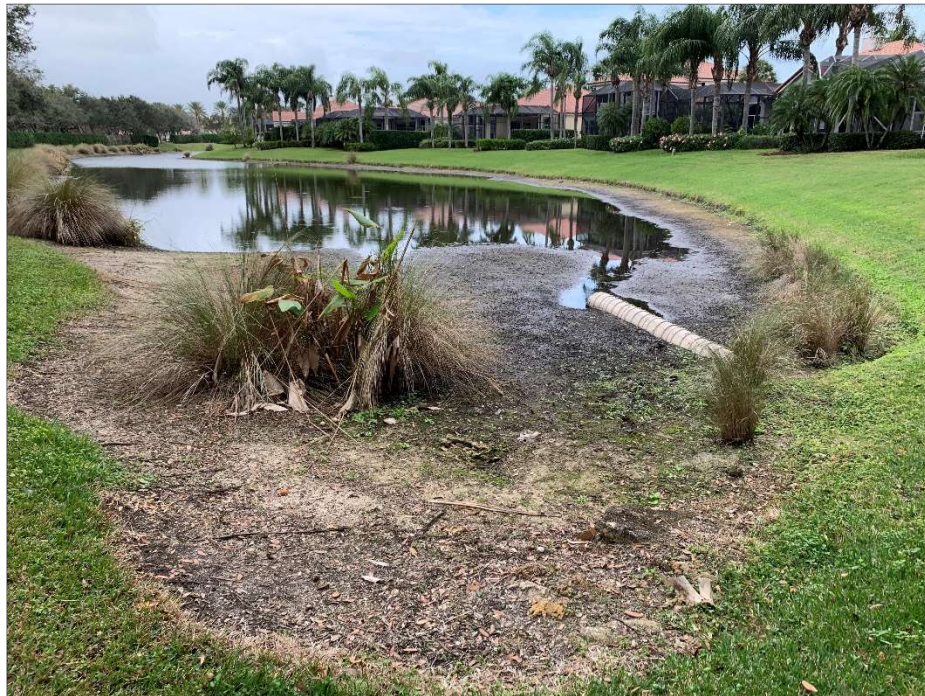
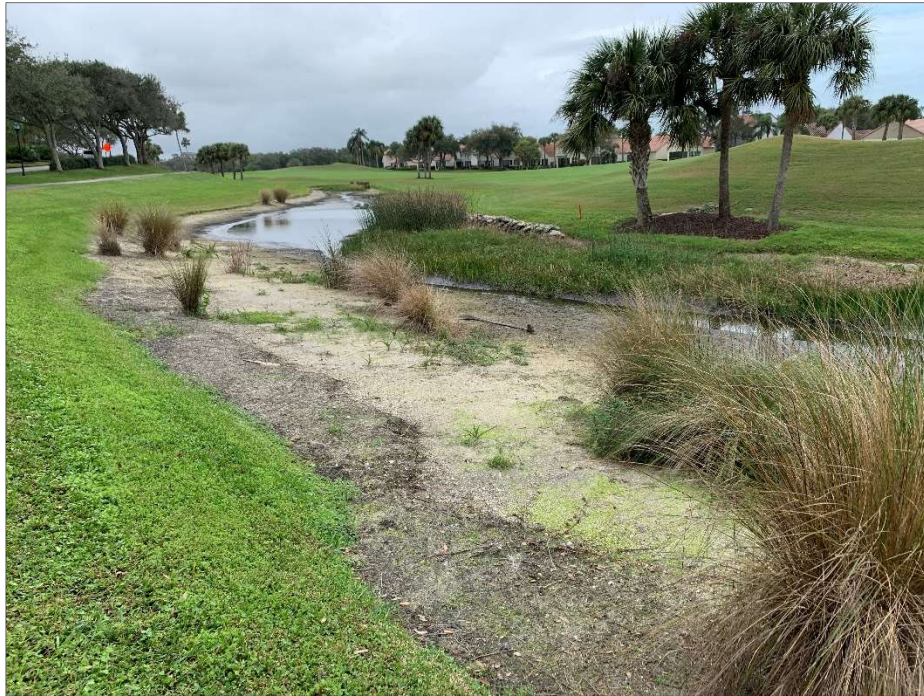
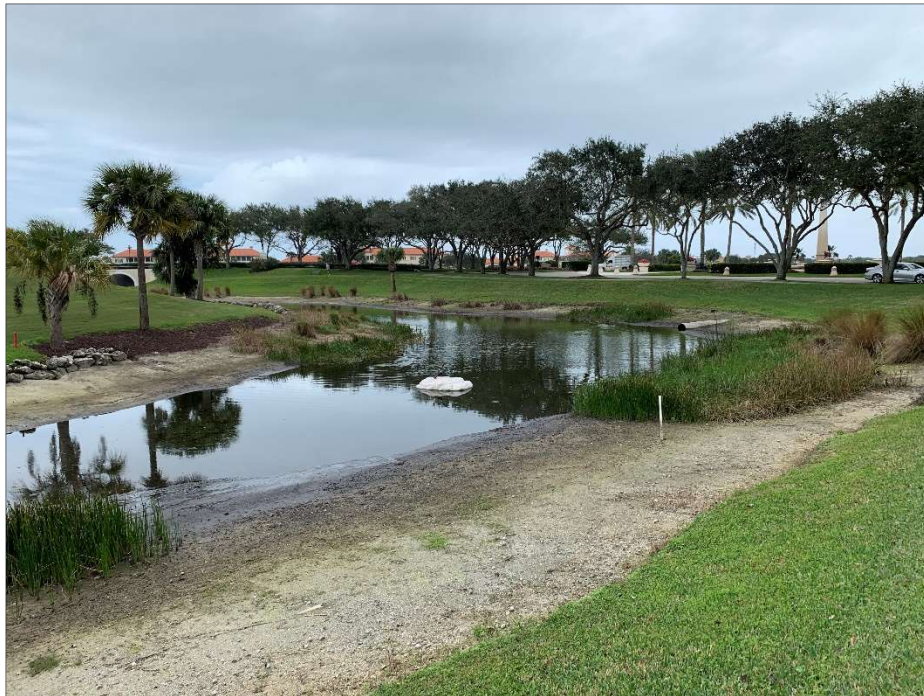
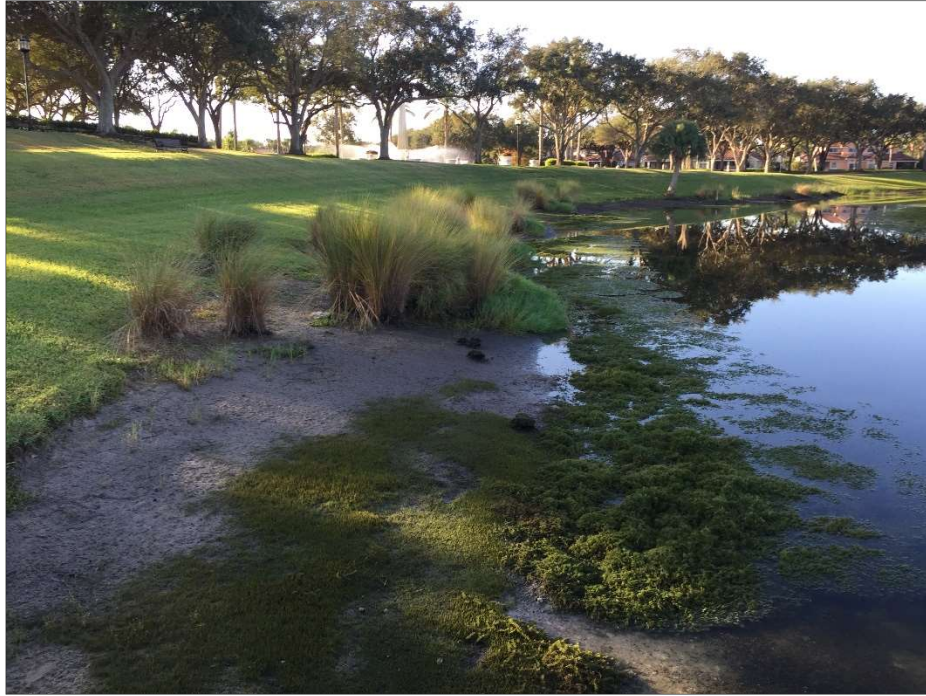
Severe siltation was observed in most ponds. This siltation causes the ponds to have less storage volume which can cause flooding conditions for the homes in its surrounding area. Some of these areas are experiencing enough siltation and have for a sustained period of time that vegetation has started to grow. It is recommended that all areas experiencing siltation be desilted immediately to the pond's permitted design conditions by excavating the first 100 linear feet outside of the interconnecting pipes. The technique described above for the pond banks uses silt/sand to fill the geotubes and restore back to permitted conditions. According to Newland Erosion Control, the silt used for this can be taken from the areas experiencing siltation.

*Photo 8.13 – Pond siltation*

*Photo 8.14 – Pond siltation*

*Photo 8.15 – Pond siltation*

*Photo 8.16 – Pond siltation*

*Photo 8.17 - Pond siltation*

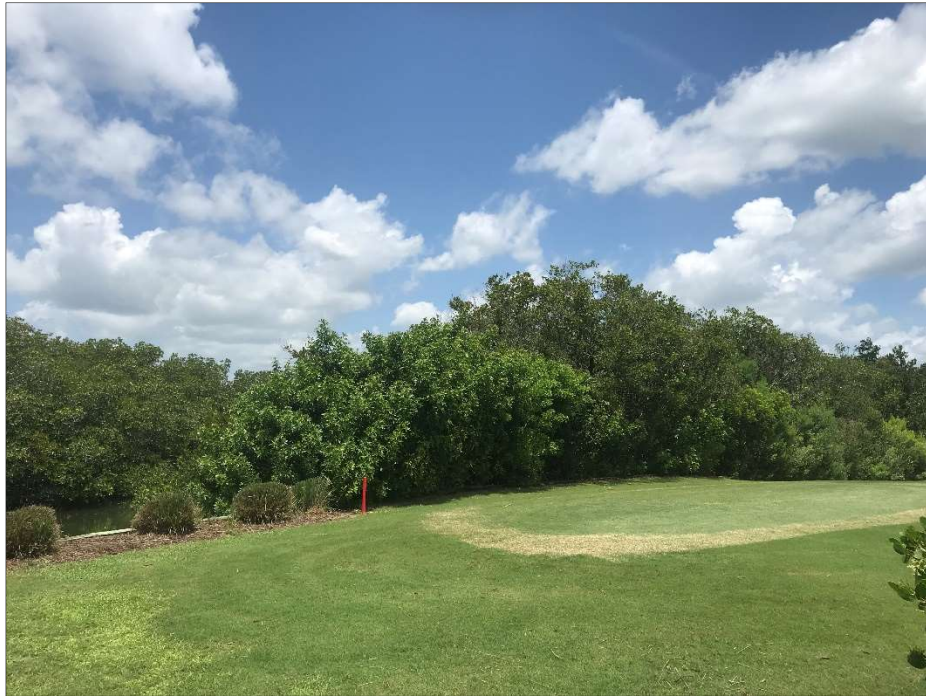
Vegetative conditions in the estuarine wetlands appear to be in compliance with the FDEP and SJRWMD permits. Coverage of exotic vegetation, such as Brazilian pepper, was extensive but was limited to the landward edges of the system in most cases. Exotic vegetation must be removed as required by the Conservation Easement in effect for the estuarine area. The estuarine system was originally designed to function as a saltwater marsh, with a prevalence of herbaceous vegetation such as smooth cordgrass, saltwort, glasswort, saltgrass, and sea ox-eye daisy. However, the existing vegetative species composition is dominated largely by mangroves. Recruitment and proliferation of mangrove species in the wetlands was documented in the vegetation monitoring reports that were submitted to and accepted by FDEP and SJRWMD, indicating that the natural succession of vegetative communities is in compliance. However, the hydrologic condition appears to be inadequate based on aerial approximation and ground truthing. The watercourses appear to be experiencing siltation that does not allow for adequate tidal flushing of the estuarian system partly due to the growth of mangroves. Therefore, it is our recommendation to have these areas re-channelized to permitted design conditions as the upkeep of these areas is a maintenance obligation per a provision in the Conservation Easement. This process would include the removal of mangroves; therefore, it is also recommended to consult with FDEP before work has commenced to know if a mangrove removal permit or any additional permits are required.

*Photo 15.3 – Brazilian pepper observed growing next to red mangroves in the estuarine system*

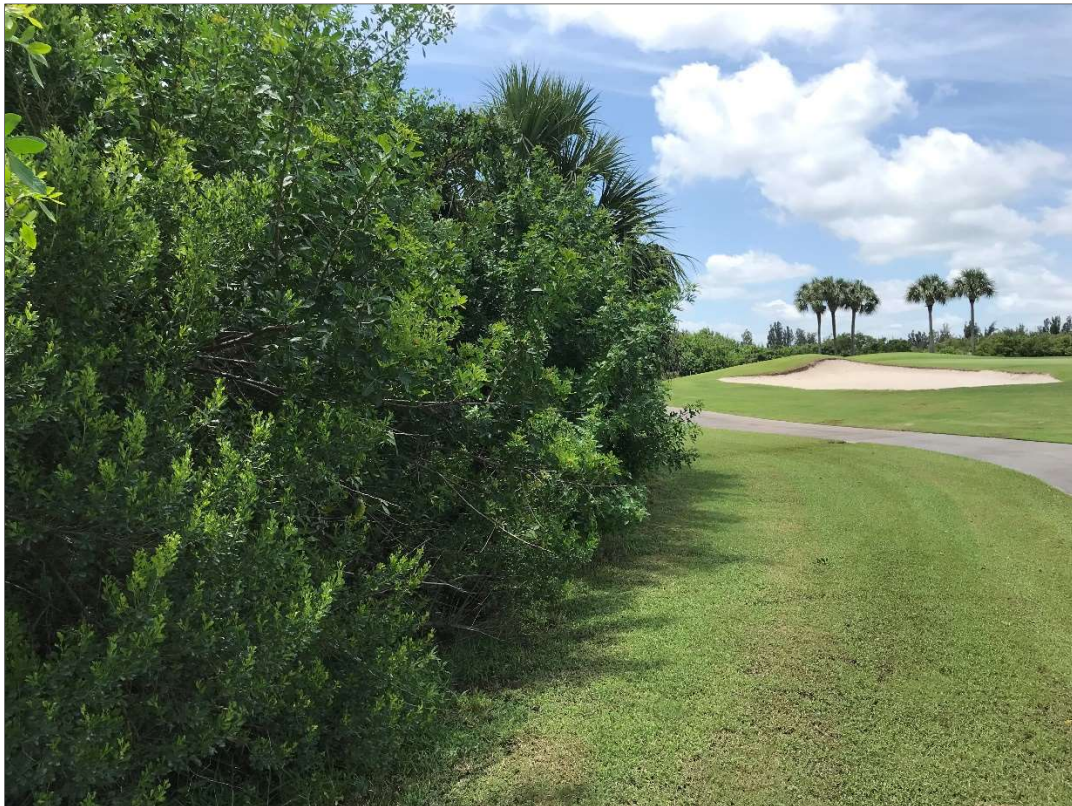
*Photo 15.4 – Brazilian pepper, saltbush, and cabbage palm growing along estuarine wetland edge*

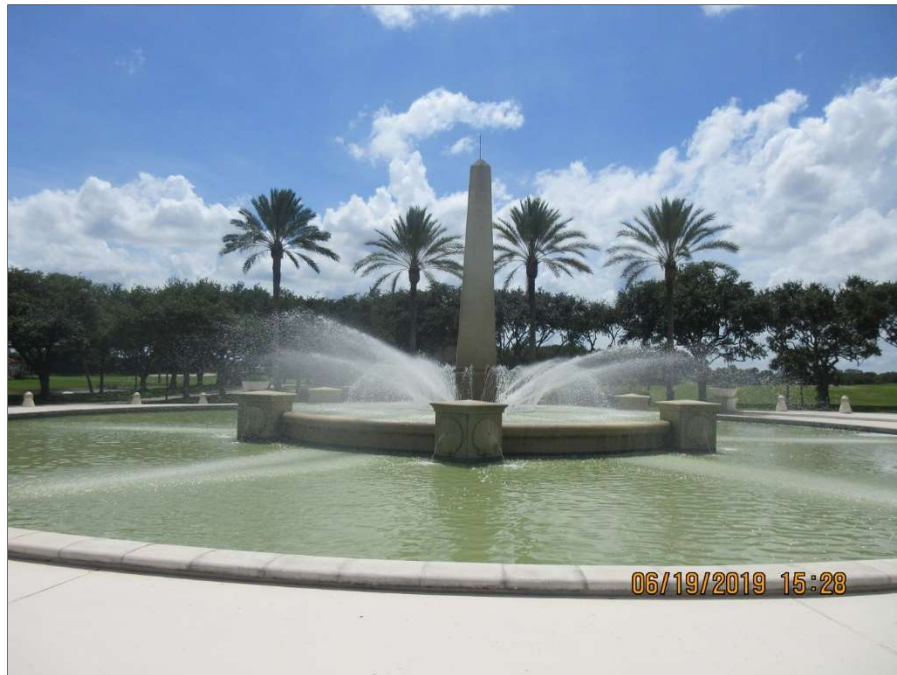
*Photo 20.9 – Overview of Fountain*

At the fountain, we recommend re-sealing the coping to prevent water infiltration and degradation of the coping and slab. The lighting within the fountain was also found to be non-functioning. We recommend replacing all light bulbs or fixtures. There are approximately 30 fixtures.
